## INTERSTATE COMMERCE COMMISSION

REPORT OF THE DIRECTOR OF THE BUREAU OF SAFETY IN RE  
INVESTIGATION OF AN ACCIDENT WHICH OCCURRED ON THE  
GREAT NORTHERN RAILWAY NEAR INDEX, WASH., ON  
SEPTEMBER 4, 1930.

October 17, 1930.

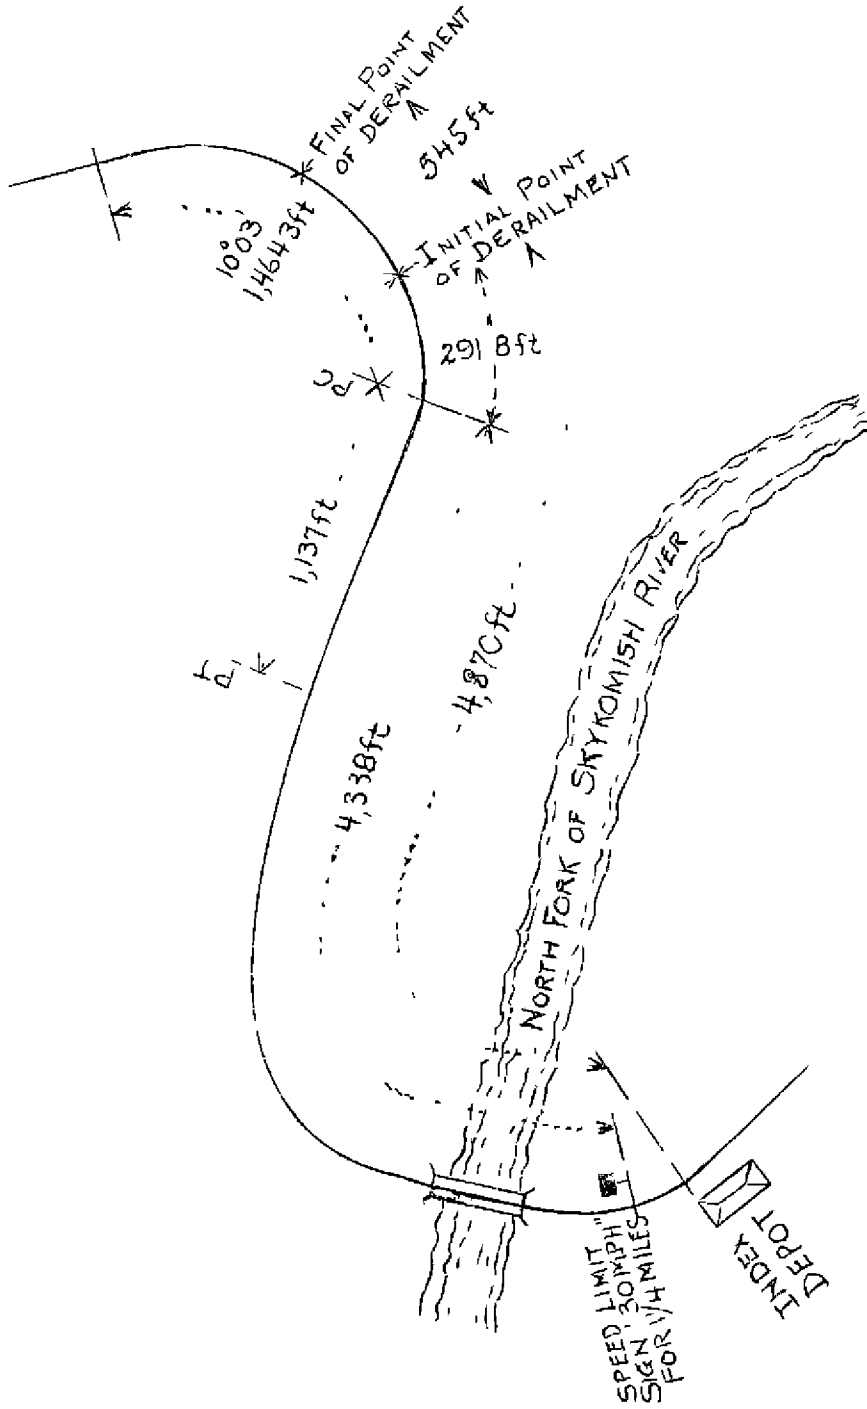
INV. No. 1662

GREAT NORTHERN RAILWAY  
INTEX, WASH.  
Sept. 4, 1930.
