REPORT OF ACCIDENT ON
THE GREAT NORTHERN RAILWAY NEAR
SHARON, N. DAK., DECEMBER 30, 1911

BY THE CHIEF INSPECTOR OF
SAFETY APPLIANCES

REPORT OF THE ENGINEER-PHYSICIST OF THE
BUREAU OF STANDARDS

REPORT OF THE CHIEF INSPECTOR OF SAFETY APPLIANCES COVERING HIS INVESTIGATION OF AN ACCIDENT WHICH OCCURRED ON THE GREAT NORTHERN RAILWAY NEAR SHARON, N DAK, DECEMBER 30, 1911, ACCOMPANIED BY REPORT OF THE ENGINEER-PHYSICIST OF THE BUREAU OF STANDARDS COVERING HIS INVESTIGATION OF THE BROKEN RAIL CAUSING THIS ACCIDENT

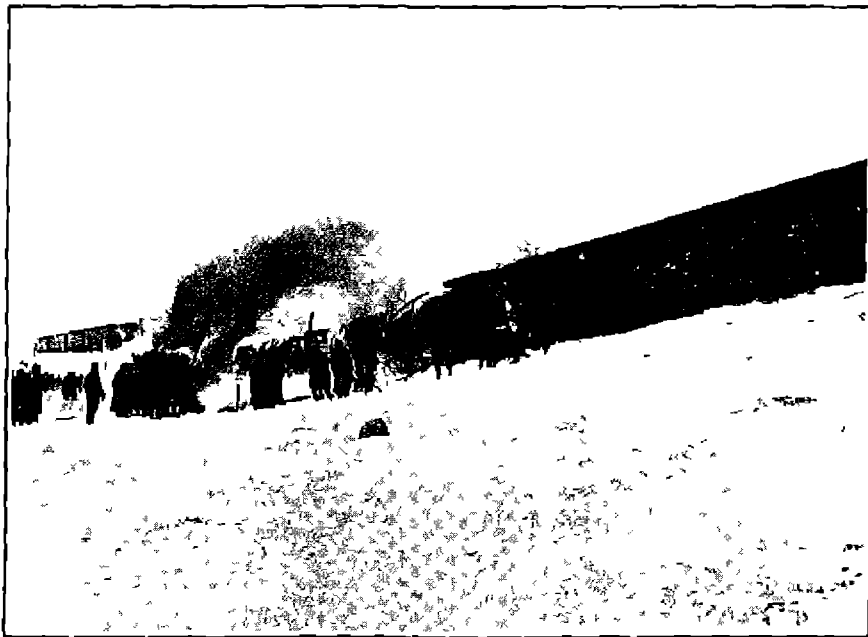
FIG. 1.—General view of wreck

The scene at the derailment is shown by photographs, figures 1 and 2, which were taken soon after the occurrence and while the cars were still burning

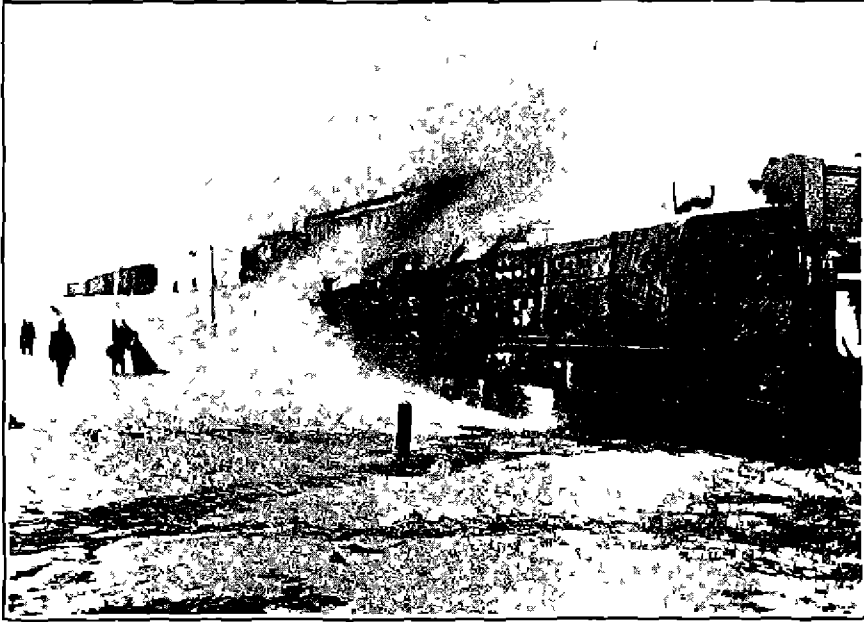
FIG 2—Dining car burning at foot of embankment

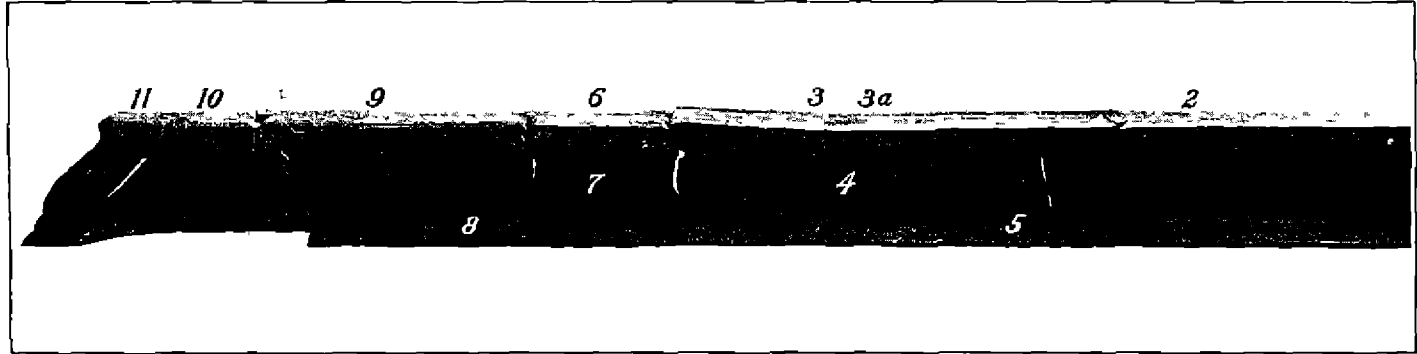
followed by the fracture of the web and head between fragments Nos 6 and 7 and fragment No 9, shown in figure 3. Other lines of rupture followed in succession. The lines of rupture at the westerly end of piece No 2, shown in figure 3, and the easterly, or receiving end of piece No 18 shown in figure 4 represent the limits between which all the fractures in this rail were developed. The fissure in the head extended from a point near the easterly end of piece No 1 along the length of the rail into fragment No 11. Etching of fragment No 12 showed the split head, or fissure, to extend into that fragment, but it could be traced no farther. Figures 5 and 6 clearly show the black line on the running surface of the head of the rail, indicative of interior defects.

Figure 3 shows fragments Nos 2 to 11, inclusive, as they were marked for identification. No 1 was a short piece cut off at St Paul, into which the fissure of the split head extended, but which it was not necessary to represent in a photograph.

FIG 3—Fragments of broken rail, viewed from gauge side Easterly portion of fragments

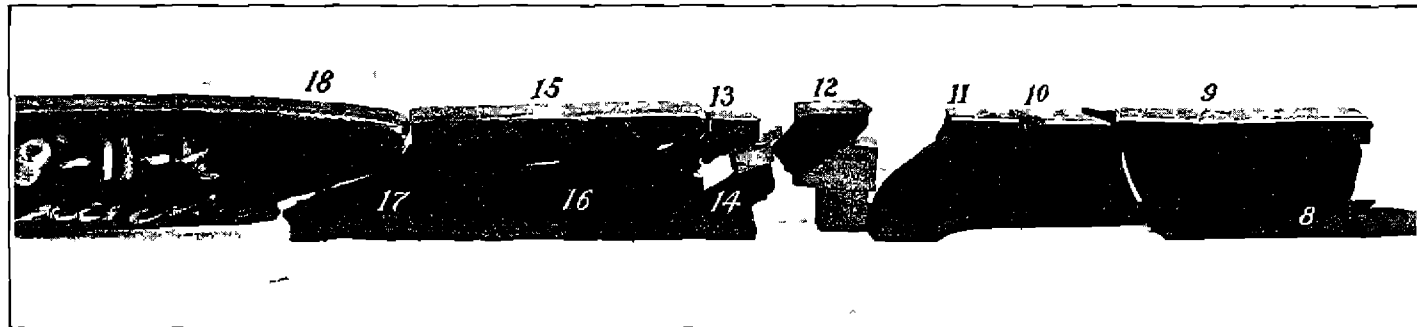
Figure 4 shows the balance of the fragments included within the 5 foot 5 inch section. The direction of the movement of tram No 3 was from right to left over the rail, as photographed. The lines of rupture at the westerly end of piece No 2 and the easterly end of piece No 18 represent the limits between which the track fractures were developed. The fissure of the split head extended from a place near the easterly end of piece No 1, along the length of the rail into fragment No 11, an open fissure nearly 8 feet long, while upon etching fragment No 12 the split seemed to be present in that fragment, but could be traced no farther.

FIG 4—Fragments of broken rail viewed from gauge side Westerly portion of fragments

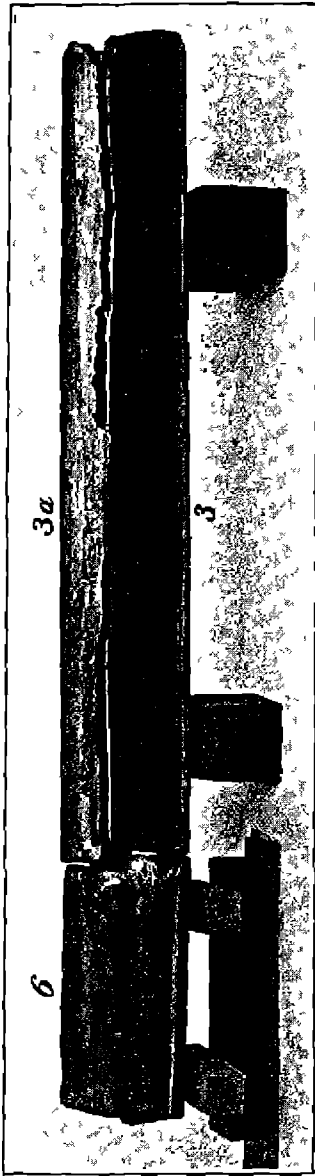
Figures 5, 6, and 7 show the running surface of the rail. The usual dark band along the middle of the head, indicative of a split head, was visible for the greater part of the length which was fissured. There was a measurable increase in the width of the head over a considerable part of the length of the fissure. No further remarks need be made concerning the appearance of the running surface since the familiarity of track inspectors with such examples is very complete. The flaked surface of the head immediately on each side of the fracture between fragments 6 and 9 will be noted on figure 6. The receiving ends of all other fragments were battered by the blows of the wheels as they were in succession detached from the main part of the rail, excepting the halves of the split head Nos 3 and 3a, that were forced off the web.

FIG 5—Fragments of broken rail, viewed from top. Easterly portion of fragments. Showing battered receiving end of fragment No 6

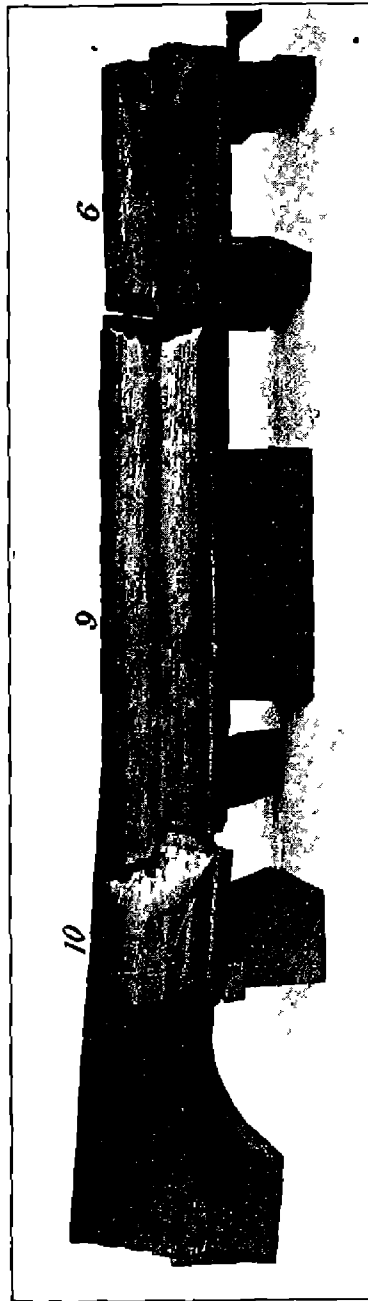
FIG 6—Fragments of broken rail, viewed from top. Middle portion of fragments. Showing battered receiving ends of fragments Nos 6 and 10, and where metal flaked off between Nos 6 and 9

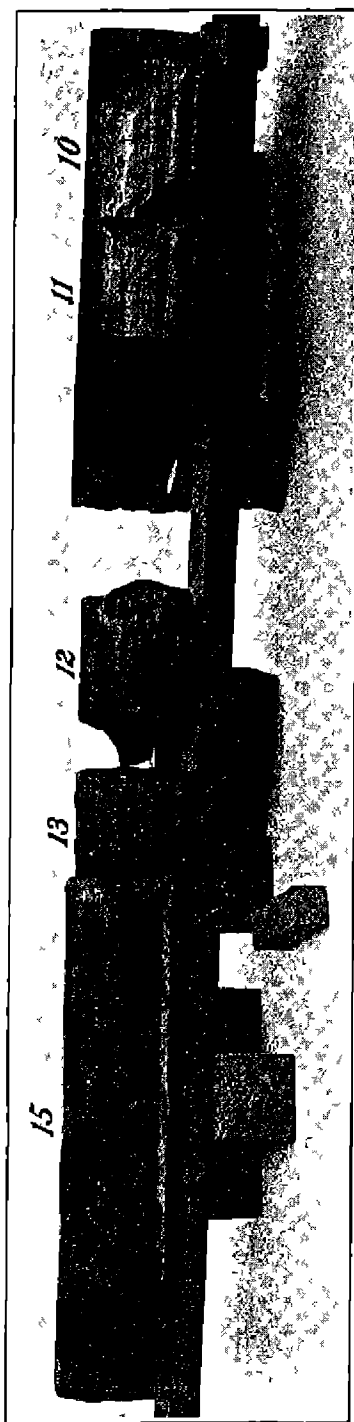
FIG. 7.—Fragments of broken rail viewed from top. Westerly portion of fragments. Showing battered receiving ends of each fragment.

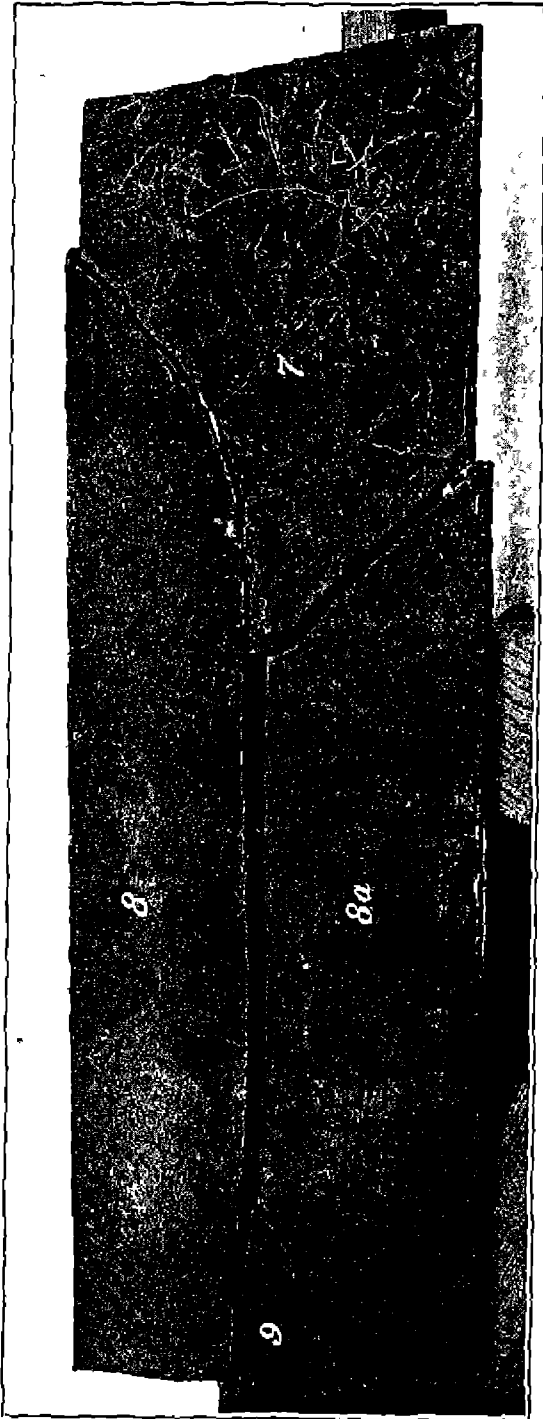
Examination of this rail showed that although the head was split for a length of nearly 8 feet, the initial rupture at the time of derailment was the crescent base fracture between fragments Nos. 8 and 8a, as shown in figure 8. The rail was necessarily in a weakened condition by reason of the split head, but it had undoubtedly been in that condition, to some extent, for some time preceding the time of the derailment. The accident is believed to have been precipitated at this particular time by the development of the base fracture above mentioned. Between fragments 8 and 8a was found a longitudinal streak or laminated seam, 6½ inches in length, with a depth of about 0.1 inch. This line of rupture appears to have preceded all others with respect to the time of development. This initial fracture was

Figure 8 shows the line of rupture between fragments 8 and 8a of the base regarded as the initial line of rupture of the rail at the time of the wreck. Evidence concerning this feature of the case seems complete and consistent throughout. There were other secondary flange fractures, which also followed seams in the steel, the same as the initial line of rupture. Figure 9 shows the appearance of the fractured surface of flange 8 and two other similar fractures. In different parts of the length of the rail there were five such flange breaks, two being located in the intact ends of the rail on either side of the part destroyed at the time of the accident.

It is characteristic of these crescent-shaped flange breaks that there is little or practically no display of extension prior to rupture of the steel across the laminations. Rails may and do display ample extension when the metal is strained in the direction of the length of the rail, that is parallel to the lengths of the laminations, but in a crosswise direction they fracture with great brittleness, when, for example, the flanges are bent crosswise.

FIG 8 — Base fracture of rail between flanges 8 and 8a Believed to have been the initial line of rupture at time of wreck

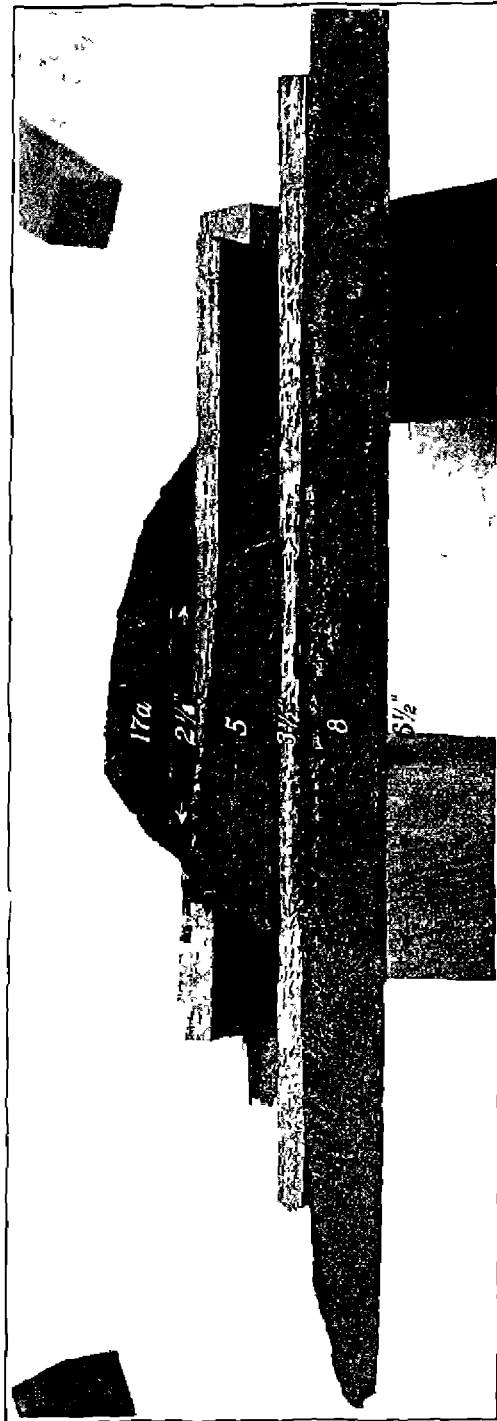
FIG. 9 — Appearance of fractured surface of Hange 8 and two others. Each fractured surface displayed one or more laminated seams.

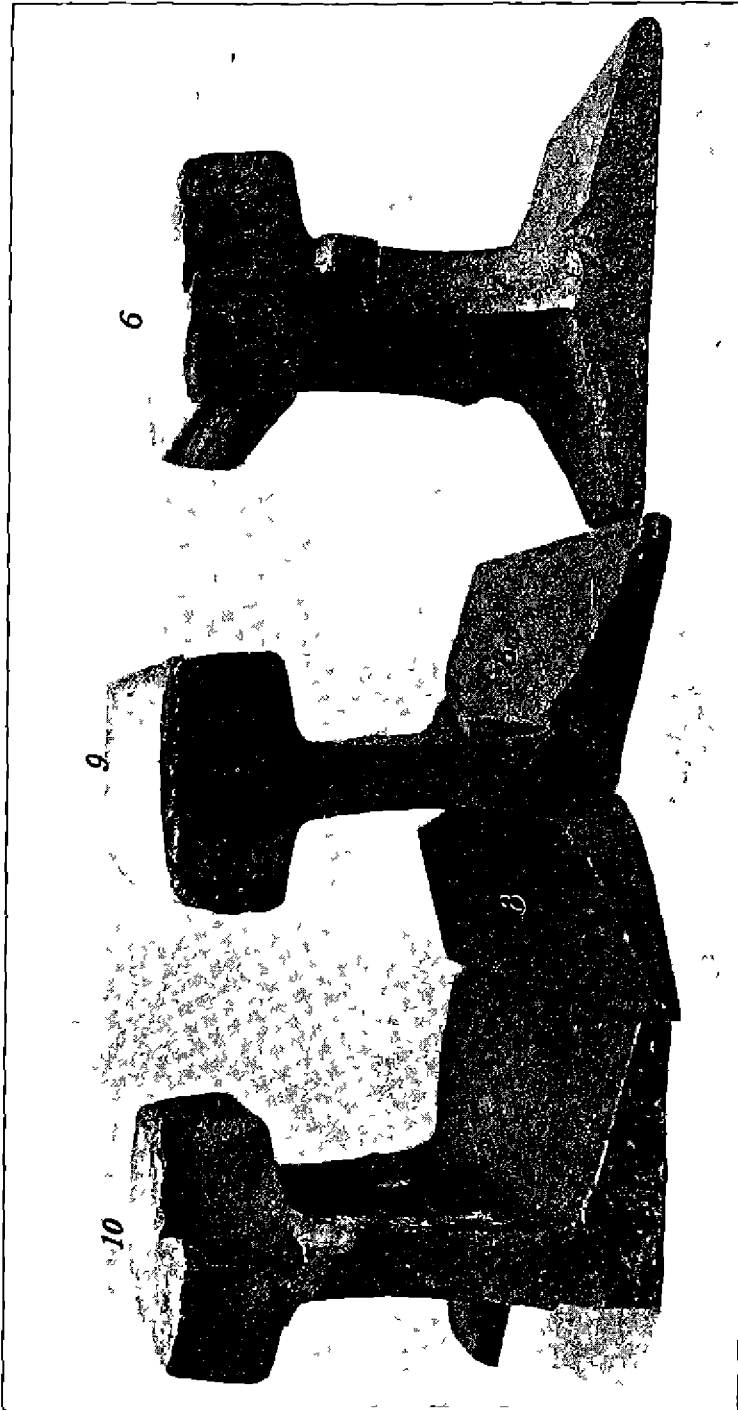
Figure 10 shows end views of several fragments, illustrating the size attained by the fissure of the split head. Such a fissure could not reasonably have been formed by the passage of a few trains but was one of progressive development and since its incipient stage had been in existence for a considerable length of time. It is less disquieting than certain other fractures, any of which may lead to ultimate disaster, in that it admits of being discovered in the track in time to avert an accident; nevertheless it is undesirable, as all defects are which may cause injury and loss of life.

FIG 10 —I nd views of fragments showing size of fissure of the split head

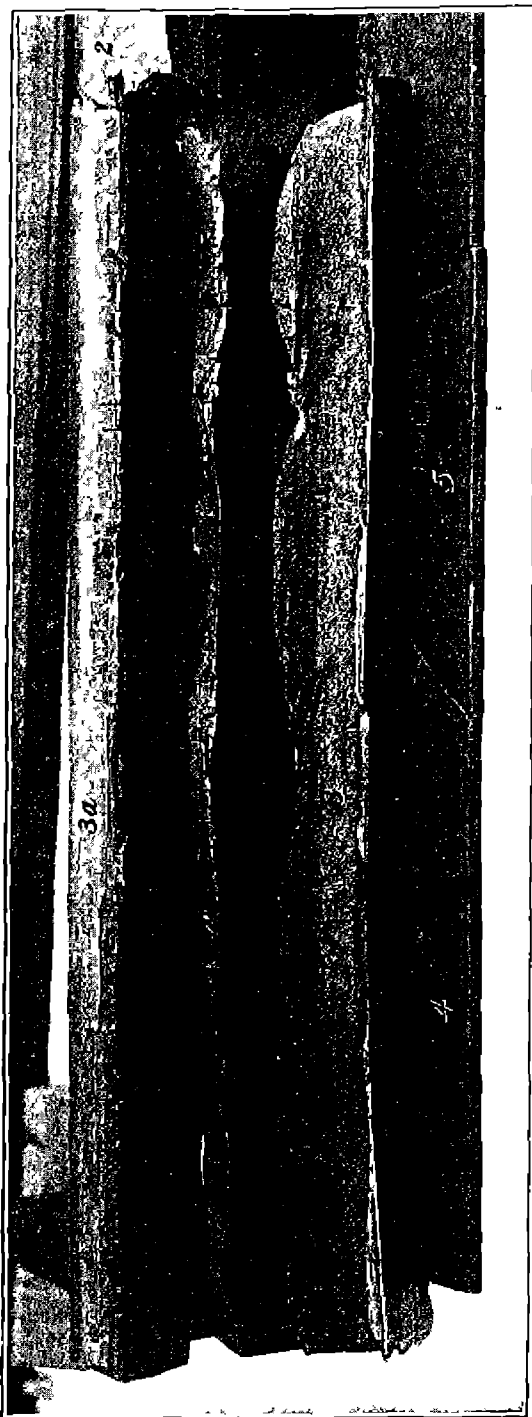
Figure 11 shows the two fragments of the head, one on either side of the fissure which constituted the split. These pieces were each about 18½ inches long. While the evidence presented in the fragments was not sufficient to definitely establish the place along the length of the rail where the fissure in the head had its origin, still there was

a suggestion that the place was located near the westerly end of these fragments and extended in each direction therefrom. There was no evidence of slag along the line of the fissure, that is, no more than that which may have been present in the laminated streaks. No slag pocket or inclusion of size was present.

FIG. 11.—Showing two parts of split head fragments 3 and 3a, believed to have been detached from rail next succeeding the basic fracture, between flanges marked 5 and 5a.

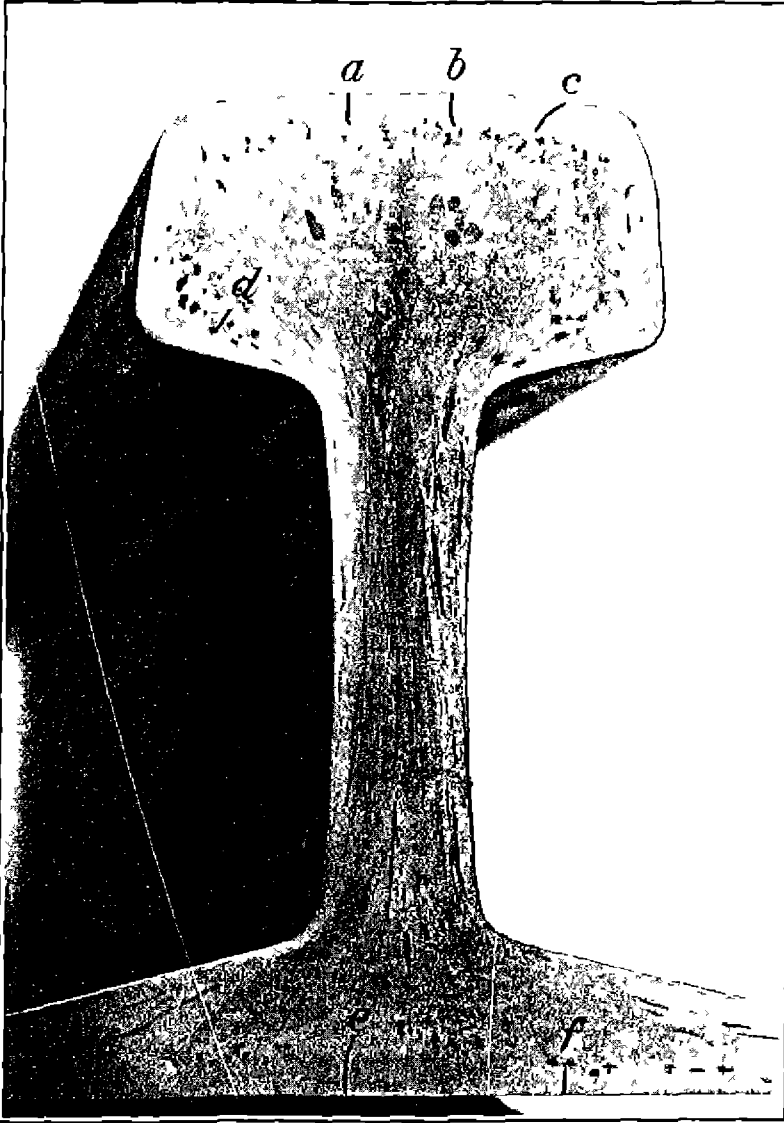
FIG. 12.—Cross section of rail piece milled No. 1 beyond limits of split head. Laminated seams at places marked *a*, *b*, *c*, *d*, *e* and *f*, revealed by bending, a thin section of the rail.

Figure 12 represents a polished and etched cross section of the rail just beyond the end of the fissure of the split head. A thin section was taken and ruptured in six places—four in the head and two

in the base, by transverse bending. Each fracture displayed a laminated seam, one of which was attributed to the lateral cold flow of the surface metal of the head from the wheel pressures, the others to the initial structural condition of the steel.

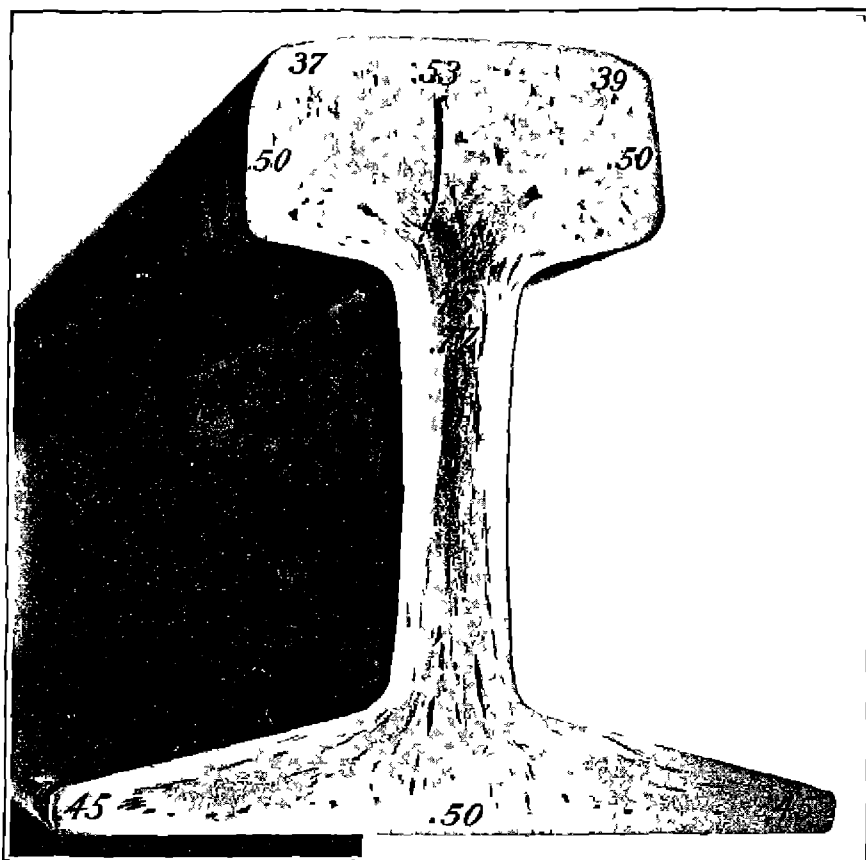
Figure 13 shows a cross section of the rail at the westerly end of piece No. 1, in which the fissure of the split head appears. Carbon determinations were made from chips taken at the places

FIG. 13—Cross section of rail, piece marked No. 1, showing fissure of the split head. Figures on illustration show percentage of carbon found at different parts of the head, web, and base.

indicated on the figure. It will be noted that the range in carbon was from 0.45 per cent to 0.77 per cent, the lower carbon metal being found near the surface of the rail. Subsequently other determinations were made, using chips taken nearer the top surface of the head, and the minimum carbon content there found was 0.37 per cent.

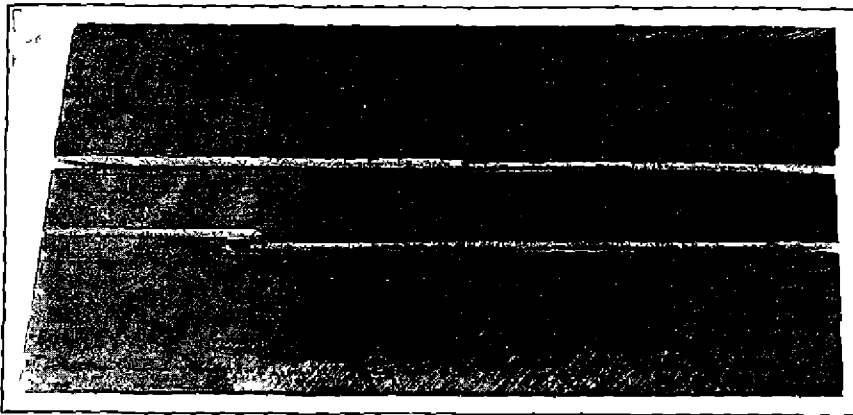
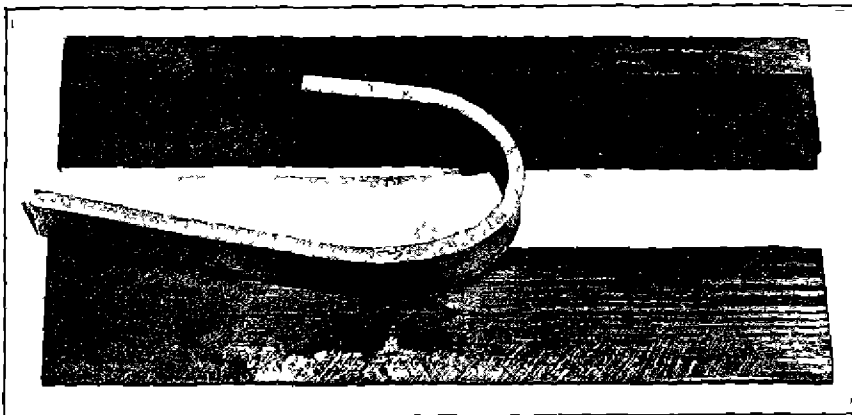
The results obtained by bending a piece of the rail under examination in a crosswise direction are shown in figures 14 to 17, inclusive. Figure 17 shows that when bent in the direction in which rails are usually tested satisfactory results can be obtained. It thus appears that there is practically no extension of the metal in a crosswise direction, and that laminated and streaky metal, such as was responsible for the failure of this rail, can not be detected by the usual lengthwise tests.

FIG. 14 — Base of rail, from piece marked No. 1 rough polished and etched to show location of seams. Appearance before crosswise bending.

FIG. 15 — Base of rail from piece marked No. 1, showing brittle fractures developed along lines of seams by crosswise bending.

FIG 16—Base of rail, from piece marked No 1 Brittle fractures completed, separating base into three strips

FIG 17—Base of rail, from piece marked No 1 Appearance of middle strip which after having been detached by brittle crosswise fracture displayed good bending qualities when bent in lengthwise direction of the rail

Figures 14 to 17, inclusive, form a group illustrating the result of bending a piece of this rail in a crosswise direction In

preparing this specimen the base was planed off from the web side to a thickness of one-fourth of an inch. It was then rough polished and etched, to show the location of the streaks which appeared, as shown by figure 14 at the middle of the width of the piece. The specimen was then bent in a crosswise direction, starting two fractures, practically without the display of any extension of the metal, as shown by figure 15.

The fractures were completed, separating the base into three strips, shown by figure 16. Thus it was shown that the metal of the base was devoid of the ability to display permanent extension without fracture when bent in this direction but the result merely conformed with experience in the track, where brittle base fractures of this class are of common occurrence.

stresses The results are of interest, since crosswise stresses are held to be directly accountable for the flange breaks in the bases of rails in service Tests should certainly be made in the direction in which numerous fractures occur in order to demonstrate the useful proper-

ties of the rail in the track Such tests should be made and not ignored in any earnest effort to secure structurally sound rails

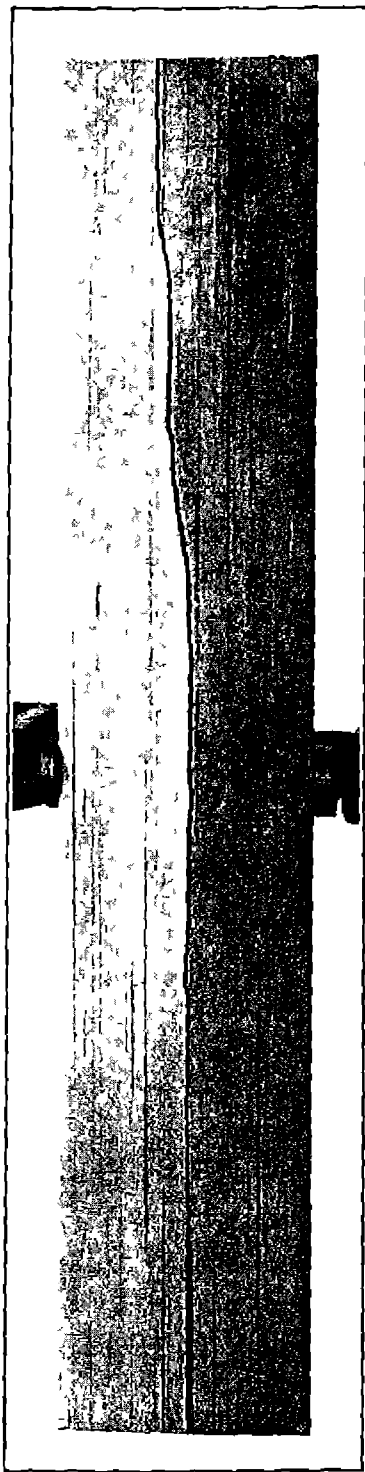
FIG 18—Head of rail, from piece marked No 18 Showing brittle fracture developed along line of seam by crosswise bending.

along the line of a streak, in a brittle manner. Figure 18 shows the appearance of the specimen after fracture.

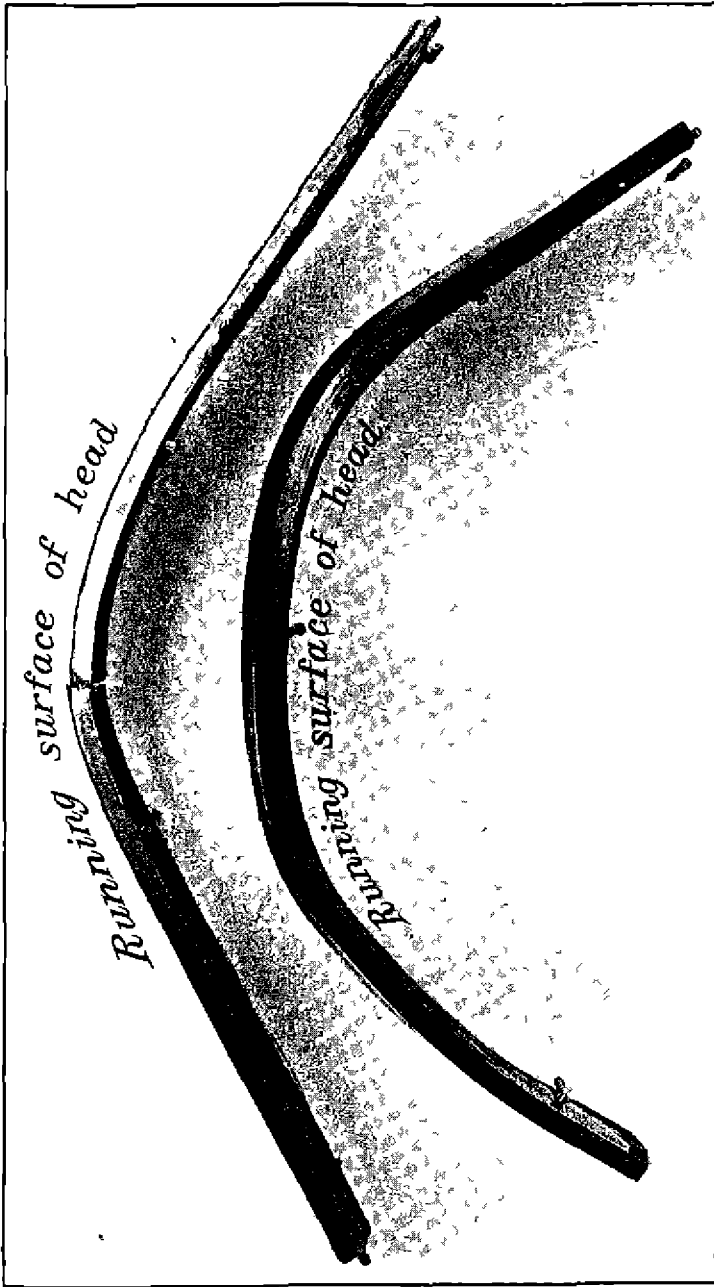
FIG 19—Head of 110, from piece marked No 18. Appearance of strips which after having been detached by brittle crosswise fracture displayed good bending qualities when bent in lengthwise direction of the tail.

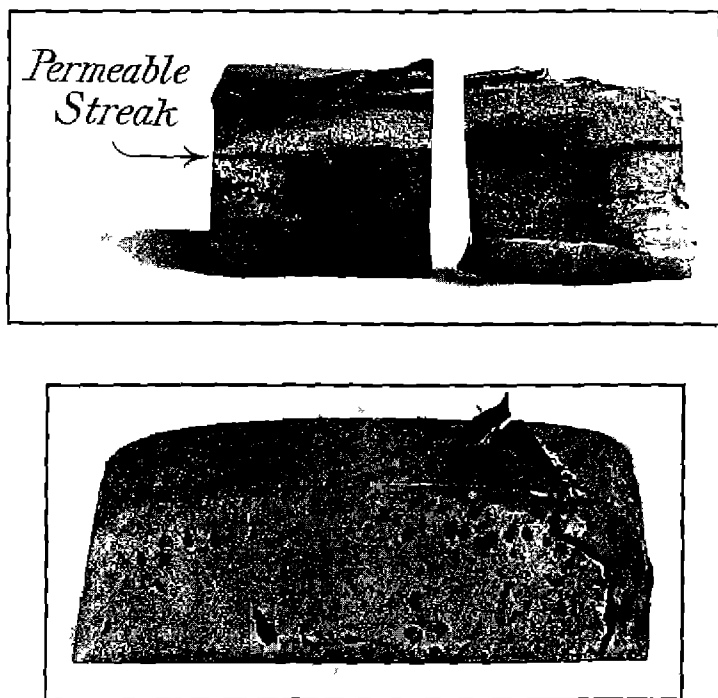
The fissure of the split head terminated at a place near the end of the piece which was marked No. 1, for identification. A short section of the head was cut off where the fissure ended. Two views of this section are shown by figure 20, an end view and an interior one after wedging off the outside portion of the head. The fissure

FIG. 20—Head of nail at end of fissure of split head. Showing surface of fissure with permeable acicular streak and etched end view.

in its course had deflected, leaving the center line of the head and approaching the outside edge.

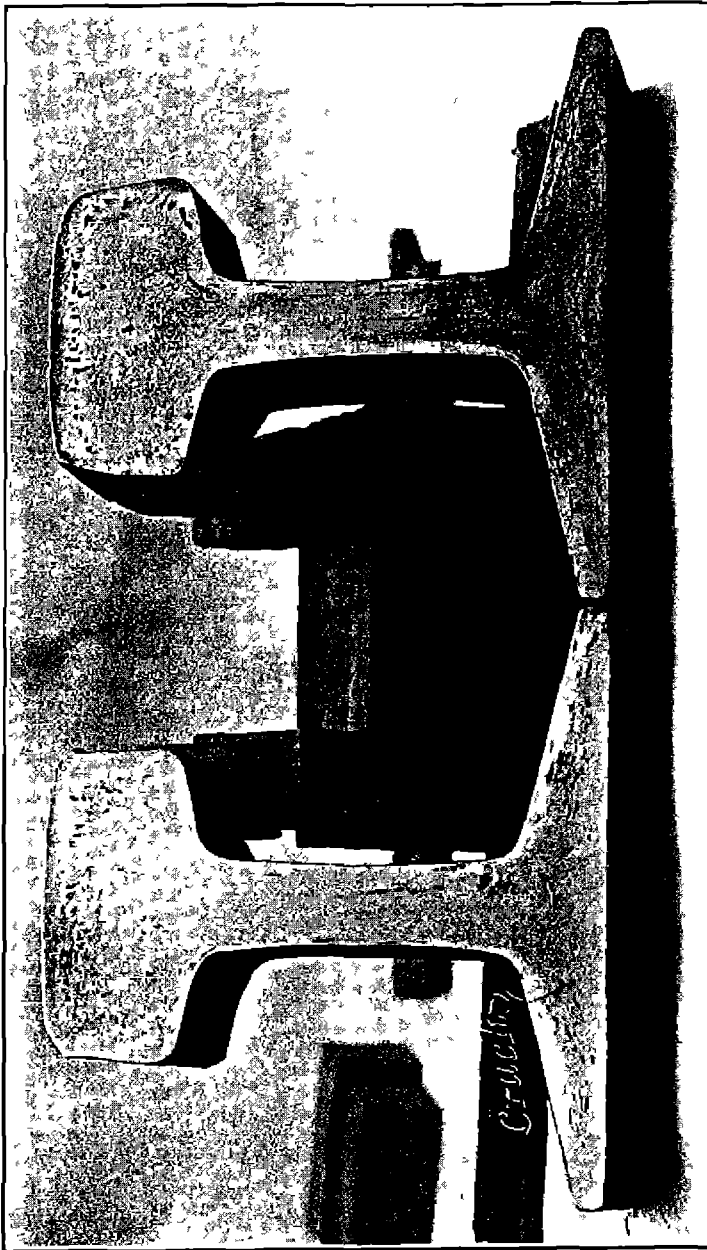
from either end of the full length 33-foot rail. The section on the left displays a crack penetrating the inside flange from the upper

Fig. 21 — Etched cross sections, near opposite ends of rail. Showing crack in flange entering from upper side, which started at a seam in the steel.

surface. This crack had its origin at the extreme end of the rail and started at a well-defined seam in the metal in the fillet at the junc-

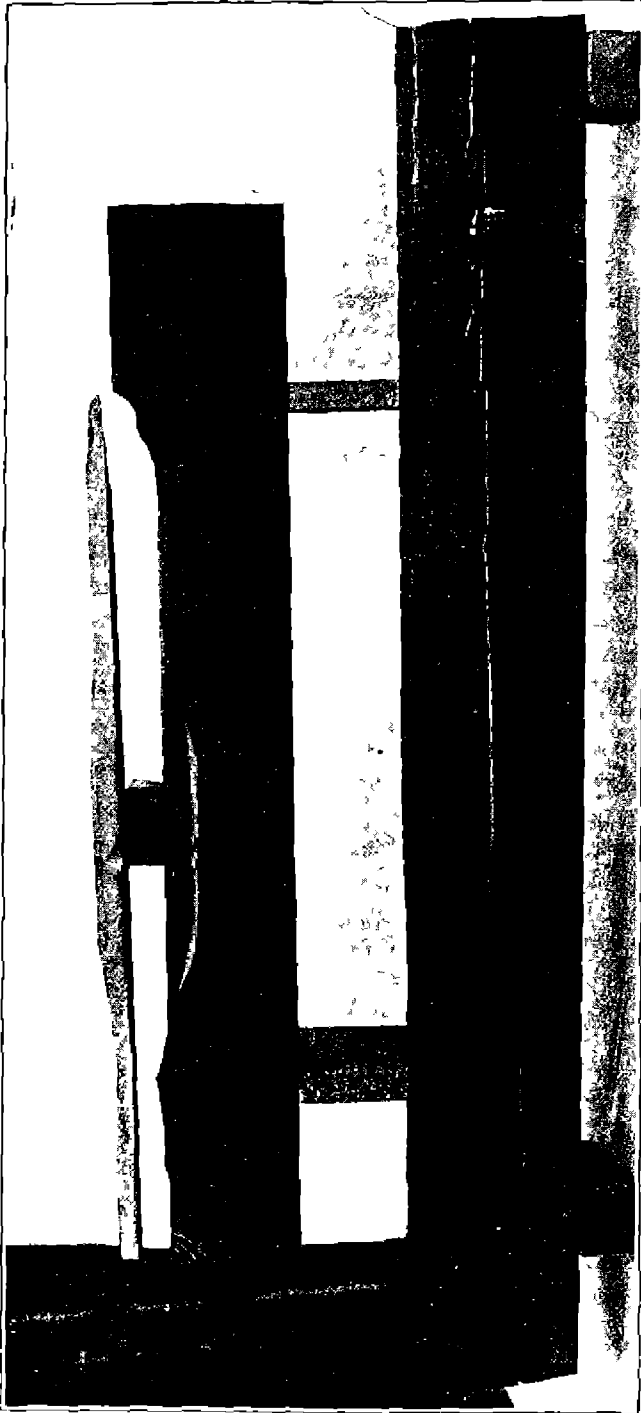
When subjected to the drop test the rail fractured on the first blow, but fulfilled current rail specifications in respect to elongation and interior soundness. Two other drop tests were also made, neither of which revealed any interior defects. The fragments tested were then subjected to crosswise bending, and it was found that laminated seams were present. The drop test, therefore, in this instance failed to detect these interior defects.

FIG. 27—1 rods, of and after drop test, showing brittle seamly fractures developed by cross-wise bending. Pieces in which these internal defects were not revealed by the drop test.
