REPORT OF THE DIRECTOR OF THE BUREAU OF SAFETY IN RE
INVESTIGATION OF AN ACCIDENT WHICH OCCURRED ON THE
ILLINOIS CENTRAL RAILROAD NEAR SALINE, ILL., ON
DECEMBER 20, 1931

Inv. No. 1745
Illinois Central R. R.
Saline, Ill.
December 20, 1931.

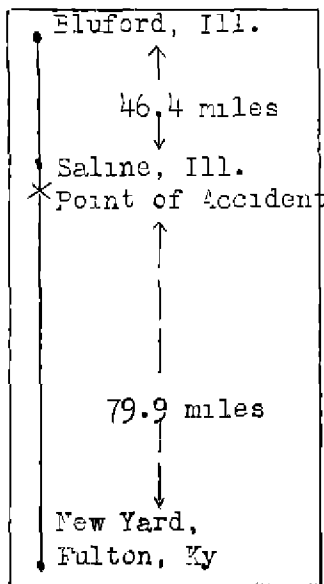
Beginning at a point 4,000 feet south of the point of accident, there is a deep cut 1,200 feet in length with a maximum height of 55 feet, followed by a 15-foot fill about 525 feet in length and then a smaller cut about 175 feet in length, followed by a fill having a maximum depth of 30 feet, and it was on this latter fill, at a point about 1,700 feet from its southern end, that the collision occurred.

Supervisor of Trains and Tracks Willingham stated that he arrived at the scene of the accident about four hours after its occurrence and made a careful inspection of the track to determine what protection had been afforded extra 1814. At a point 345 feet south of the point of accident he found two torpedo burns, about two rail-lengths apart, and the first indication of fusee drippings was in the middle of the track at a point 1,219 feet south of the point of collision; these drippings were in the center of the track and indicated that some one had been walking around with the fusee. Fusee drippings were also found at a point 1,851 feet south of the point of accident, which probably were left by some member of the crew of the light engine which came to pick up the rear end of extra 1838 after the accident, these drippings extended southward a distance of 80 feet. At a point 3,285 feet south of the point of accident a fusee cap

was found in the ditch alongside the track, and 539 feet south thereof a fusee was found lying about 18 inches inside of the rail, it had tipped over and burned the edge of the tie, and apparently was the one which was thrown off by Conductor McNew, of extra 1814, on approaching Saline. A half-burned fusee was found at Stonefort, 4,451 feet south of the point of accident, which had apparently been left by the flagman of extra 1838 when the light engine came along to get his train.
