## INTERSTATE COMMERCE COMMISSION

REPORT OF THE DIRECTOR OF THE BUREAU OF SAFETY IN RE  
INVESTIGATION OF AN ACCIDENT WHICH OCCURRED ON THE  
INTERNATIONAL GREAT NORTHERN RAILROAD, MISSOURI  
PACIFIC SYSTEM, NEAR NECHES, TEXAS, ON DECEMBER 23,  
1928.

February 26, 1929.

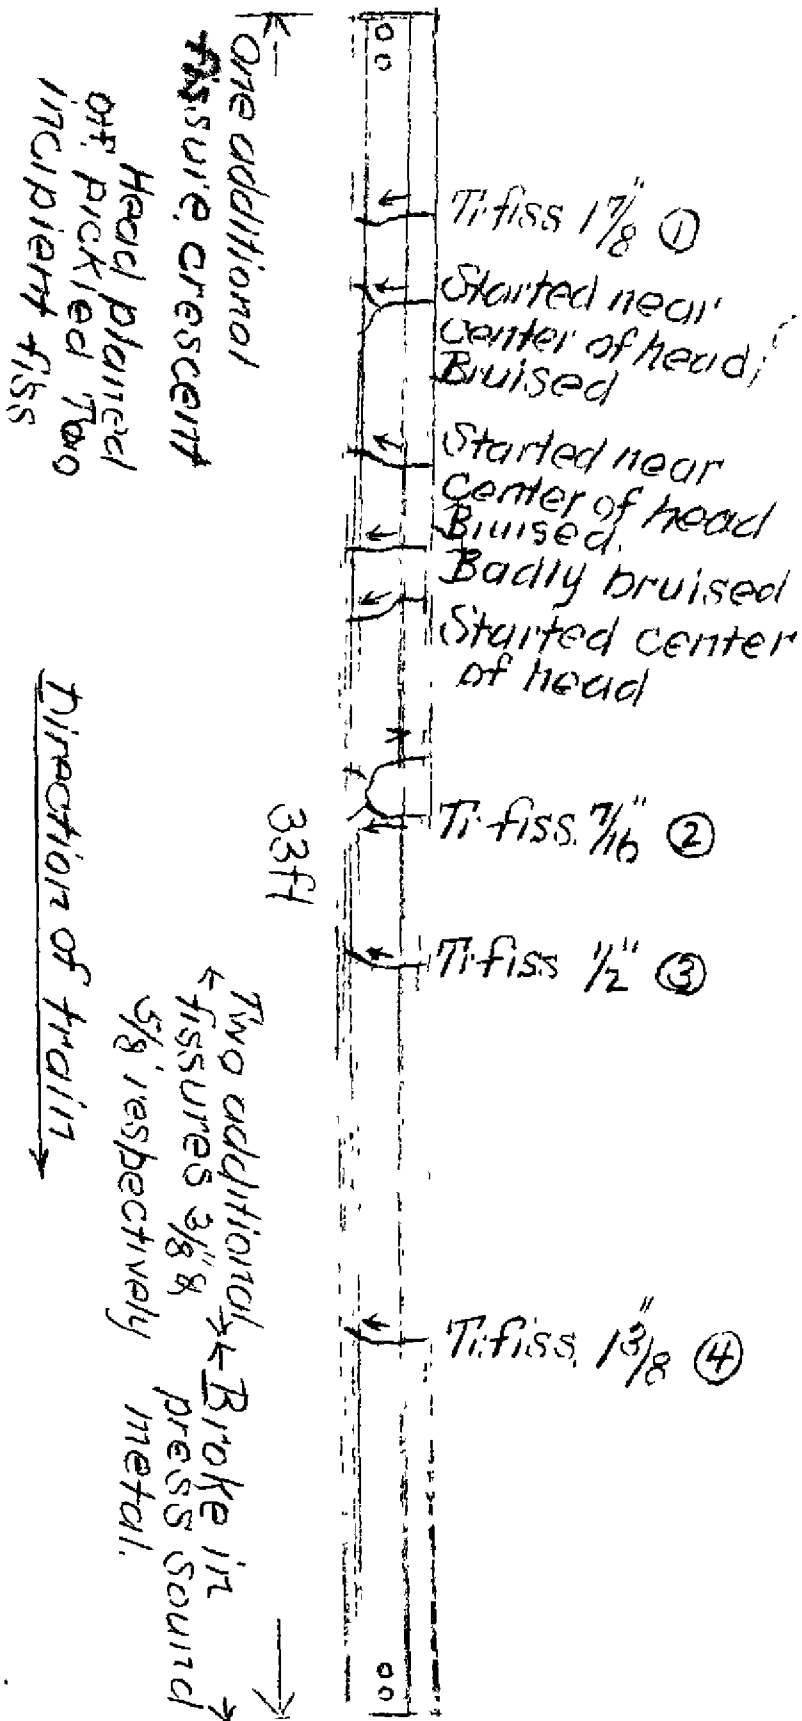
Broken rail 85lbs OH Tennessee 8540A SCE 6-1919 B90522  
 Accident on the International-Great Northern Railroad.  
 near Meches Texas Dec 23 1928

The examination of the fragments of the rail showed that it broke by reason of the presence of transverse fissures. Four transverse fissures were displayed at the time of the accident. The first fissure was located 4 feet from the receiving end of the rail and had a diameter of  $1 \frac{7}{8}$  inches. The other transverse fissures measured  $\frac{7}{16}$ ,  $1 \frac{1}{2}$ , and  $1 \frac{3}{8}$  inches in diameter, respectively.

The receiving ends of three of the small fragments were considerably bruised, destroying evidence of the type of fracture which they represented. One other fracture started near the center of the head. It had a starring effect, indicating the incipient point of rupture was near the center of the head. A starring effect, or fracture having a nucleus near the center of the head does not indicate, necessarily, that an embryonic transverse fissure had its locus at that point. The center of the starring is the point where the fracture had its origin. It may be located in some part of the head or in some part of the base, according to the direction in which the rail is broken as a beam, base or head up.
