INTERSTATE COMMERCE COMMISSION

REPORT OF THE CHIEF OF THE DIVISION OF SAFETY, COVERING THE INVESTIGATION OF AN ACCIDENT WHICH OCCURRED ON THE KANSAS CITY SOUTHERN RAILWAY NEAR AIR LINE JUNCTION, MO , ON OCTOBER 19, 1914

NOVEMBER 9, 1914

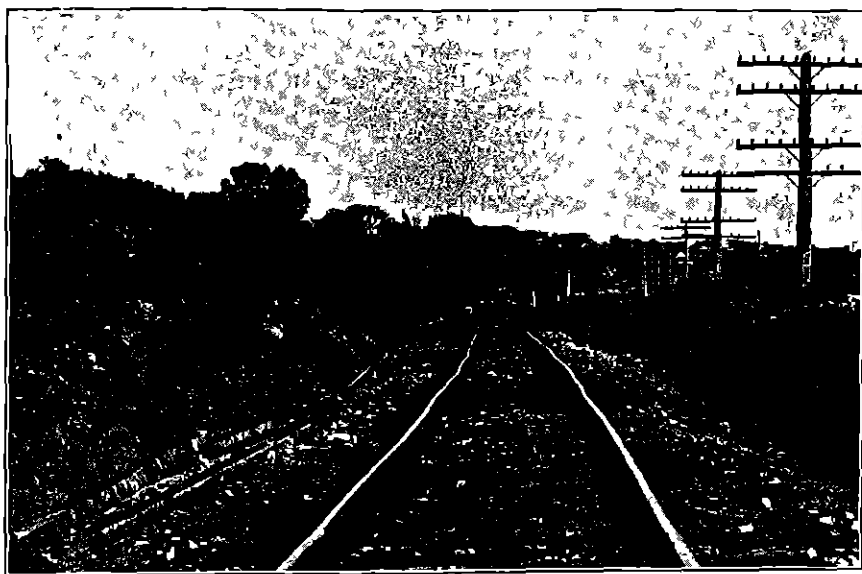
Examination of the track showed that the wheels of the locomotive had dropped down inside of the outer rail of the curve, due to the spreading of the inside rail There were flange marks on the inside of the webs of the next two rails, which indicated that these rails had turned over, the locomotive running along on the webs At this

No 1—View of track approaching point of derailment from the north

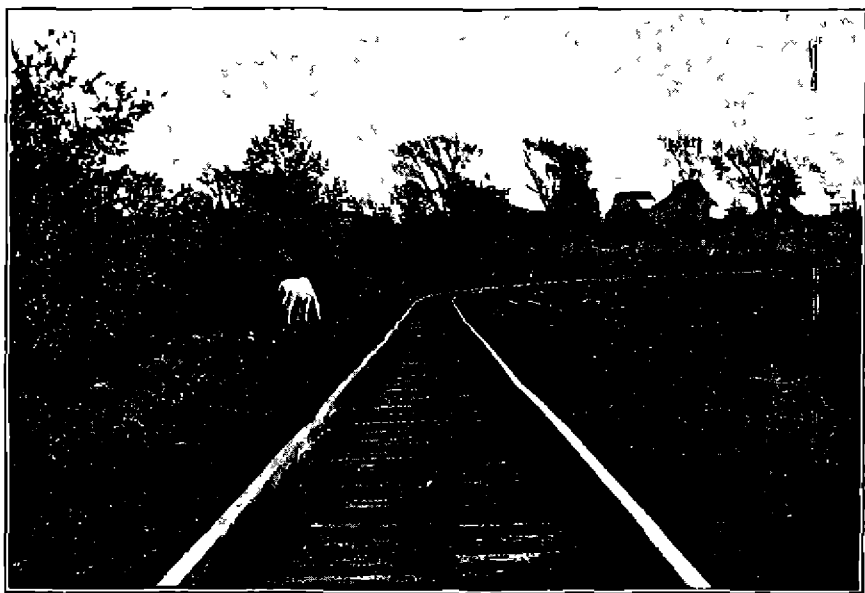
The track for a distance of one-half mile on each side of the point of derailment was found to be in bad condition, and in many instances the gauge was tight at the rail joints while at the centers the rails were spread outward In some of these cases the gauge at the joints was 4 feet 8 inches, while at the centers it was 4 feet 9 $\frac{1}{4}$ inches This condition is shown in illustration No 1, a view taken from the north, looking toward the point of the accident Illustration No 2 shows a similar condition existing south of the point of derailment Two rails were found with crescent-shaped breaks in the flange on the inside, one 6 inches in length and one 11 inches in length About 50

No 2 —View of track south of point of accident

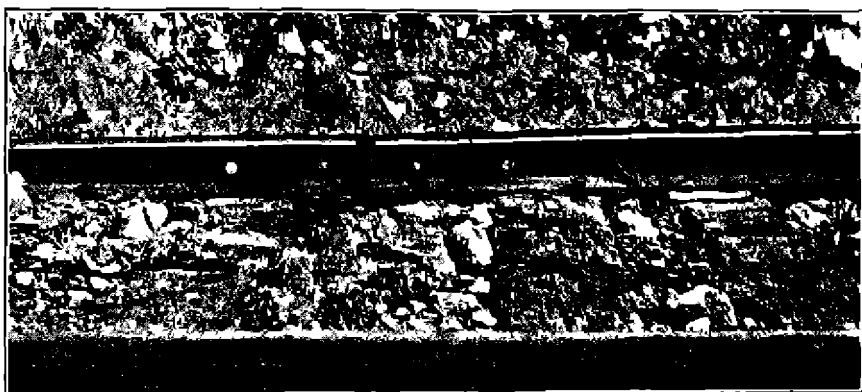
angle bars were found having only one or two bolts in them, this condition being due to the fact that some of the rails had no bolt holes drilled in them, while others were so badly matched that the holes in the angle bars did not register with the holes in the ends of the rails. Illustration No 3 shows the use of a broken angle bar at a rail joint, while illustrations Nos 4 and 5 show the use of angle bars in cases where no bolt holes were drilled in the rails, or the bolt holes in the rails did not match with the holes in the angle bars. Twenty-five angle bars were found in this mile of track which were broken or badly sheared, while in some cases there were spaces of as much as 2 inches between the ends of the rails.

No 3 —Use of broken angle bar at joint
