INTERSTATE COMMERCE COMMISSION

REPORT OF THE DIRECTOR OF THE BUREAU OF SAFETY IN RE INVESTIGATION OF AN ACCIDENT WHICH OCCURRED ON THE LINE OF THE KEY SYSTEM TRANSIT COMPANY AT OAKLAND, CALIF., DECEMBER 4, 1924

JANUARY 12, 1925

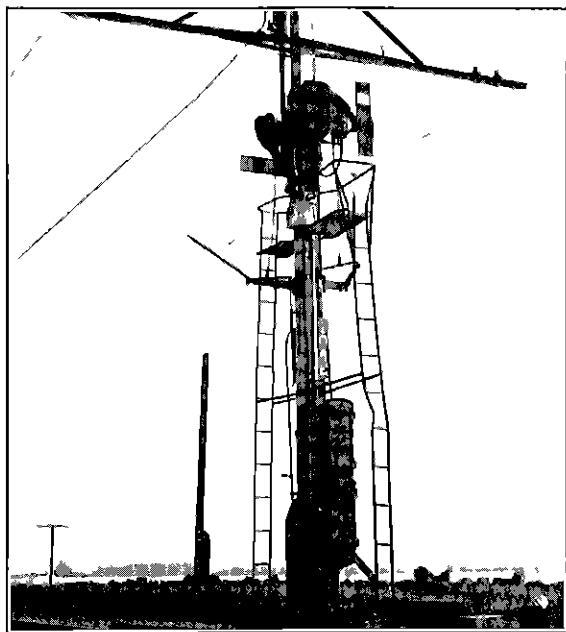
FIG 1 --Signal pole 104 looking eastward. Eastbound signal in clear position, westbound signal at stop, with automatic stop arm extended.

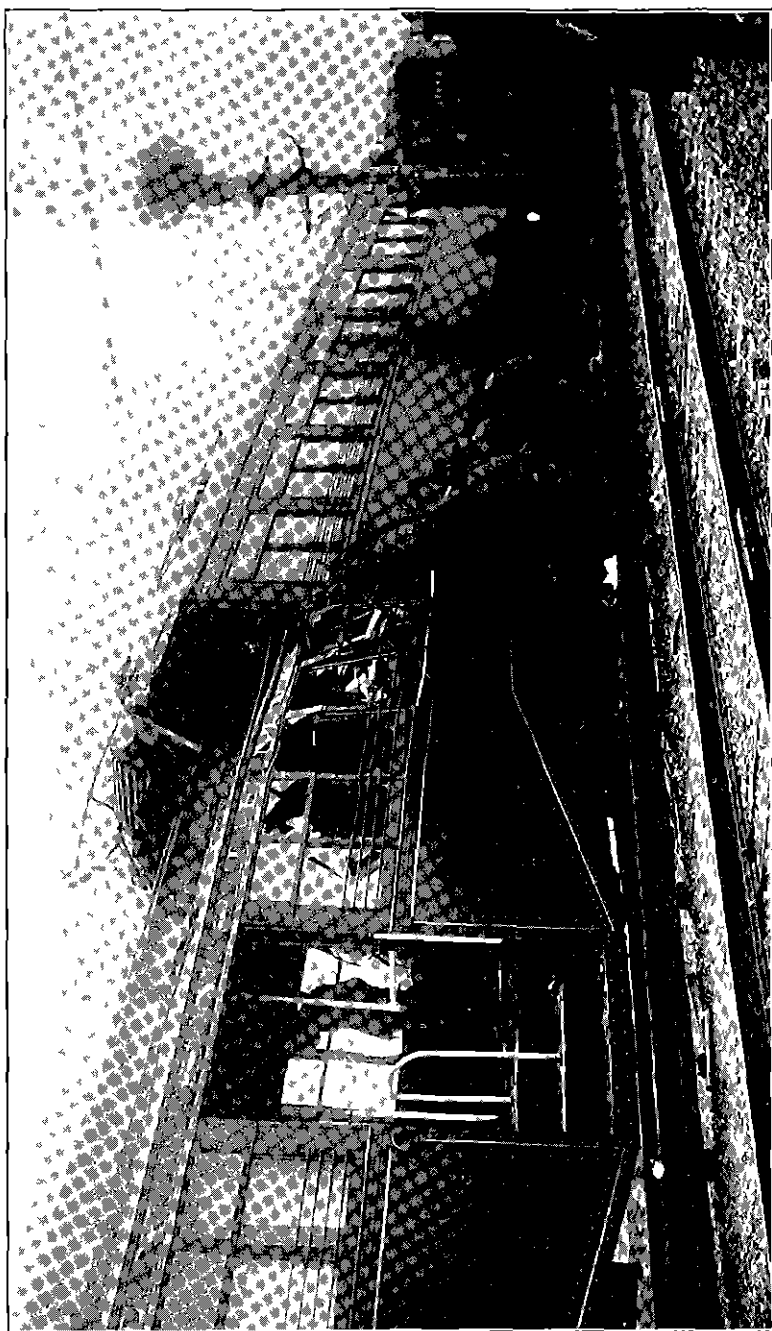
Motor car 1014 telescoped the rear car of train No. 729 for a distance of 18½ feet. It came to a stop with the head end of car 1014 at a point 37 feet west of signal 104, and the rear end of car 665, the last car of train No. 729, was 18 feet 6 inches west of signal 104.

Fig 2—Key System car 665 telescoped by car 1014, signal pole 104 opposite car 1014

48 inches. The rear portion of this car was practically demolished, the damage probably being due in part, at least, to the fact that the floor line and top of the body buffers were lower than the floor and buffers on the San Francisco-Sacramento car. Motor car 1014 was of steel-underframe construction, having wooden superstructure. It was 57 feet 10 inches long, weighed 93,260 pounds, and the distance from top of rail to top of 8-inch buffer beam was 53 inches. The platform of this car overlaid the floor of the Key System car. The forward end of car 1014 and a partition 7 feet from the head end were demolished, pipe connections and other equipment broken or torn from the car, and the truck on the damaged end was driven

overridden by the buffer on car 1014 but was driven back over the top of the center sills, at the same time pulling in the side angle-iron sills which prevented the sides of the car from being fanned outward by the telescoping action.

To provide against a recurrence of an accident of this character, the Key System Transit Company should at once establish a maximum speed restriction for all trains operated over this line, which will insure that any train can be stopped in the minimum braking distance provided by the automatic stop system

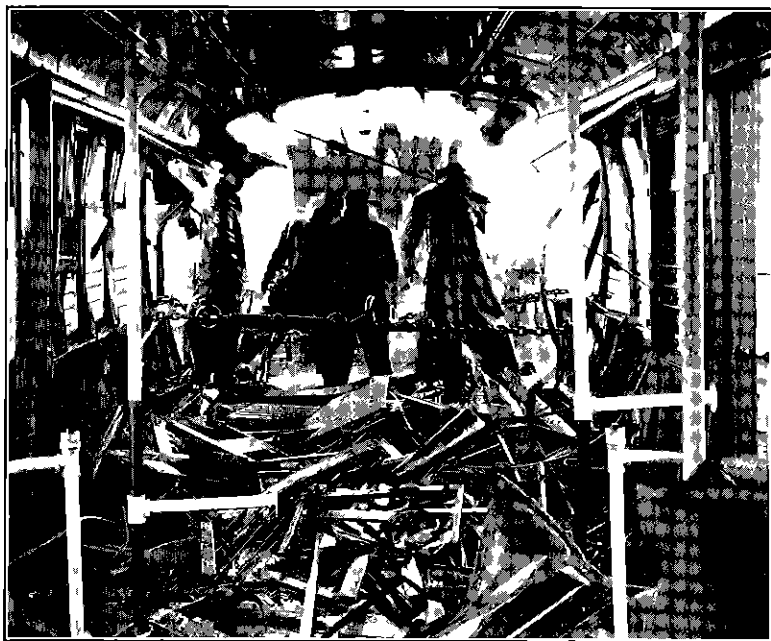
FIG. 3—Interior of car 665 after separation from car 1014
