INTERSTATE COMMERCE COMMISSION

REPORT OF THE CHIEF INSPECTOR OF SAFETY APPLIANCES COVERING HIS INVESTIGATION OF AN ACCIDENT WHICH OCCURRED ON THE LONG ISLAND RAILROAD NEAR COLLEGE POINT, LONG ISLAND, ON SEPTEMBER 22, 1913

OCTOBER 30, 1913

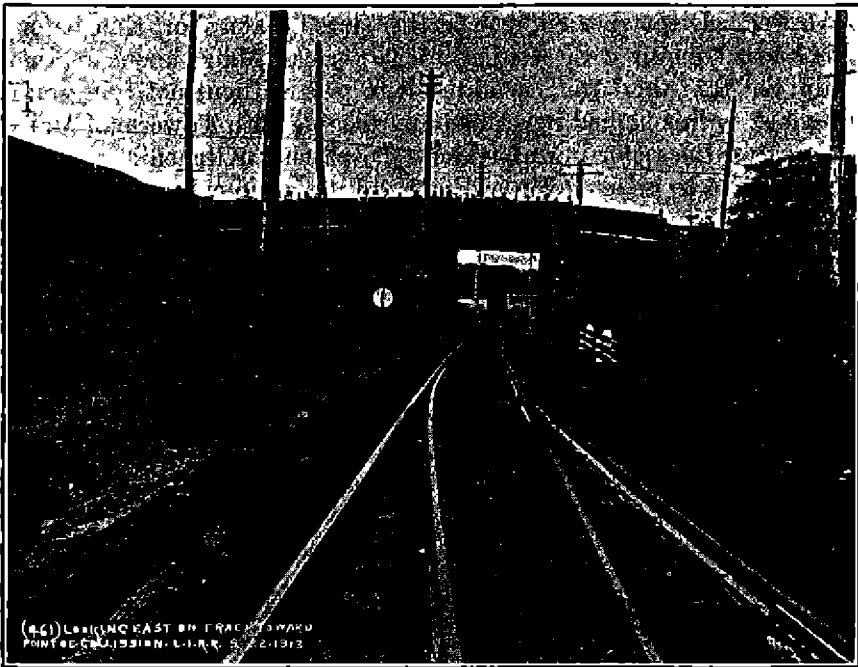
for about 1 mile At a point about 600 feet east of College Point station there is an overhead highway bridge, the approaches and abutments of which materially obscure the view in either direction This condition is shown in illustration No 6, which is a view looking

easterly toward the point of collision, which occurred about 200 feet east of the bridge Approaching this bridge from the opposite direction the view is obscured by trees located on property adjoining the right of way At the point of collision and approaching the same from the east there is an ascending grade of 1.15 per cent

No 6 — Looking easterly toward point of collision, which occurred east of the bridge
