INTERSTATE COMMERCE COMMISSION

REPORT OF THE DIRECTOR OF THE BUREAU OF SAFETY IN RE INVESTIGATION OF AN ACCIDENT WHICH OCCURRED ON THE MISSOURI PACIFIC RAILROAD AT BLAKE, KANS., ON JANUARY 14, 1926

APRIL 23, 1926

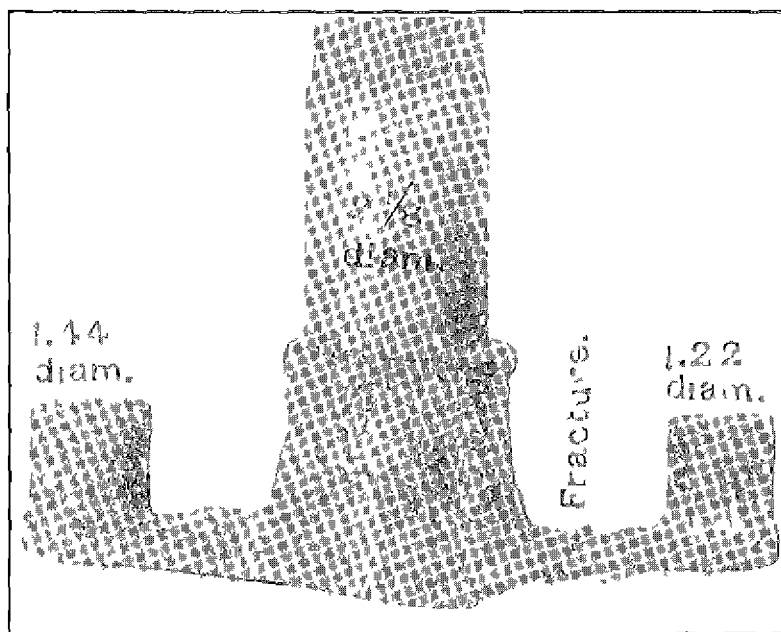
Figure 1 shows the appearance of the broken lever. Its corroded condition is shown by the photograph. The diameter of the lug, on the broken side, was 1.22 inches. The opposite lug had a diameter of 1.44 inches. A blue print of the switch stand calls for lugs having diameters of 1½ inches each. The diameter of the eye of the new connecting rod was 1½ inches conforming to the dimensions on the drawing.

Examination of the lever arm of the switch-stand shaft showed a reduction in the thickness from one-half inch, called for on the blue print of the stand, to an average thickness of 0.3 inch. Some, if not all, of this reduction was due to corrosion of the metal. The fracture of the arm was progressive in its character.

Fig. 1.—Photograph of fractured crank lever. Diameter of lug on broken side 1.22 inches; diameter of opposite lug, 1.44 inches.

The lug over which the connection rod of the switch mechanism engaged was a quarter of an inch in diameter under size. The opposite, unused lug, was substantially full size. This discrepancy in size of the working lug should have been observed and a new full-dimension lever arm installed.

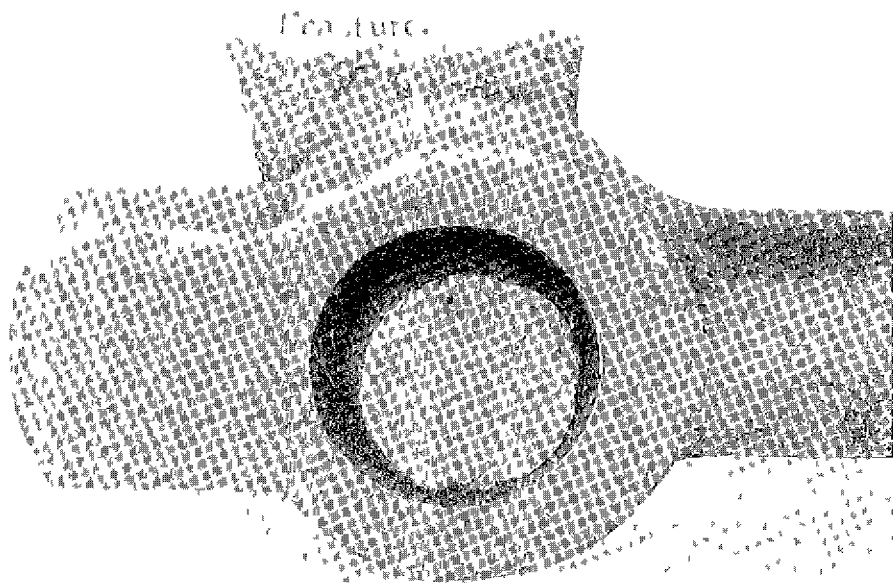
Figure 2 shows the looseness of the fit of the connecting rod engaging its lug on the broken arm of the lever. The connecting rod was a good mechanical fit on the opposite unused lug, for this class of work.

The looseness of the fit of the connecting rod over the lug was a matter which should have attracted attention. It must have been apparent when the new connecting rod was put in place one month prior to the accident, if indeed it was not in evidence when the stand was installed in June, 1925.

Fig. 2.—Photograph showing loose fit of connecting rod over lug of broken lever arm of switch stand stem.

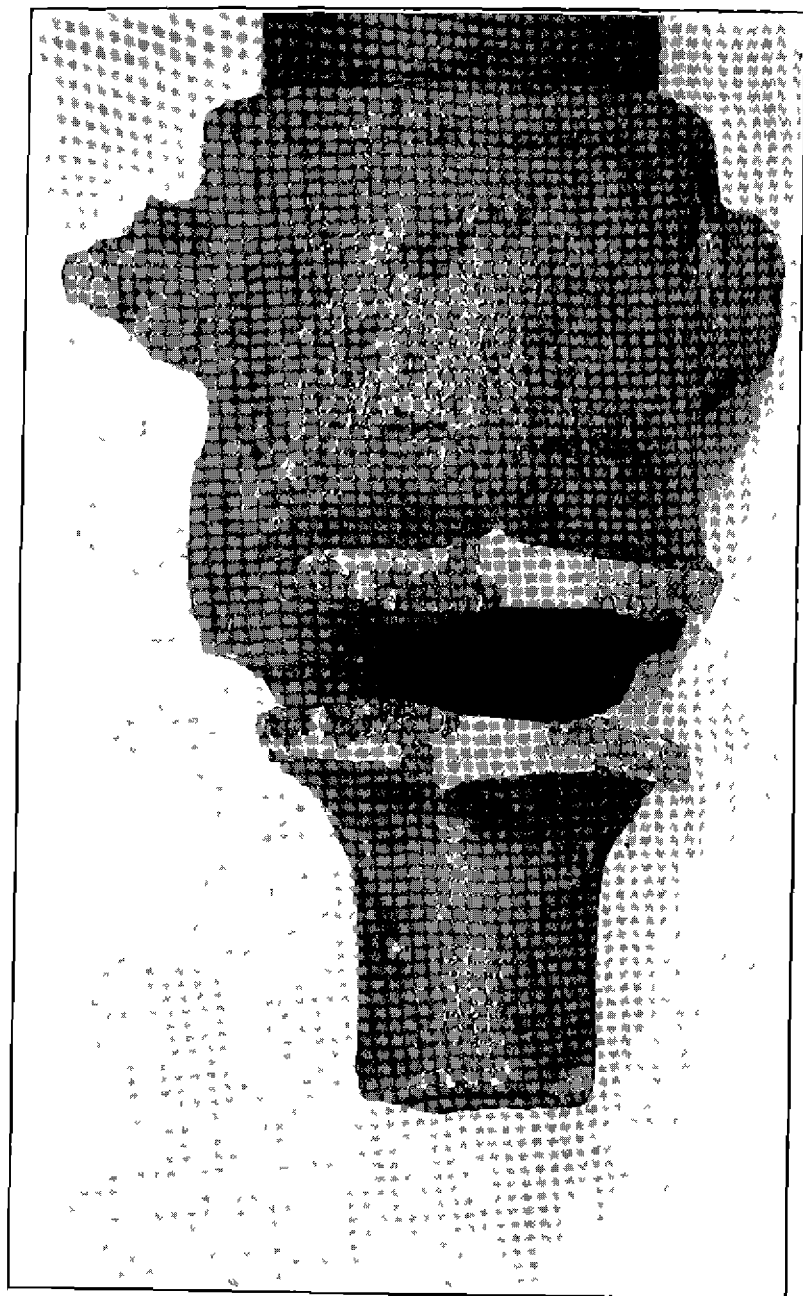
Figure 3 shows the opposite faces of the broken lug lever. The average dimensions of the lever at the place of fracture were 0.3 inch thick by 2.06 inches wide. The drawing calls for a thickness of one-half inch.

The middle of the width of the fractured surface displayed a progressive fracture. It seemed to have had its origin at the upper face of the lever. In its first stages the fracture separated the upper half of the thickness of the lever, as indicated by its fan-shaped outlines, with center of radiation at the upper side of the casting.

The final stage separated the lower half of the thickness of the lever. At an intermediate period there was probably an extension of the upper fracture toward one edge of the casting. When the balance of the casting was finally broken, control of the switch rails was lost.

The steel casting showed blowholes, but that is not an unusual circumstance in steel castings. Blowholes prevail near the upper surfaces of open sand castings, and in the upper parts of two-part-flask molds, in the absence of sink heads or risers. The occurrence of blowholes in steel castings is therefore hardly a matter for adverse criticism in view of their general prevalence, but their presence must be reckoned with in establishing safe dimensions in castings to meet working stresses.

FIG. 3.—Photograph of fractured surfaces of broken lever arm of switch stand stem. Origin of fracture indicated by a star on the cut

reveal the element of weakness and the approach of rupture. Details of a switch stand should possess adequate strength, obviating the need of critical inspection under ordinary circumstances. If exposed to exceptional corroding influences such conditions should be taken into consideration and weakened parts renewed.
