INTERSTATE COMMERCE COMMISSION

REPORT OF THE CHIEF INSPECTOR OF SAFETY APPLIANCES COVERING HIS INVESTIGATION OF AN ACCIDENT WHICH OCCURRED ON THE MISSOURI PACIFIC RAILWAY AT BRANT, MO, ON MAY 21, 1913

JULY 11, 1913

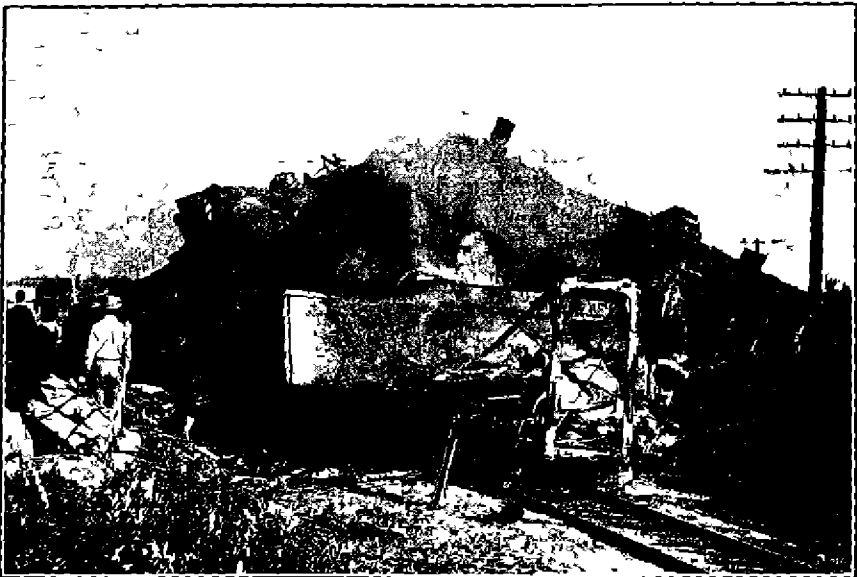
No 2--View looking westerly showing remains of wooden chair car on head end of train No 11

This accident affords an exceptionally interesting opportunity for comparison between wooden and steel equipment. Both trains were traveling at about the same rate of speed, and one had a wooden car immediately behind the locomotive, while the other had a steel car in a similar position. The wooden car was completely wrecked and was

destroyed by fire which broke out afterwards, while the steel car was badly damaged only on the end adjoining the locomotive, even the window glass in the other part of the car not being broken, all this notwithstanding the fact that the steel car had the weight of six cars behind it while the wooden car had the weight of only four cars
