INTERSTATE COMMERCE COMMISSION

REPORT OF THE DIRECTOR OF THE BUREAU OF SAFETY IN RE INVESTIGATION OF AN ACCIDENT WHICH OCCURRED ON THE MISSOURI PACIFIC RAILROAD AT NEARMAN, KANS., ON FEB- RUARY 7, 1925

APRIL 22, 1925

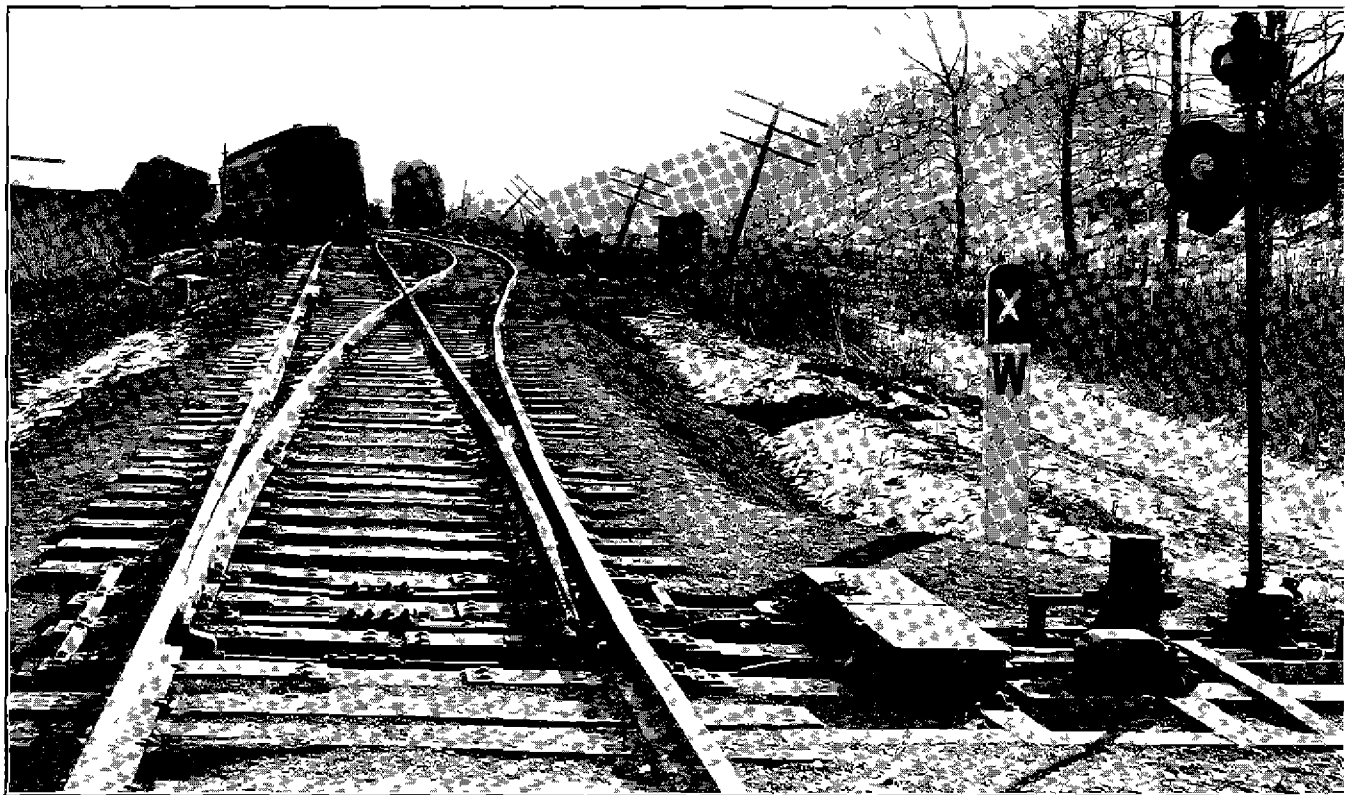
The main-line track approaching the passing track from the west showed no signs of injury incident to the derailment. There were minor injuries to the track from the switch point eastward to a point beyond the frog. The marks of blows on the switch rail, at the frog, and on the end of the guardrail were comparatively insignificant in respect to offering adequate resistance to deflect this engine, weighing 259,000 pounds, of which 47,000 pounds weight was on the engine truck, traveling at a rate of about 70 feet per second, and cause it to collide in so short a distance with the engine on the passing track. Beyond the frog the rails and ties were torn up as the engine plowed into the roadbed.

FIG. 1—View of track at scene of derailment. Passing track arranged as short detour to main line. Photographed after removal of last coach of passenger train which was not derailed; main line and passing tracks, including switch rails and frog, not being injured by derailment.

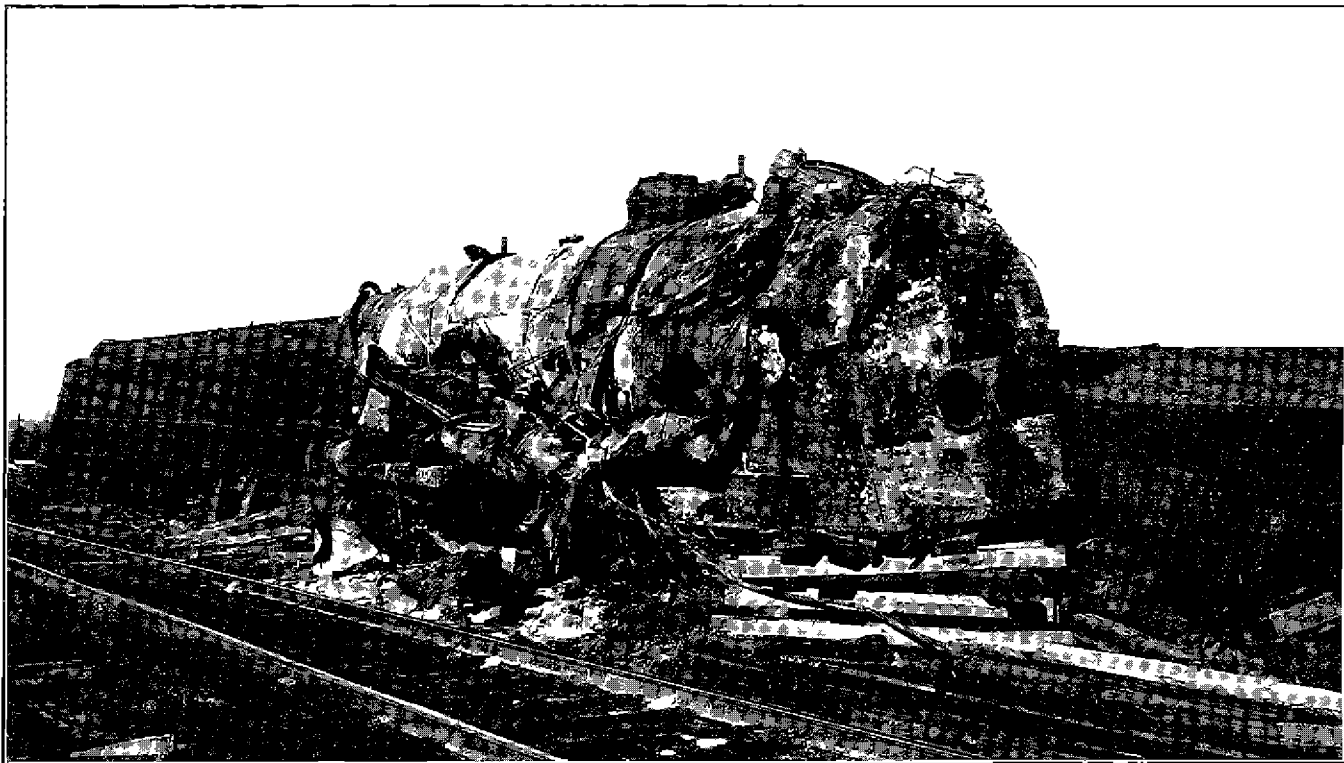
FIG 4—Appearance of passenger engine 6437 left side, after it was picked up

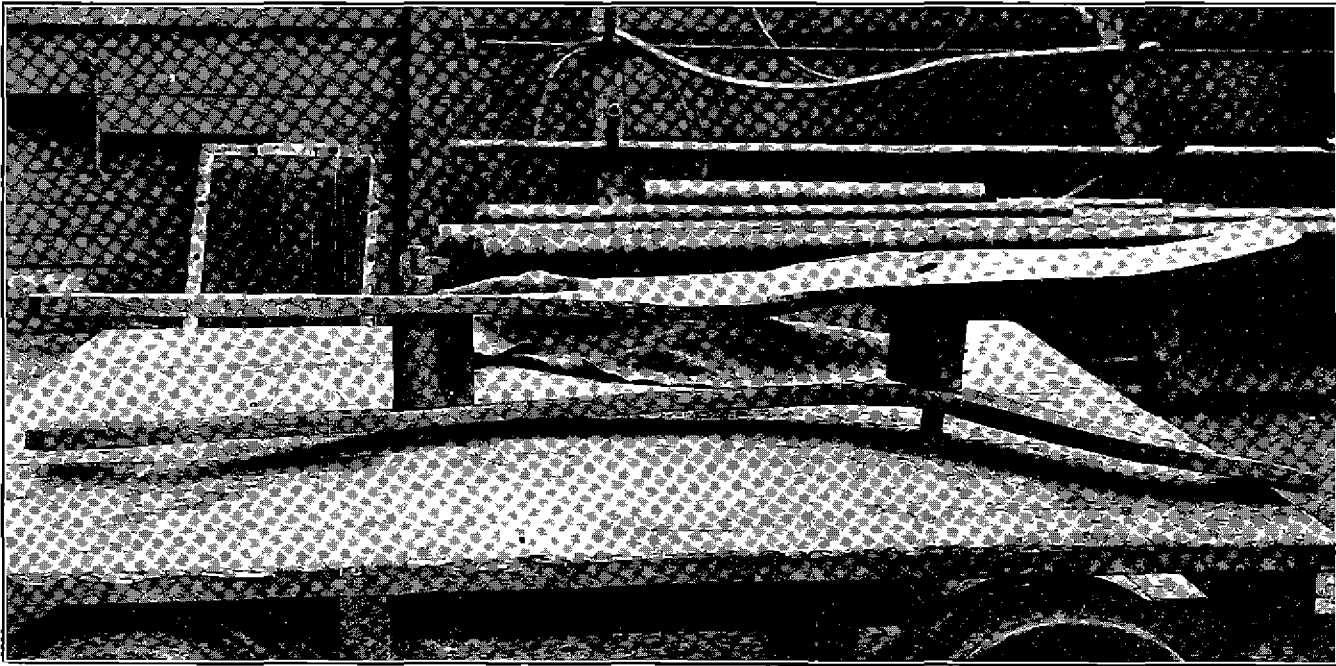
The antecedent incident, necessary to account for the sequence of events as they are believed to have transpired, appears to be presented in the fractured bolt from which the forward spring hanger was suspended. This bolt, which secured the two equalizer bars, was broken at its inside end at the root of the thread on which a nut was used, the nut being retained in place by a cotter pin.

The fracture of this bolt permitted the forward ends of the equalizer bars to spread and also bend into a warped shape, unseating them on the journal box and leading to the detachment of the forward end of the truck spring. This suspension bolt is a vital member in the construction of the truck, and its fracture seems to afford an adequate explanation of the failure of the truck.

The shank of this bolt was larger than its threaded end. Its reduction in diameter to the size of the nut and the cutting of the thread introduced an unnecessary element of weakness. The bolt did not exhibit a sheared fracture, but one in which alternate pressure on one side and then the other of the nut culminated in rupture. The element of danger pertaining to the use of sharp shoulders in a sudden change in the cross section of a member is too well known to require further comment.

The essential evidence of the cause of the derailment is believed to be shown in the three photographic cuts numbered 5, 6, and 7, respectively, indicating the fracture of the spring-hanger bolt as the incipient and originating cause of the accident.

FIG 5—Right engine truck equalizer bars Bolt carrying forward spring hanger broken Forward ends of equalizer bars spread and twisted

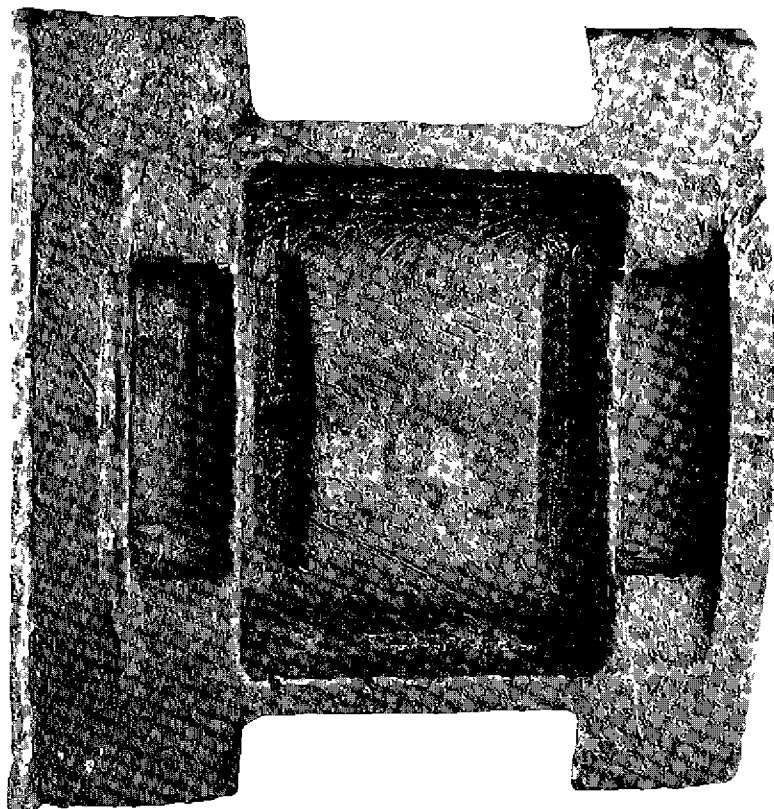
Concerning the general condition of the equalizer bars, they were members which had been subjected to considerable wear at their ends, where they seated on the journal boxes. The upper side of each journal box was recessed to receive lugs on the ends of the equalizer bars. The forward right-hand journal box, the one immediately involved in the accident, showed that one of the equalizer bars had left its seat at some time and had ridden on the top surface of the box at the edge of the recess. The bottom of the recess on that end of the box showed a depressed area, unlike the smooth seat of the opposite bar. These unevenly worn seats were undoubtedly of long standing. Their condition would account for unfavorable strains being put upon the bolt of the forward spring hanger, racking and swaying strains calculated to fracture the bolt at the root of the thread at the place where rupture actually occurred.

FIG 6—Appearance of top of axle box, forward axle right hand side showing where equalizer bar had ridden on top surface of box at edge of one recess

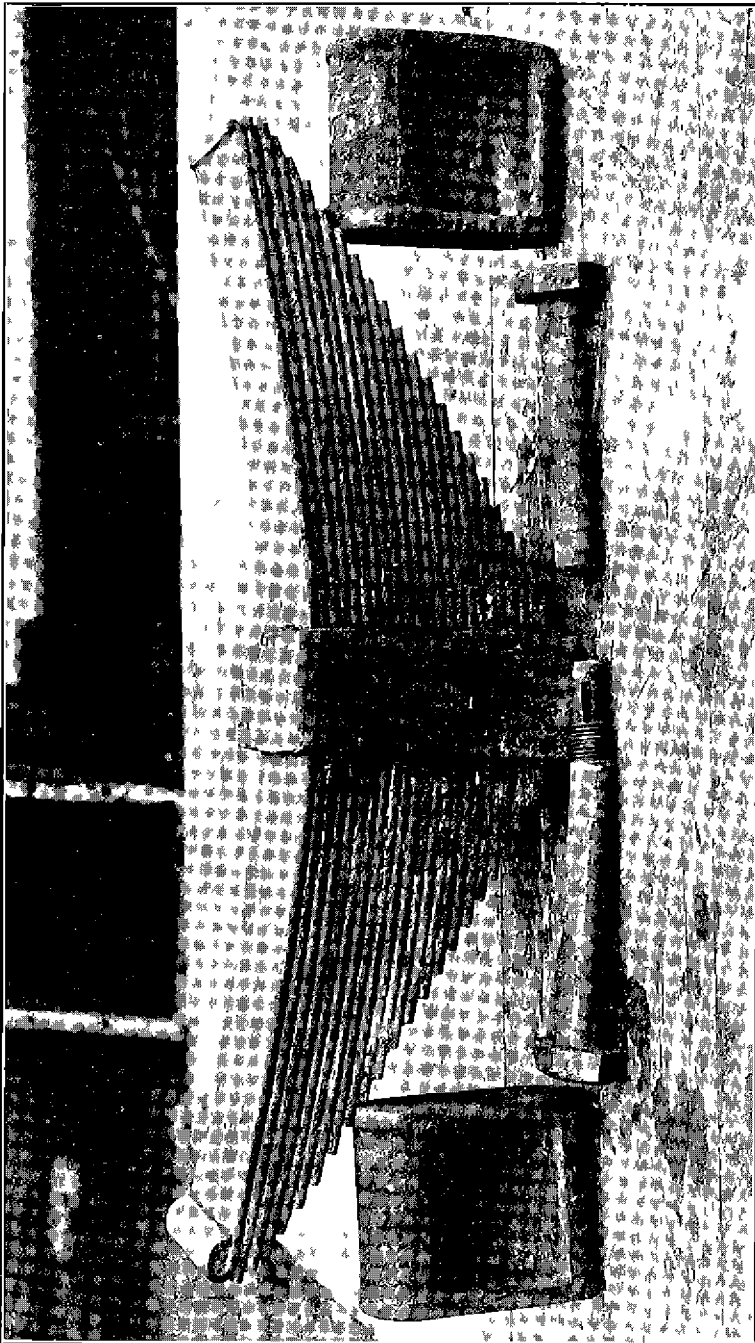
The loop of the lower leaf of the semielliptic spring, front end, which seats in a hanger suspended from the equalizer bars, was broken off, presenting in part a newly fractured surface. The pocket of the hanger indicated the end of the spring had been drawn over the retaining lip, and therefore relieved of its bearing at its forward end. This circumstance calls for some still earlier condition which would permit such an event to take place.

It was demonstrated by test of the spring, loading it with 11 tons that the lower leaf would still retain a concave shape and therefore tend to remain in its seat in the spring hanger, notwithstanding the fracture of the loop or in its absence. Measured on a chord of 30 inches from end to end of the spring, the versed sine of the arc was $1\frac{3}{4}$ inches when the spring was under 11 tons load.

FIG. 7.—Right semielliptic spring of ensue truck, photographed bottom side up. Loop of lower leaf of spring, forward end broken hanger not joined bolt of spring was dislodged from its hanger. Broken bolt of forward hanger, shown in cut. Rear right spring, hanger not joined bolt of same slightly bent.
