## INTERSTATE COMMERCE COMMISSION

### REPORT OF THE DIRECTOR OF THE BUREAU OF SAFETY IN RE INVESTIGATION OF AN ACCIDENT WHICH OCCURRED ON THE MISSOURI PACIFIC RAILROAD AT REILY LAKE, ILL., ON DECEMBER 10, 1927

JANUARY 25, 1928

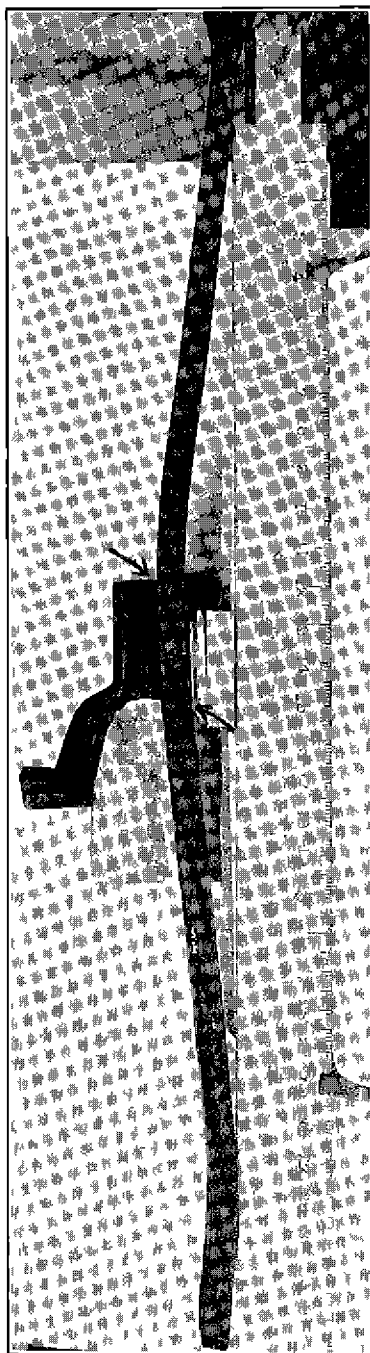
The switch rail clip was bolted to the bent head rod on the sloping face of the latter. The righting of the switch rail caused the clip to abrade the metal of the head rod at diagonal corners. Bending stresses, incident thereto, concentrated at the minimum cross section of the head rod—that is, across the bolt hole. Final rupture ensued as the result of repeated bending stresses. Repeated bending stresses, of sufficient degree, will ultimately cause the rupture of any grade of steel.

Figure No 1 shows the appearance of the head rod as it was received after the accident. The rail clip appears on the cut near its location on the head rod. A short distance from its outer end the rod was bent upward  $10^{\circ}$ . There was a long upward bend in the body of the rod, the crest of which was just inside the position of the rail clip. The maximum deflection, on a chord of 30 inches, was  $1\frac{1}{2}$  inches. These were the bends referred to in the testimony at the investigation as having been present when the head rod was first installed in 1919.

Describing the condition of the head rod immediately after the accident, about one-quarter of the fractured surface was new and bright colored. Three-quarters of the cross section was dark colored and smooth, representing a portion of the fracture of earlier formation. The section of metal first to fracture was located next the root of the jaws of the rail clip.

The bolt hole was elongated one-fourth inch in diameter, parallel to the length of the head rod. The semicylindrical surface of the bolt hole was rounded axially on the side toward the middle of the track, the counter-surface of the worn bolt which was replaced by a new one five days prior to the accident. The looseness of the rail clip was therefore one-fourth of an inch plus whatever the bolt was worn.

Fig 1 —Side view of fractured head rod showing its original bent shape. Arrows point to places where abrasions of upper and lower faces were deepest.

The section of metal between the bolt hole and the inner edge of the head rod was not materially reduced in thickness. On the opposite side the metal was drawn down 0.03 of an inch in thickness.

The upper face of the head rod was worn a depth of 0.02 of an inch. The under face, diagonally opposite, was worn to a depth of 0.04 of an inch. This loss of metal was due to the abrasive action of the jaws of the rail clip. The diagonal wear was incident to the bent shape of the head rod. Arrows on the cut indicate the places of maximum abrasion.

In conclusion it appears that a defective head rod was installed in 1919, which under the influence of repeated bending stresses developed a progressive fracture, eventually terminating in complete rupture. Responsibility for the accident therefore appears to attach to the installation of this defective member in the switch mechanism.

A new bolt was inserted at the rail clip five days prior to the accident. Opportunity was then offered to inspect the condition of the head rod, the bolt hole in which was finally elongated one-quarter of an inch. The feature of chief importance attached to the use of a bent head rod. It is not justifiable to install members in a track structure which are of distorted shapes, and thereby expose them to strains for which they were not designed nor adapted to resist.
