## INTERSTATE COMMERCE COMMISSION

### REPORT OF THE DIRECTOR OF THE BUREAU OF SAFETY IN RE INVESTIGATION OF AN ACCIDENT WHICH OCCURRED ON THE MISSOURI PACIFIC RAILROAD AT WEST JUNCTION, KANS., ON JUNE 25, 1928

JULY 18, 1929

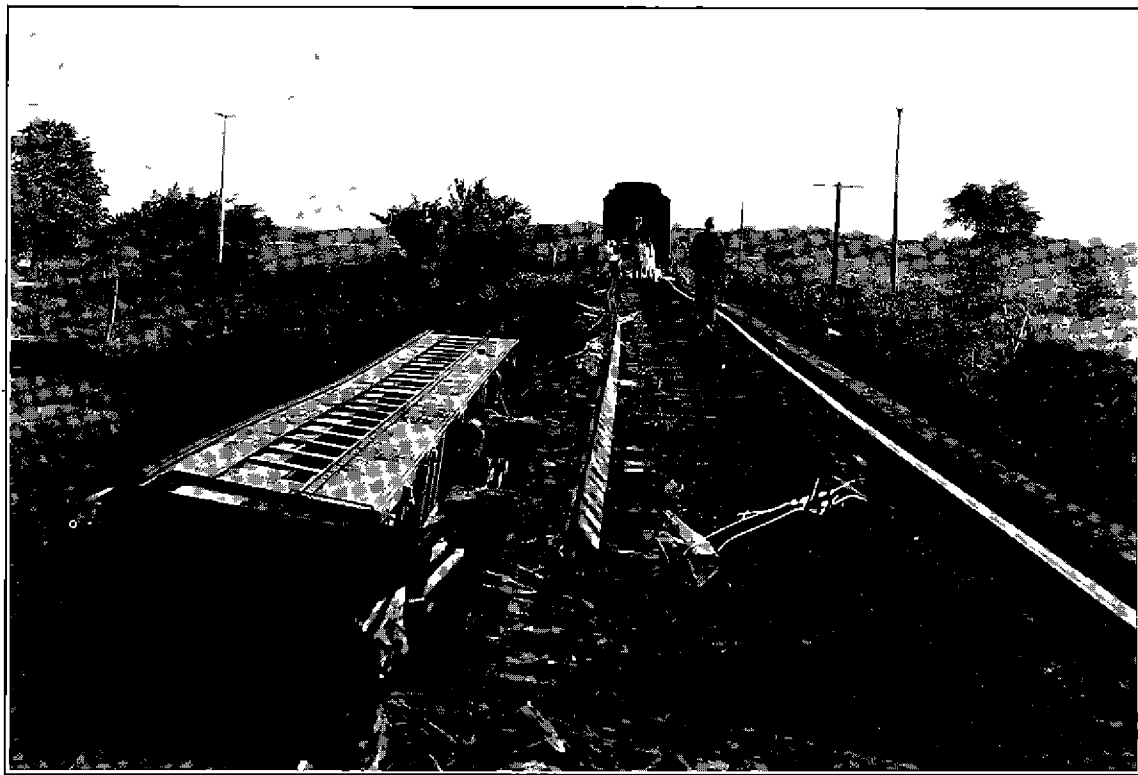
FIGURE 1 —Derailed chain car, on its side parallel to trestle, spanning the bed of the creek

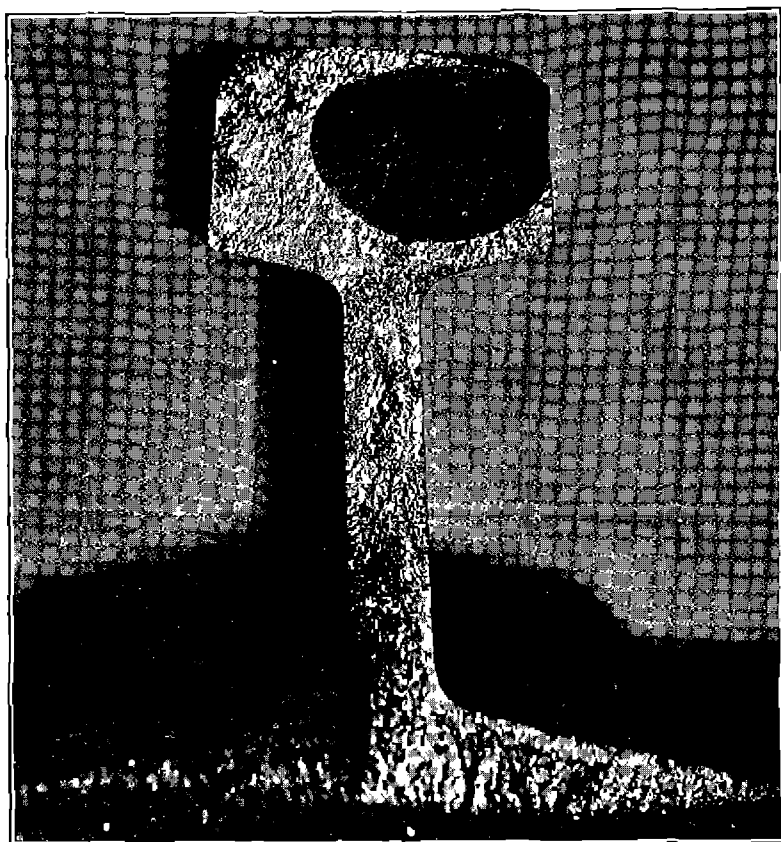
The rail broke 14.85 feet from its receiving end, at a large transverse fissure. Two other fissures, each of large size, were displayed at places beyond the initial break. These fissures had evidently reached the peripheral surface of the head of the rail prior to the time of the accident.

Figure 3 illustrates the transverse fissure which was located 14.85 feet from the receiving end of the broken rail. The nucleus of the fissure was on the gauge side of the head. It had reached the periphery, admitted air and became darkened. Transverse fissures which reach the peripheral surface of the head commonly appear on the gauge side, and at the fillet under the head. A thin layer of metal next below the running surface usually remains unbroken, while the metal of the outer half of the head also remains intact.

FIGURE 3—Appearance of transverse fissure located 14.85 feet from receiving end of tail

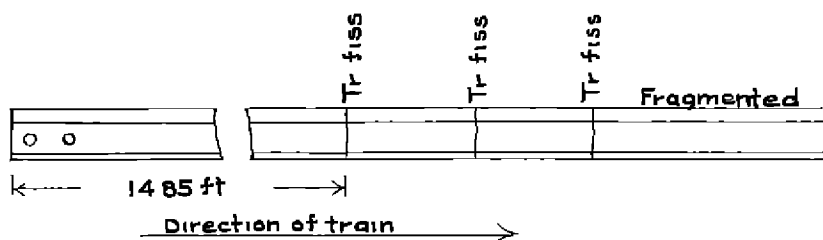
Figure 4 represents the places of the three fissures which were displayed at the time of the accident, while Figure 5 shows the places of the incipient fissures detected in the laboratory of M. E. A. Sperry.

FIGURE 4—Relative places of three transverse fissures displayed at time of accident

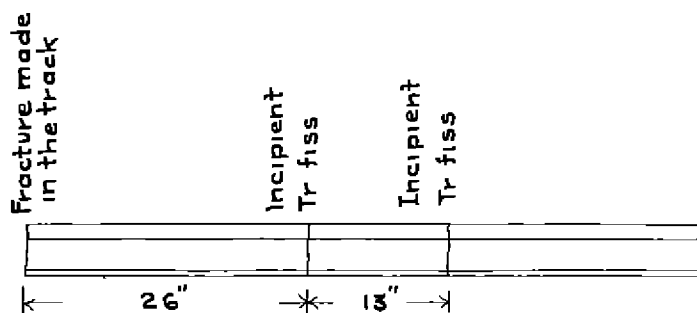
Two additional fissures were detected, their places located and marked on the surface of the rail. It was also stated that they differed in size, and which was the larger was foretold. They were subsequently found in the places indicated and in their relative sizes.

FIGURE 5—Positions of two incipient transverse fissures located by the Sperry detector

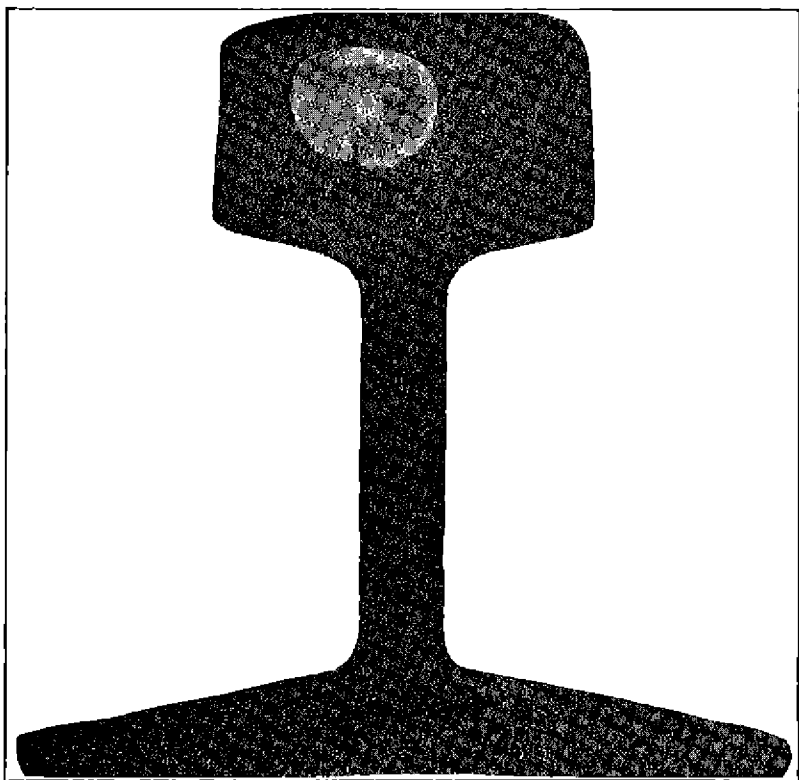
FIGURE 7—End view of rail showing the larger of the incipient transverse fissures located by the Speiry detector

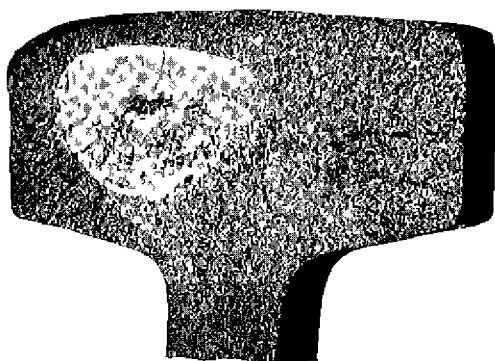
Figure 8 is an example in which the upper part of the area of an incipient fissure showed more complete burnishing than the lower portion. It does not follow, however, that actual extension of a transverse fissure takes place only when the rail above its neutral axis as a beam is in tension. Much might be said upon this point. Longitudinal vibrations suggest themselves as factors.

FIGURE 8 —Incipient transverse fissure showing variable burmishing effect, greatest in upper part, incomplete in lower part of its area

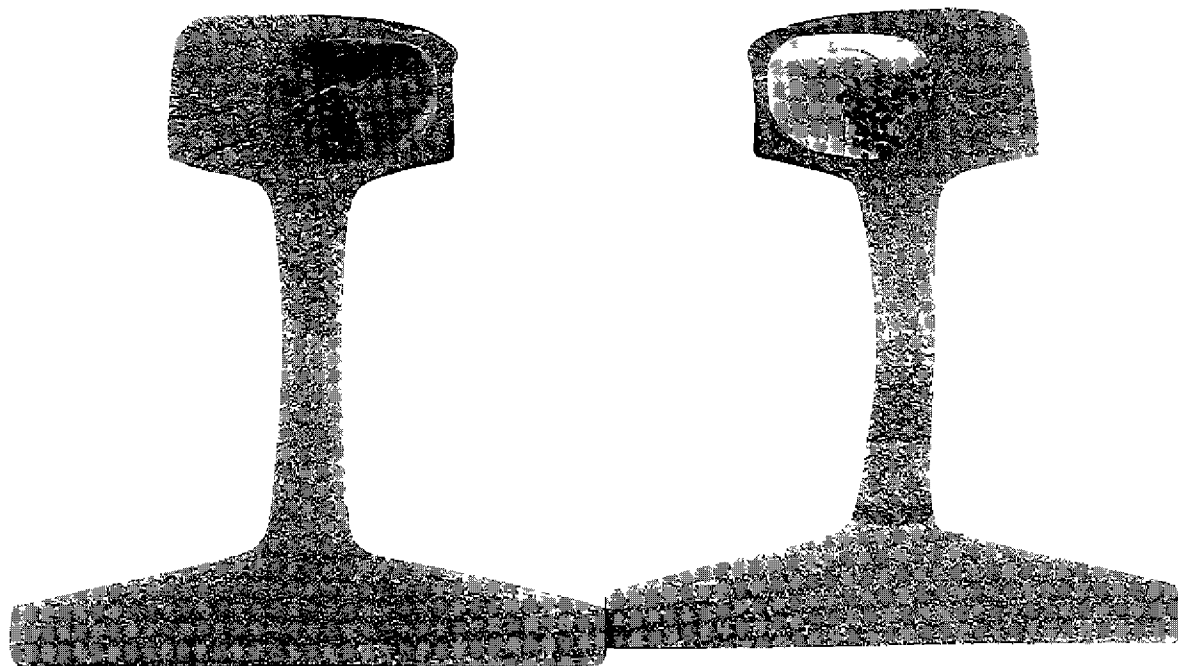
Figure 9 illustrates the fracture of a rail containing an incipient transverse fissure, the completion of the fracture having been accomplished by longitudinal vibrations. This and two other fractures in the same piece of rail, each at a transverse fissure, were made by blows of a light sledge hammer delivered endwise on the rail. Wave motions under high-speed trains, transverse and longitudinal vibrations present matters for mathematical analysis. Profitable lines of inquiry suggest themselves whenever a careful consideration is given the conditions under which steel rails are exposed in service.

FIGURE 9—Incipient transverse fissure in a 100 pound rail. Fracture of rail completed by endwise blows of a sledge hammer. Opposite faces of the fissure hole shown.

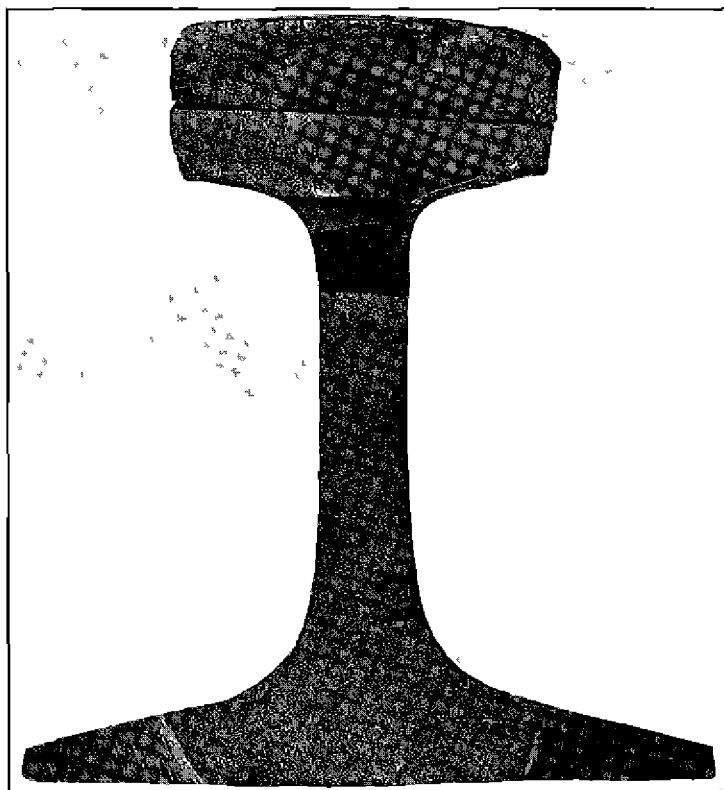
Figure 10 illustrates a transverse fissure in a 115-pound rail which was located by the Sperry detector. A saw scarf was made in each flange of the base, directly opposite the indication of the transverse fissure in the head. The rail was then broken as a beam with the base in tension.

The plane of rupture, notwithstanding the transverse fissure was a large one, took an oblique course and separated the metal of the head at a short distance from the fissure. Other saw scarfs were made and the metal wedged off, revealing the fissure at the place where its presence had been announced.

FIGURE 10—End view of a 115 pound rail showing a transverse fissure which was located by the Sperry detector
