## INTERSTATE COMMERCE COMMISSION

REPORT OF THE DIRECTOR OF THE BUREAU OF SAFETY IN RE INVESTIGATION OF AN ACCIDENT WHICH OCCURRED ON THE NASHVILLE, CHATTANOOGA & ST. LOUIS RAILWAY AT BELL BUCKLE, TENN., ON APRIL 26, 1930.

May 14, 1930.

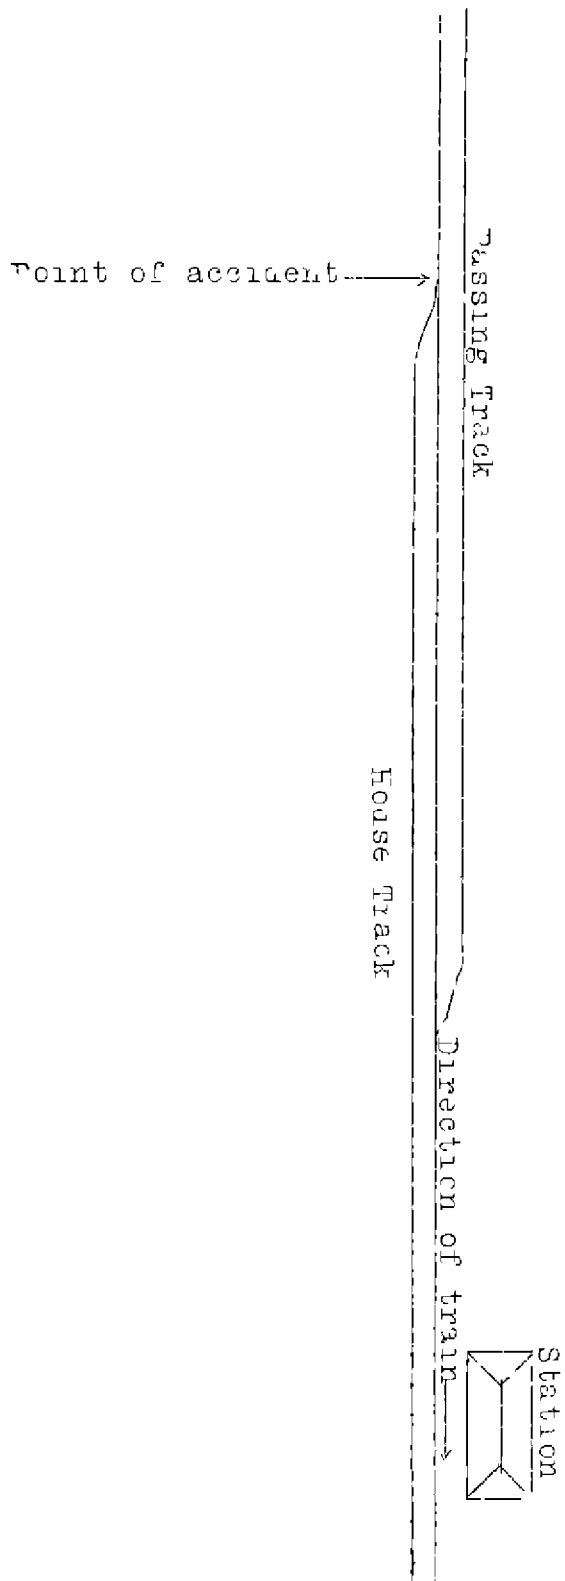
Inv. No. 1633  
Nashville, Chattanooga & St. Louis Ry.  
Bell Buckle, Tenn.  
April 26, 1970

The thirteenth to the twenty-fourth cars, inclusive, were derailed. At the time of the accident, there were three cars standing on the house track near its northern end, and the thirteenth car in the train collided with these cars, destroying one of them. The fourteenth car, with its rear truck derailed, came to a stop 300 feet south of the initial point of derailment, while the remaining derailed cars came to rest in various positions, with some of them overturned, and seven of them badly damaged.
