INTERSTATE COMMERCE COMMISSION

REPORT OF THE DIRECTOR OF THE BUREAU OF SAFETY IN RE INVESTIGATION OF AN ACCIDENT WHICH OCCURRED ON THE NASHVILLE, CHATTANOOGA AND ST LOUIS RAILWAY AT KEN NESAW, GA , ON DECEMBER 22, 1923

February 27, 1924

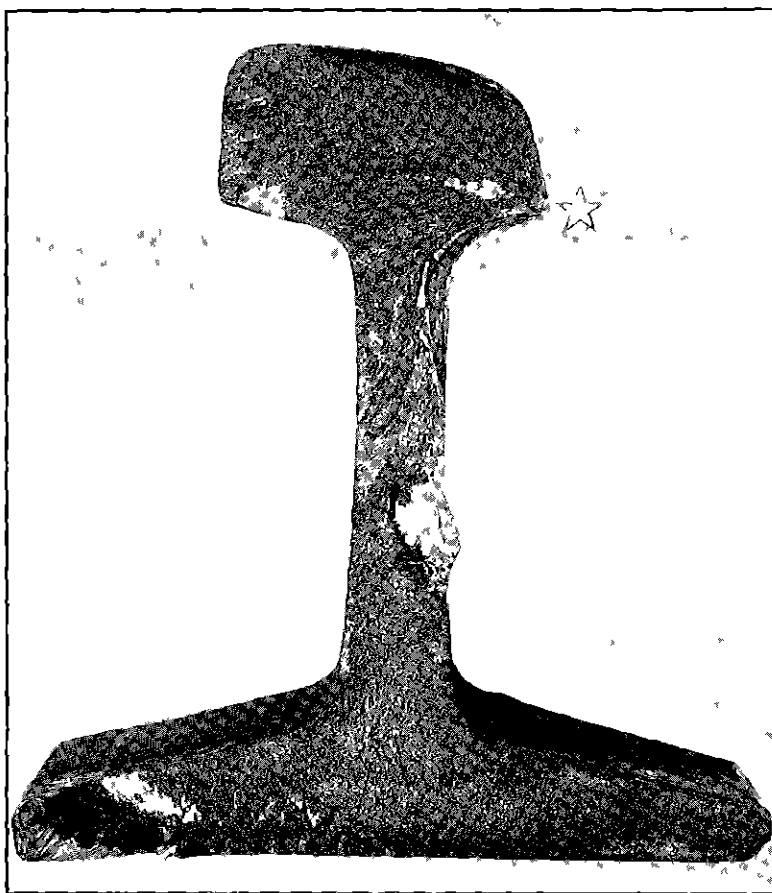
Macroscopic and microscopic examination was made of the rail on a section taken from the leaving end, from the immediate vicinity of the fractured surface. Figure 1 shows the appearance of the fractured surface at the leaving end. The incipient point of rupture was at the lower corner of the head on the gauge side, at the place marked by a star on the cut. From this initial point the plane of rupture extended across the head, thence downward through the web and the base, ending at the edges of the flanges. An oblique shearing fracture, as previously mentioned, was displayed by the metal adjacent to the running surface, representing the cold rolling effects of the wheel pressures.

The fractured surface of the leaving end was battered in a few places, all of which were secondary effects. The flanges of the wheels bruised the metal at the fillet under the head after the rail was overturned. The radiant, fan like, appearance of the fractured surface indicated its point of origin. In the fracture of steel the plane of rupture has its origin and extends from the center of radiation. This simple and reliable method of judging of the incipient point of rupture should be familiar to all. Its observance would obviate many erroneous conjectures concerning the cause of rail failures. In the present instance the cause of fracture had erroneously been attributed to flaws and defects in the steel where none existed, in three different places none of which had a relation to the incipient point of rupture.

FIG. 1 —Fractured surface of leaving end of long fragment of rail. Origin of fracture at lower corner of the head gauge side at point indicated by a star.

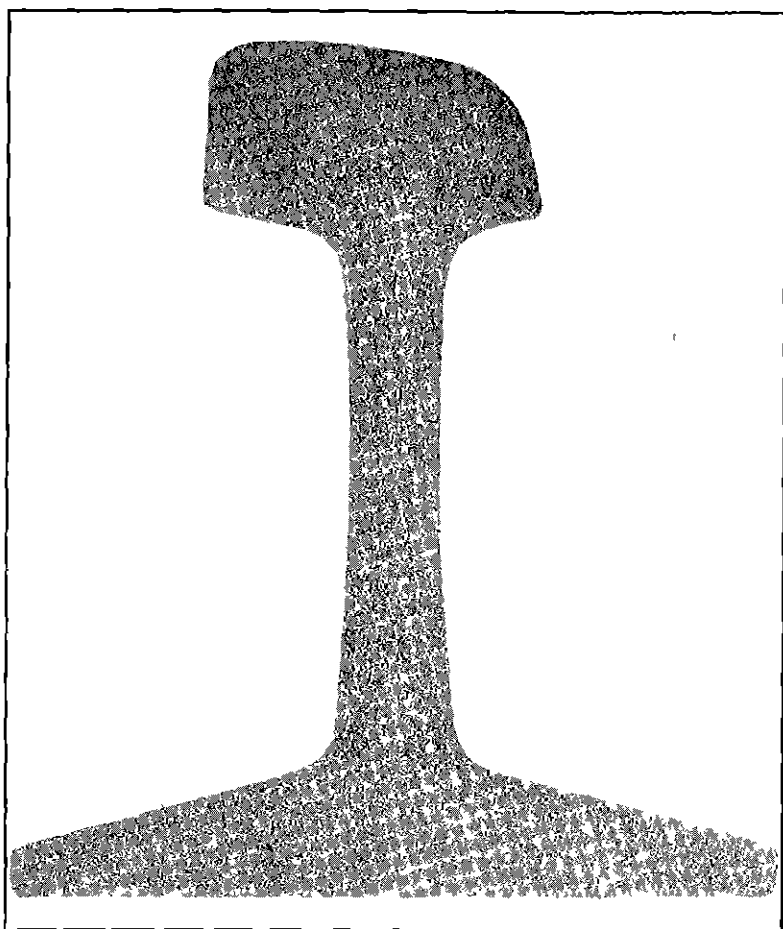
Figure 2 represents a sulphur print of the cross section of the rail, near the fractured end. The uniformity of the metal is almost phenomenal. No adverse criticism attaches to the rail respecting its composition or structure.

FIG 2 — Represents a sulphur print of rail, near fractured end

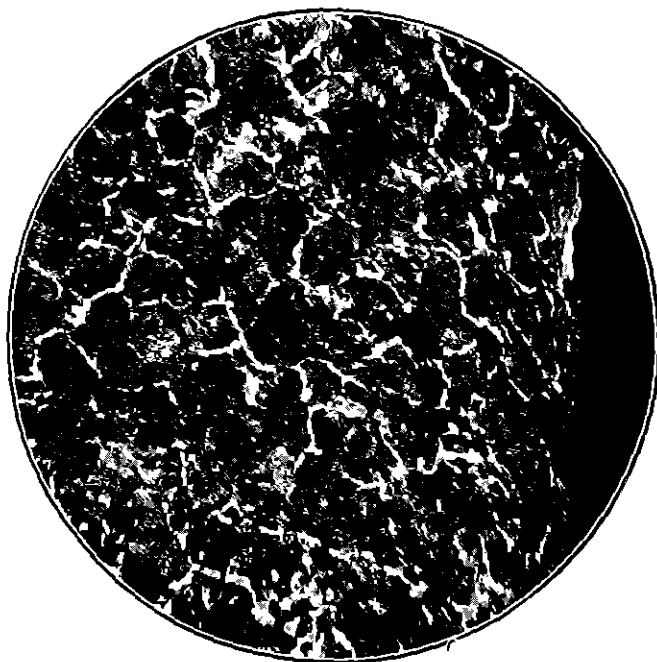
Photomicrograph, Figure 4, represents the metal on the gauge side of the head, at mid-depth. The metal in this vicinity was sheared off by the wheel flanges, with slight disturbance below the abraded surface.

FIG. 4--Photomicrograph of metal, gauge side of head middepth
Metal in this vicinity sheared off without distortion of metal below
the sheared surface Transverse section Magnification 100 diam
eters

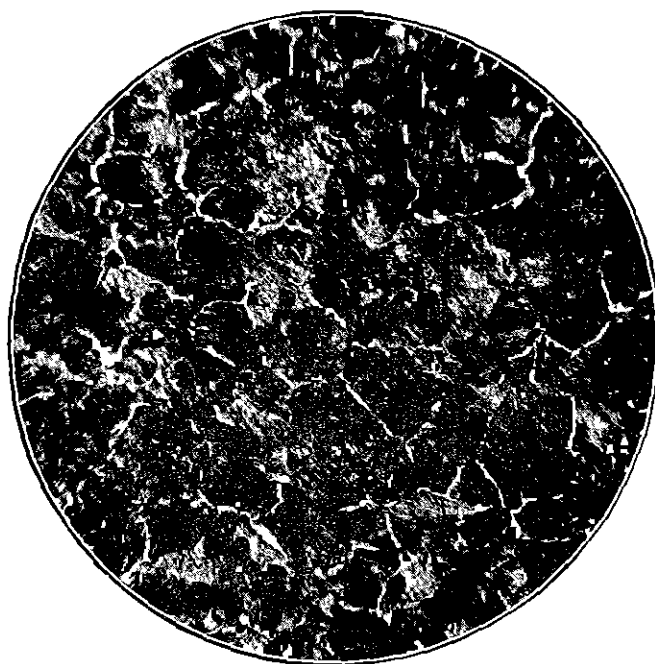
side. The normal structure of the metal, in unaffected parts of the cross section, is shown by Figure 6. Each of these photomicrographs represent transverse sections at a magnification of 100 diameters.

FIG. 6.—Photomicrograph showing normal structure of rail where not affected by wheel pressures. Transverse section. Magnification 100 diameters.

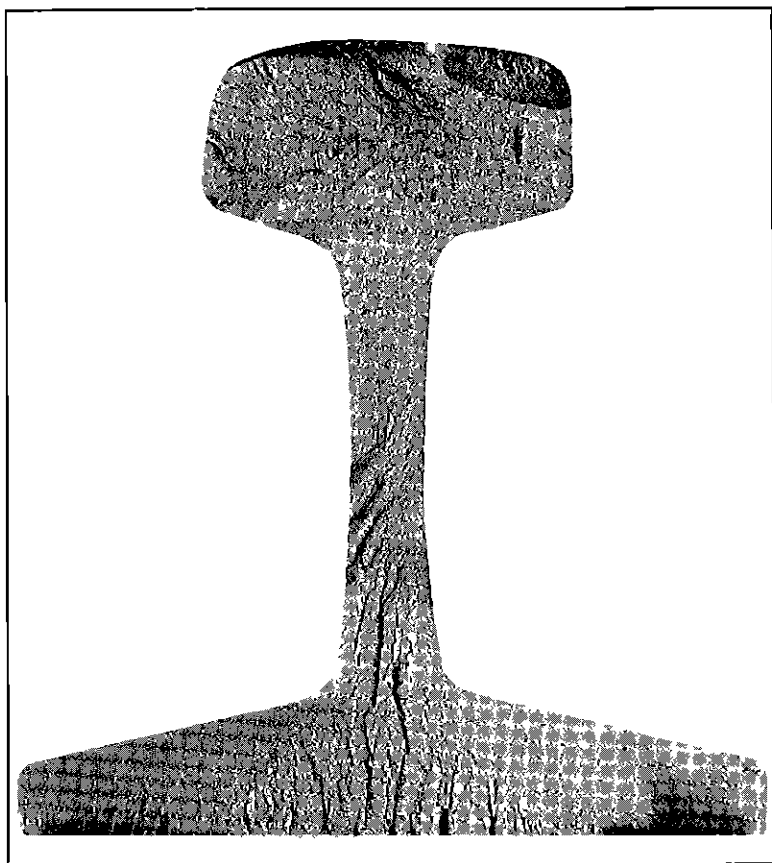
Figure 7 illustrates the fractured surface of this rail, a rail of 100 pounds weight per yard, which displayed head checks in service. Head checks were numerous on the rail—embryonic, and those of advanced stage of development. They appeared on the running surface, gauge side of the head. The head check here illustrated was one inch long by five-sixteenths inch deep.

FIG 7—Head checked rail. Progressive fracture on gauge side of head, shown by darkened area. Checked surface 1 inch long by five sixteenths inch deep.

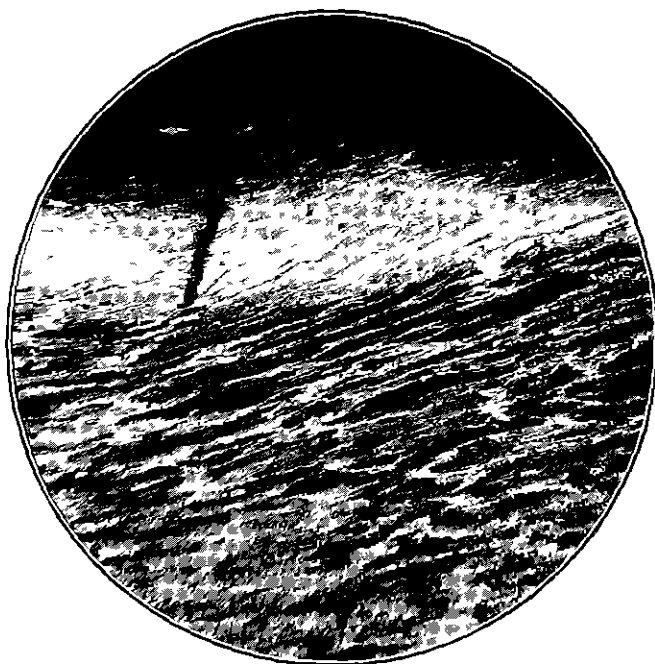
Photomicrograph, Figure 8, shows the appearance of the metal at the running surface near the outside corner of the head. There was a hardened layer of surface metal with flattened grains next below, showing an outward flow of the metal, that is, toward the outside edge of the head.

FIG 8—Head checked rail. Photomicrograph at running surface near outside corner of the head. Hardened surface with flattened grains below, flow of metal trending toward outside edge of head. Transverse section. Magnification 100 diameters.

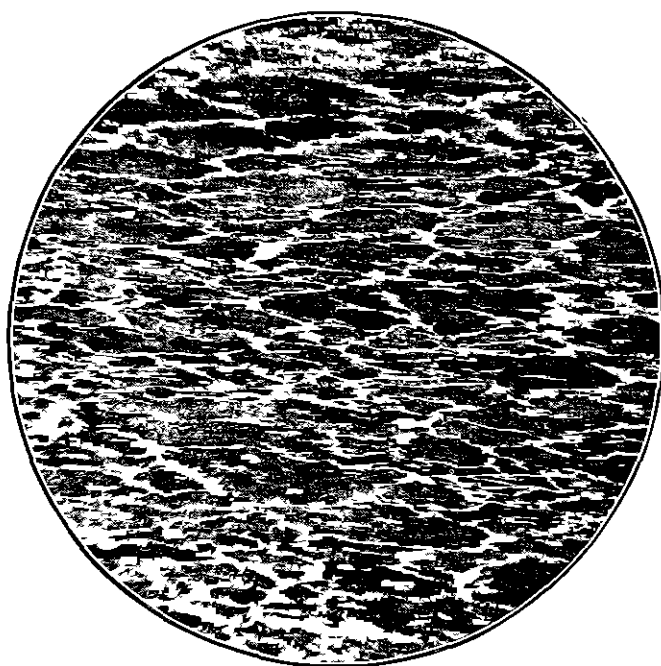
Figure 9 shows more of the metal with flattened grains, located next below the zone illustrated by Figure 8. The dip of the flattened grains toward the outside edge of the head is conspicuously shown. The normal structure of the steel is shown by Figure 10.

FIG. 9—Head checked rail Photomicrograph of metal next below
that shown by Figure 8 Showing flattening of the grains and di-
rection of flow outward Transverse section Magnification 100
diameters

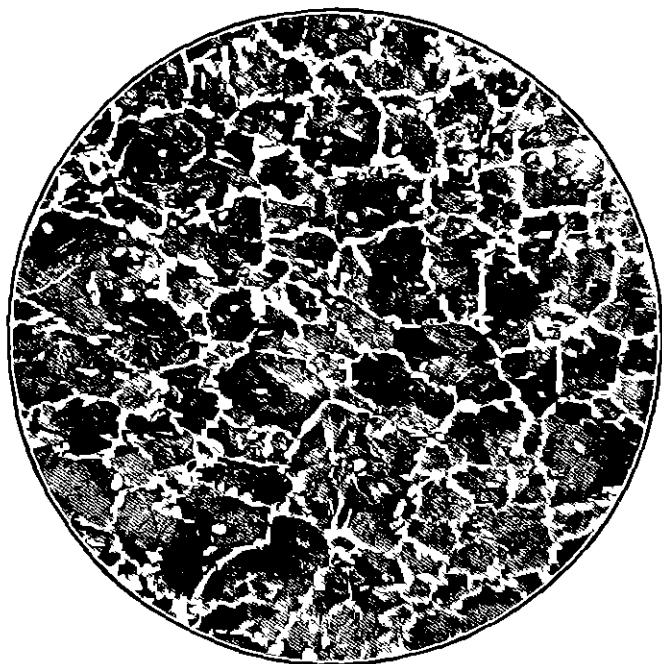
FIG 10 —Head cheel ed rail Photomicrograph showing normal structure of the steel where not affected by wheel pressures Transverse section Magnification 100 diameters

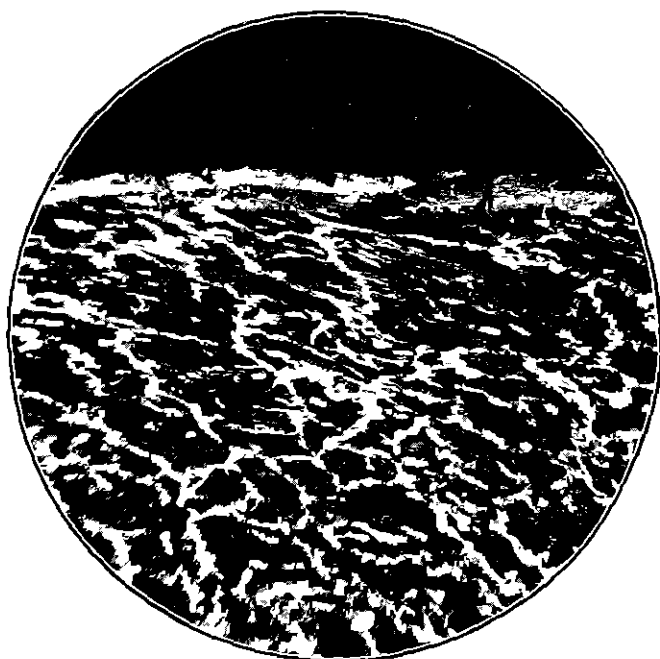
Along a median zone the structural condition of the metal is less changed by the wheel pressures. Figure 12 shows the metal at the running surface at the middle of the width of the head. There was slight hardening of the metal at the surface with a shallow zone of flattened grains. Figures 8 to 12, inclusive, represent transverse sections.

FIG. 12—Head checked rail. Photomicrograph showing appearance of metal near middle of width of head at running surface. Slight hardening at surface and shallow zone of metal or flattened grains. Transverse section. Magnification 100 diameters.

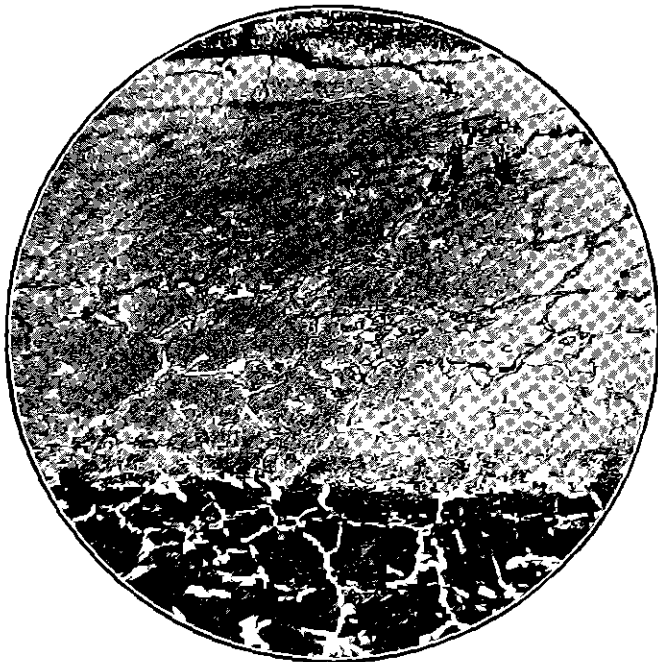
FIG 14—Head checked rail. Photomicrograph near running surface immediately below Figure 13. Hardened zone with metal of normal structure below. Sharp line of demarkation of hardened metal. Longitudinal section. Magnification 100 diameters.

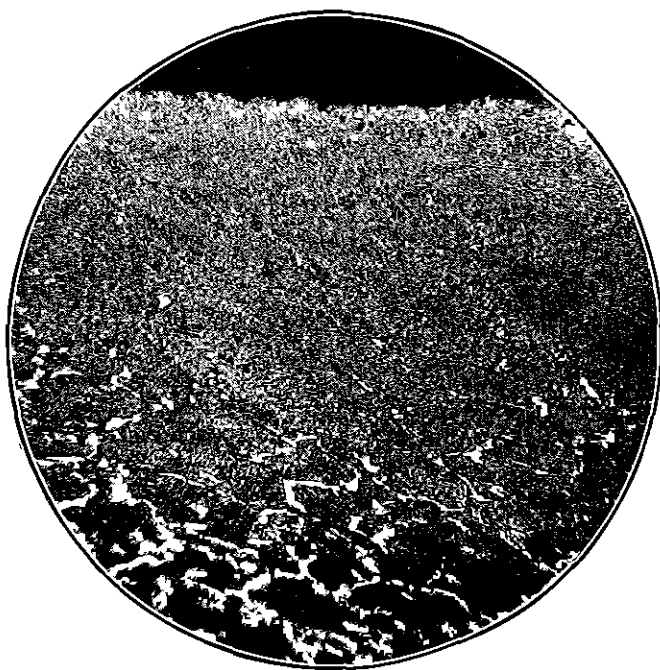
Figures 15 and 16 are transverse sections and represent the metal at the running surface near the upper corner of the head, gauge side. They further illustrate the appearance of the hardened surface metal, converted from metal of normal structure.

FIG. 15—Head checked rail. Photomicrograph at running surface near upper corner gauge side of the head. Hardened surface metal. Traces of grain structure within hardened zone. Transverse section. Magnification 100 diameters.
