INTERSTATE COMMERCE COMMISSION

REPORT OF THE CHIEF OF THE BUREAU OF SAFETY COVERING THE INVESTIGATION OF AN ACCIDENT WHICH OCCURRED ON THE NASHVILLE, CHATTANOOGA & ST LOUIS RAILWAY AT NASHVILLE TENN, ON JULY 9, 1918

August 16 1918

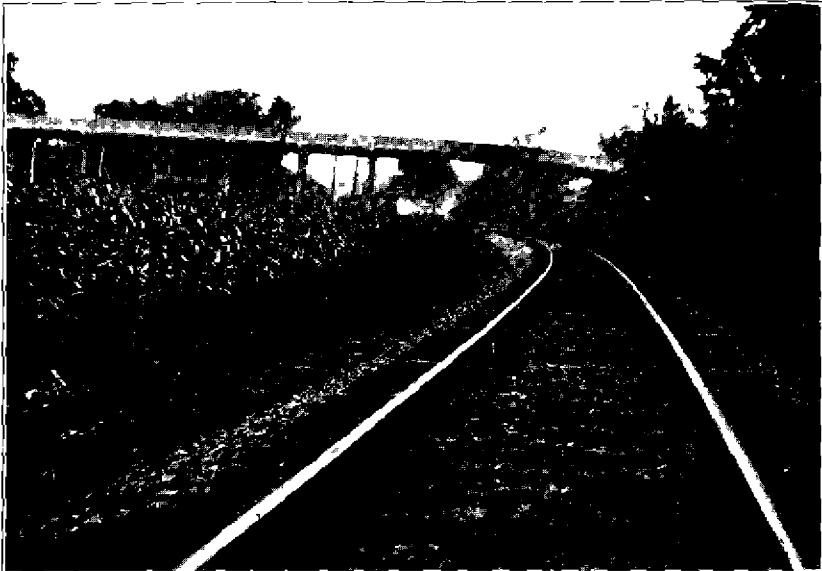
Approaching the point of accident from the direction of Shops the track is straight for approximately 4,000 feet then there is a 3-degree curve to the left about 2,200 feet long then a tangent about 1,000 feet long which leads to the 2-degree curve on which the collision occurred. The grade descends from 0.7 per cent to 1.3 per cent to within about 1,600 feet of the point of collision and is practically level the remainder of the distance. Between Shops and the point of collision there are several cuts, one of which ends about 300 feet before reaching the point of collision, and has a maximum depth of 15 feet. This cut, the overhead highway bridge and the curve upon which the accident occurred made it practically impossible for the enginemen to see approaching trains as is indicated by Fig 5. The weather at the time was clear.

FIG. 5—VIEW OF TRACK AND OVERHEAD BRIDGE FROM DIRECTION TRAIN NO. 1 WAS TRAVELING
