## INTERSTATE COMMERCE COMMISSION.

### REPORT OF THE CHIEF OF THE DIVISION OF SAFETY COVERING THE INVESTIGATION OF AN ACCIDENT WHICH OCCURRED ON THE NASHVILLE, CHATTANOOGA & ST. LOUIS RAILWAY NEAR ROCKLEDGE, TENN., ON DECEMBER 23, 1915.

JANUARY 17, 1916.

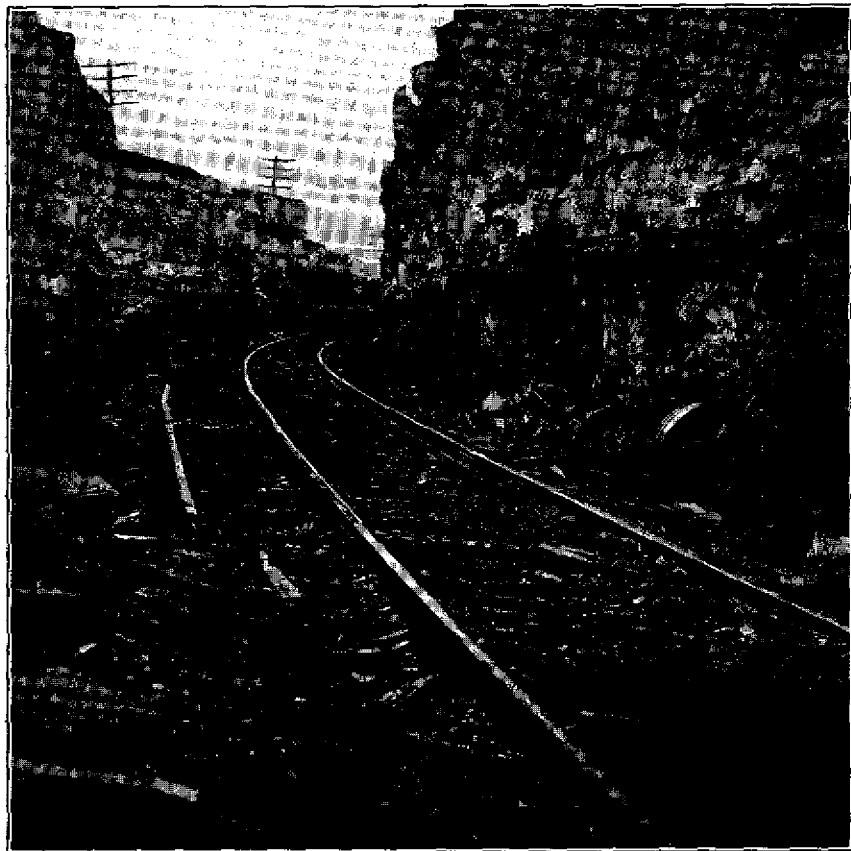
At the time of the collision train first No. 2 was running at approximately 15 miles per hour, and train No. 55 was running about 10 miles per hour. Neither locomotive was derailed, and the track was not badly damaged. The first coach was telescoped by the tender of the passenger locomotive, and nearly all of those killed in the collision were riding in this coach, being colored laborers employed by the railroad company. The first two cars of the freight train were not materially damaged; the third car was derailed and otherwise damaged, while the fourth and fifth cars were practically demolished. The forward trucks of the sixth car were derailed, but the remainder of the train sustained practically no damage. The weather was mild and cloudy.

No. 1.—View of scene of accident, looking north, showing bent rail opposite point of collision.

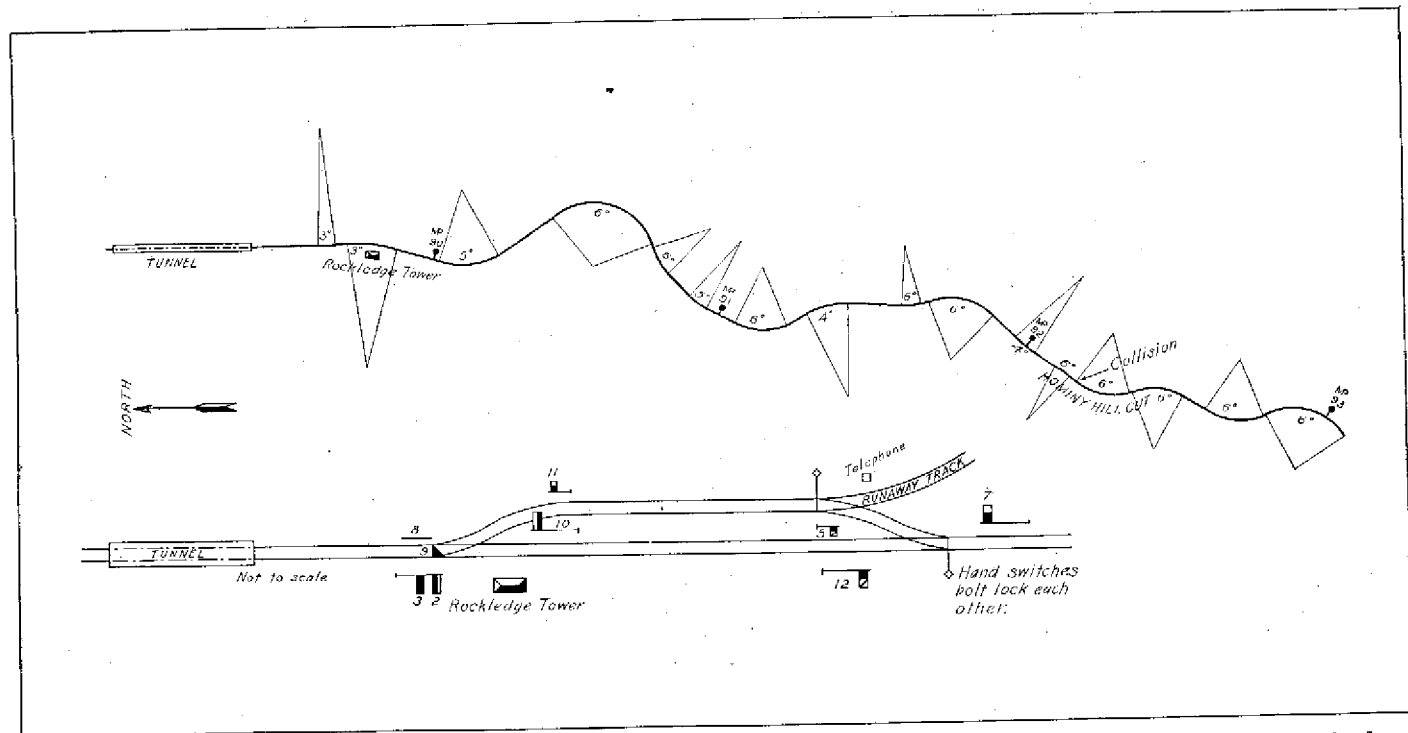
No. 2.—Drawing showing alignment of track from Rockledge southward, and track layout at Rockledge; false clear indication given by dwarf signal No. 5..

This accident was caused by a false clear indication of the dwarf signal at the south end of the passing track at Rockledge, due to foreign current.

The investigation of this accident establishes the fact that the relay controlling this dwarf signal was energized by current which came from some source external to the normal control circuit. But at the time this false clear signal occurred it was not determined where this current did come from, and as it is now impossible to duplicate exactly the conditions then existing, it is impossible to determine positively the source of this current. The fact is established that the signal common wire between Rockledge and Sherwood was grounded. This condition was not discovered until after the accident occurred, but the records of work disclose that it must have existed at the time of the accident. When the signal maintainer discovered these grounds on the common wire he unfastened this wire from the insulators and moved it back on the cross arms to a position out of contact with the guy wires. During investigation of this accident tests were made on December 28 to demonstrate whether or not the dwarf signal could be cleared by crossing the control wire for the dwarf signal with Western Union telegraph wires and also with other signal wires. The ground connection to the common wire was restored. The crosses established between the control wire and other signal wires had no effect on the signals, but the dwarf signal was cleared when crosses were made between its control wire and each of 12 of the Western Union telegraph wires.

This signal installation is more or less isolated. In view of its location, even the best modern signal engineering practice would not call for the use of alternating current apparatus or any other special precautions against foreign current. More complete protection would have been provided in this particular situation if the main track switch at the south end of Rockledge passing track was controlled from the tower, and in that event this accident would probably have been averted.

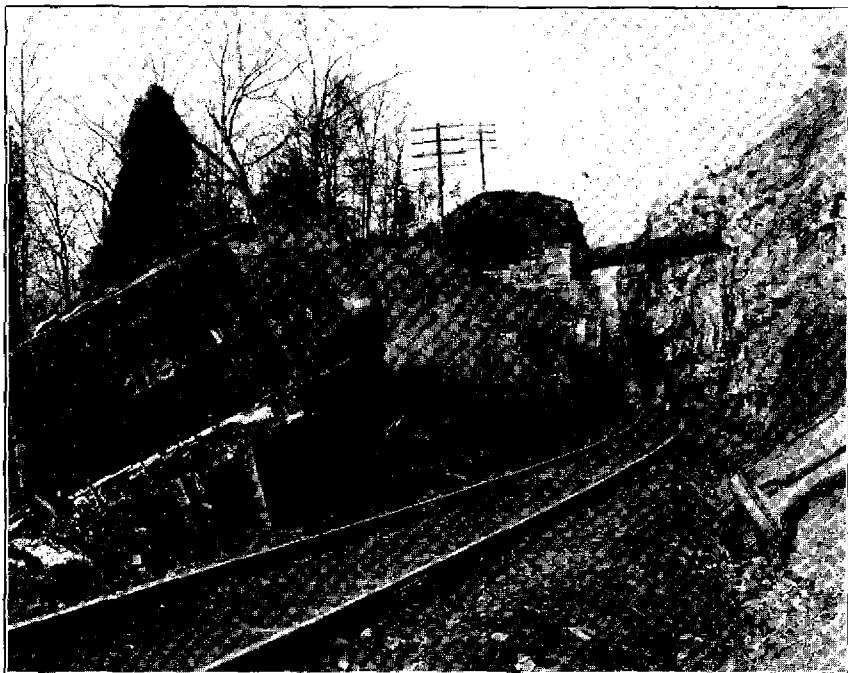
No. 3.—Tender of passenger locomotive, south end of cut, and reverse curve in cut where collision occurred.

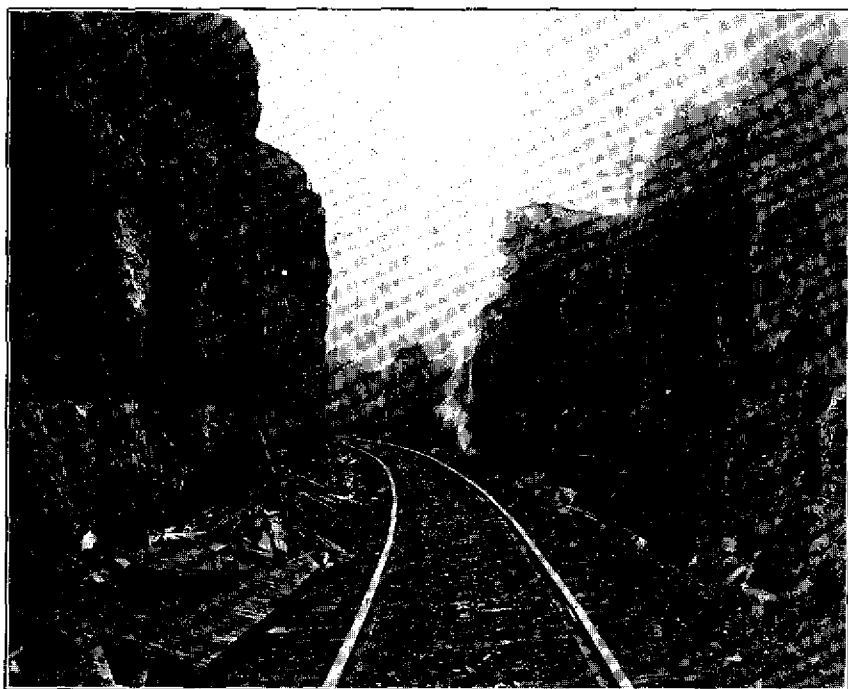
Between Rockledge and the scene of the accident the grade varies from 1.12 to 2.4 per cent, being 1.86 per cent, descending southward, at the point of the accident. The track is a series of curves with only seven short stretches of tangent. There are five cuts in this region, all of considerable depth, and the greater part of the remaining track is on embankment. Closely approaching the scene of the accident from the north there is a 4-degree curve to the east, 750 feet long, followed immediately by a curve of 3 degrees and 30 minutes to the west, 350 feet long, which in turn is followed by a 6-degree curve to the east, 950 feet long. The collision occurred at about the middle of this 6-degree curve. This series of reverse curves just described is in a rock cut, with practically vertical sides, with a maximum depth of 60 feet. The cut, which is known as "Hominy Hill Cut," is nearly 1,500 feet long.

No. 4.—Looking south in cut at scene of accident.
