INTERSTATE COMMERCE COMMISSION

REPORT OF THE DIRECTOR OF THE BUREAU OF SAFETY IN RE
INVESTIGATION OF AN ACCIDENT WHICH OCCURRED ON
THE NEW ORLEANS GREAT NORTHERN RAILROAD NEAR
BOGALUSA, LA., ON JUNE 15, 1929.

August 2, 1929.

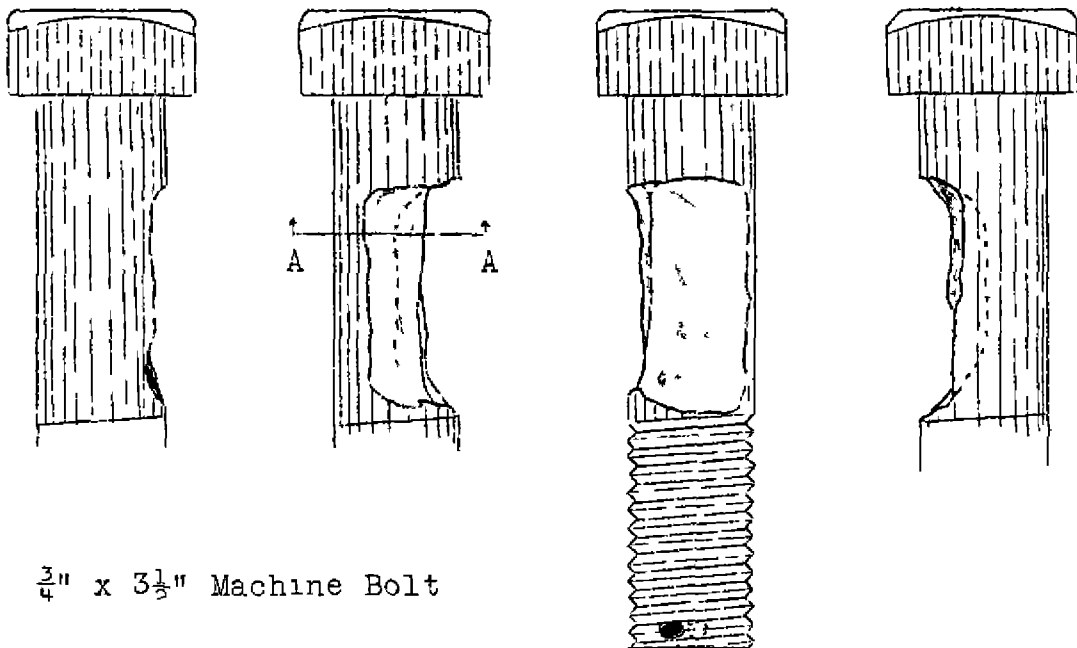
Inv 1530
New Orleans Great Northern Railroad
Bogalusa, La.
June 15, 1929

Bolt which anchors
spindle to inner sleeve
in Ramapo Automatic Safety Switch Stand

Roadmaster Smith said the switch seemed to be in perfect condition when he examined it several hours after the occurrence of the accident, but when tests were conducted subsequently it was found that the switch lever could be pushed down in place and locked without having the switch mechanism properly seated. This defect was concealed to such an extent that it would not have been noticed by the usual inspection given by the section foreman. When the switch stand had been removed and dismantled, under the roadmaster's supervision, it was found that the bolt which goes through the inner sleeve and holds the spindle in position was in a defective condition, being worn to a considerable extent where it came in contact with the spindle. The square bottom of the sliding sleeve was also worn to some extent, as well as the square socket in the top of the star block, but Roadmaster Smith did not think that the worn bolt by itself, or the worn sliding sleeve and star block by themselves, would have been sufficient to enable the switch to be locked without the mechanism being properly seated. Assistant Roadmaster Corban also expressed the opinion that the opening of the switch under train second No. 182 was due to the worn spindle bolt coupled with the wear on the bottom of the sliding sleeve and the top of the star block. Master Mechanic Peters said he examined the engine of train second No. 182, as well as the derailed equipment, but found no defective condition which could have caused the accident. Mr. Peters was present when the switch stand was dismantled and expressed the opinion that the worn conditions described by the roadmaster were the result of natural mechanical wear, coupled with some rust.

This accident was caused by a defective switch.

The evidence indicated that train No. 111 pulled by and backed in on the industrial track and that Conductor Calhoun then closed and locked the switch. As train second No. 182 approached that point, the engine passed over the switch in safety and possibly the first one or two of the cars in the train also passed over the switch before being pulled off by the following cars. These other cars, however, were derailed and when the train finally came to a stop the switch was found lined for the industrial track and still was properly locked. On being dismantled, it was found that the bolt which goes through the inner sleeve and holds the spindle in position was in a defective condition, due to excessive wear, and it was also found that the square bottom of the sliding sleeve and the socket in the top of the star block were showing signs of considerable wear. Apparently the result of this combination was that when Conductor Calhoun closed and locked the switch the slackness in the different operating parts of the mechanism resulted in the switch not being properly seated, thus allowing the points to open under the passing train.
