REPORT OF ACCIDENT ON  
NEW YORK CENTRAL & HUDSON RIVER  
RAILROAD AT HYDE PARK, N Y  
MARCH 31, 1912

BY THE CHIEF INSPECTOR OF  
SAFETY APPLIANCES

REPORT OF THE ENGINEER-PHYSICIST OF THE  
BUREAU OF STANDARDS

PRINTED BY ORDER OF THE COMMISSION  
SEPTEMBER 4 1912

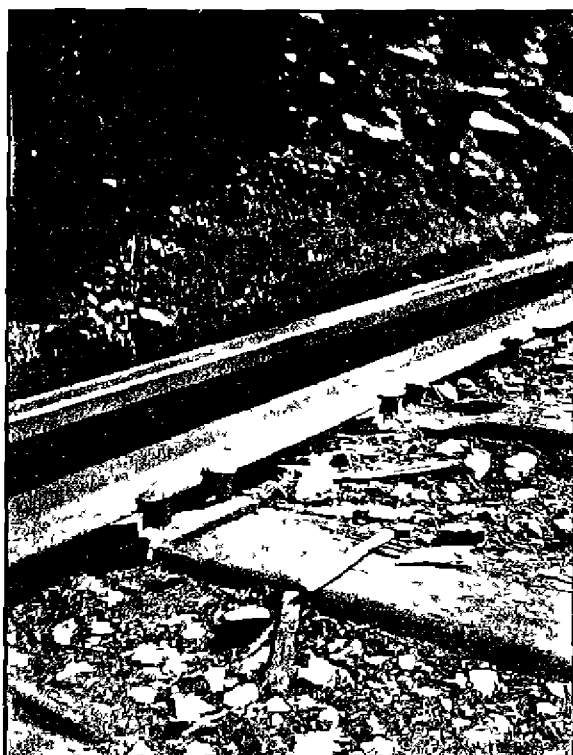
It is believed that the use of shims together with irregularity or unevenness in the track so weakened the track structure that it could not withstand the tremendous strain due to the heavy locomotive and train rounding the curve at high speed and the outside rail was forced outward probably by the engine the first wheels to drop between the rails being the rear tender wheels. This theory is practically substantiated by the condition of the spikes and spike holes in the ties after the derailment. A number of the spikes on the inside of the third rail beyond the initial marks of the derailment were left practically undisturbed and the spikes on the outside of the rail were crowded outward.

Shimming on north bound track opposite point of accident illustrating method of shimming employed in this vicinity

One obvious remedy for this condition is the use of longer spikes where shimming must be resorted to.

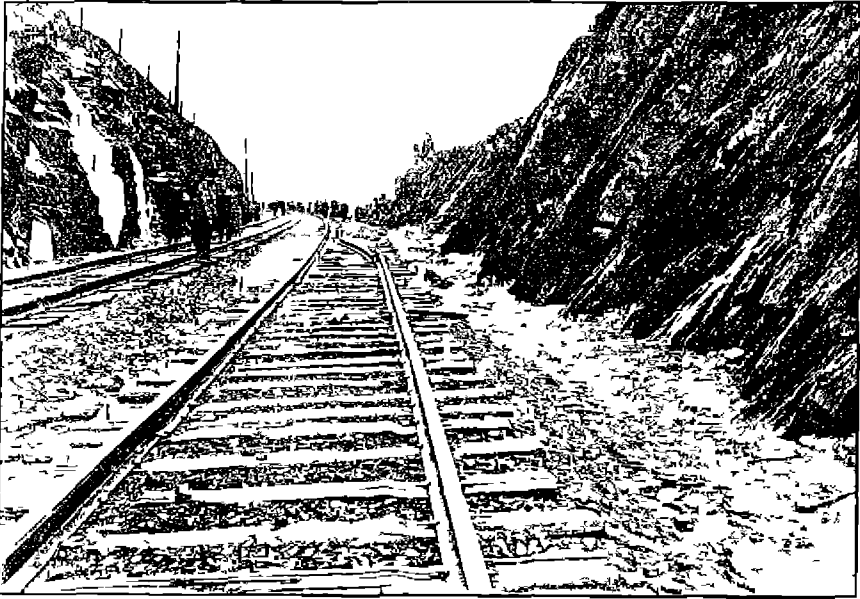
View looking south, showing point where derailment began

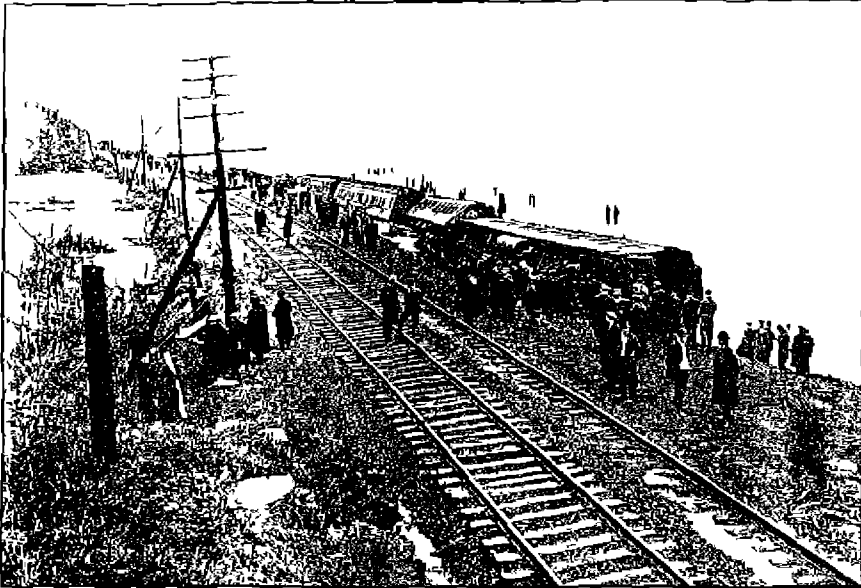
General view of detachment looking south

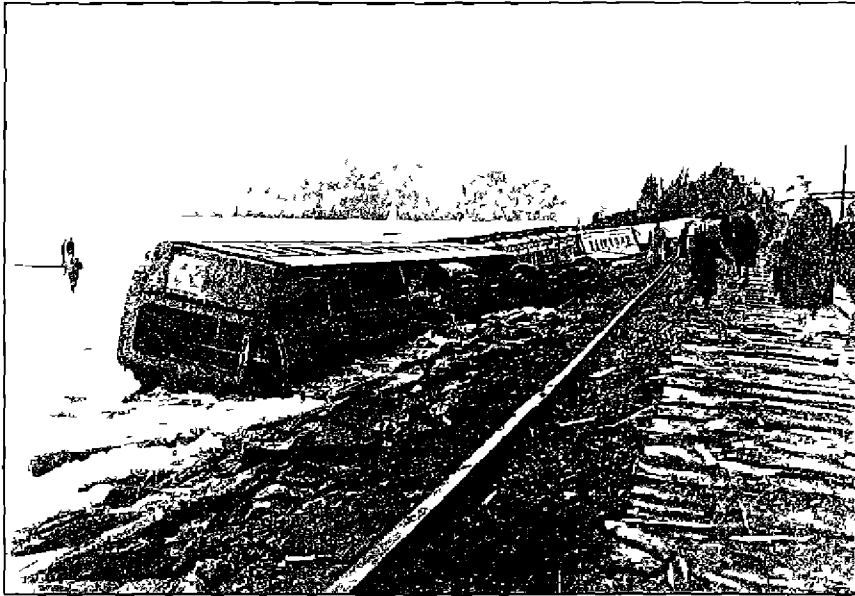
View of derailed cars looking north

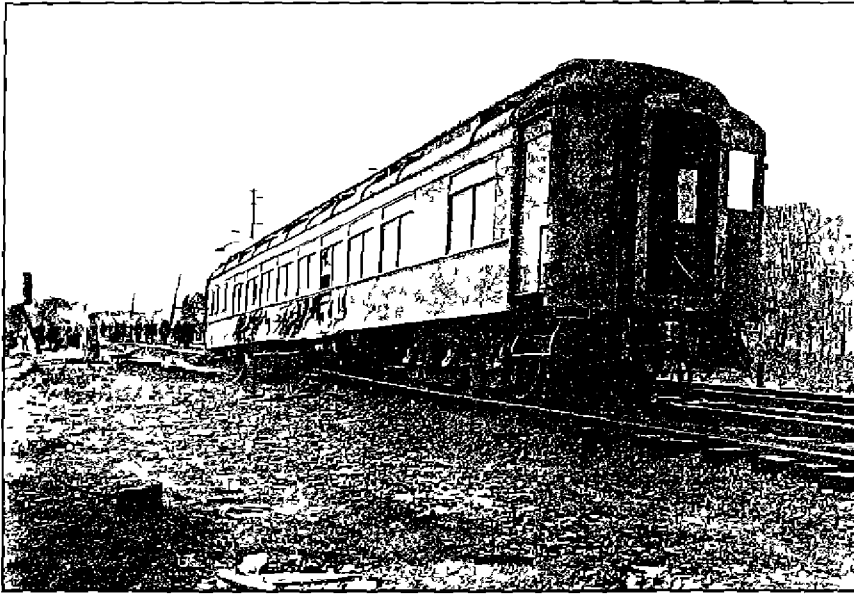
Passenger car overturned showing wheels of forward truck resting on web of overturned rail.

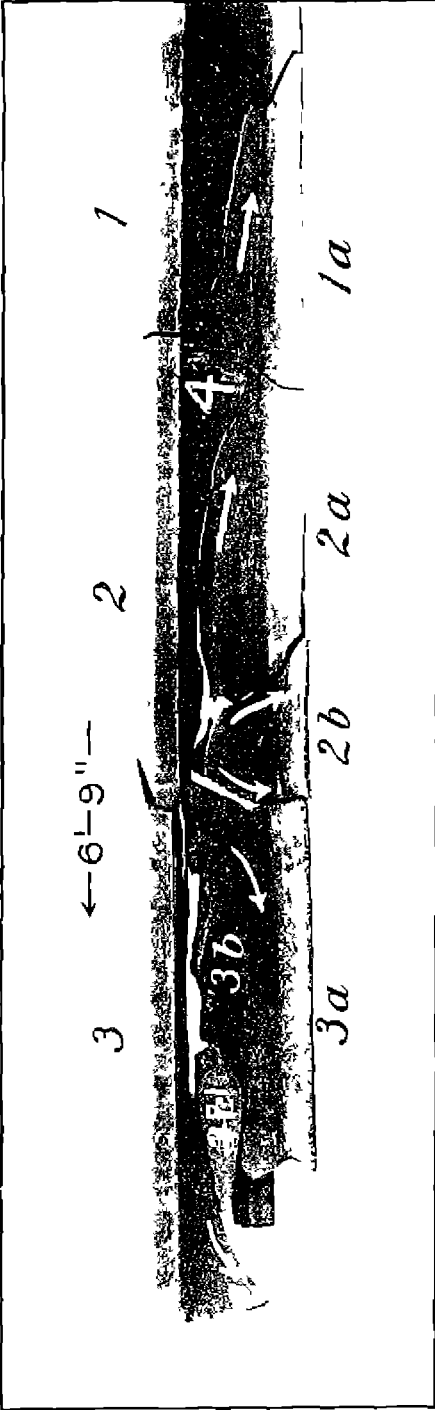
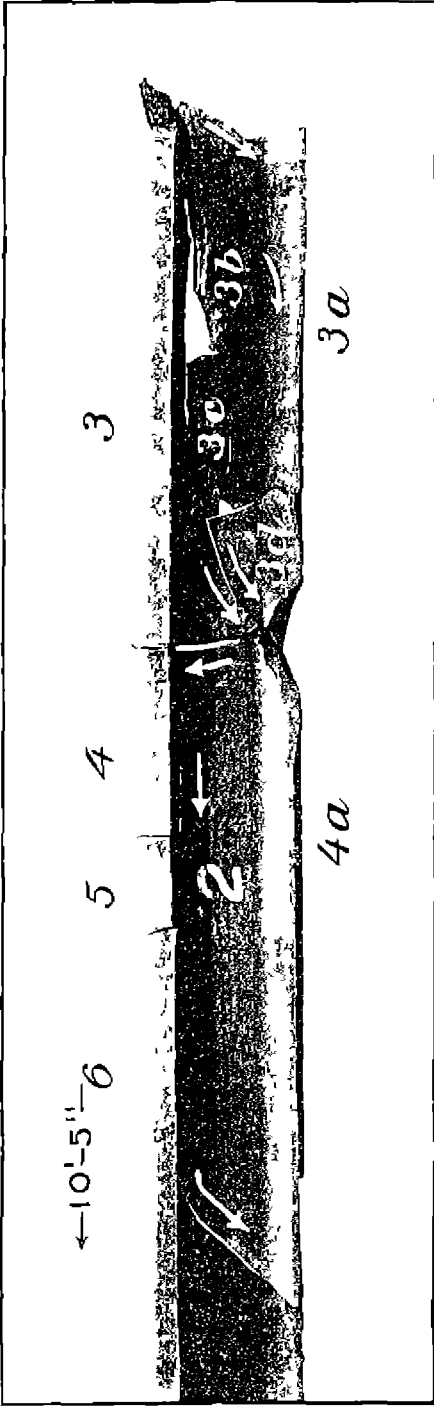
No. 1. Fragments of rail No. 1 viewed from south side - central point of fracture at joint front of head and web between pieces Nos. 3 and 1a - total length of 6 feet 9 inches from receiving end of rail

Fig. 2. Elements of rail No. 1 combined. Fragment 1000 3 inches from receiving end of rail. Arrows indicate directions in which the line of fracture were developed.

Rail No 4, the next rail in order following the direction of the train, was broken into a number of small fragments, which comprised about one-third its length, at the receiving end. Figures Nos 1 and 2 show the appearance of the fractured parts. These fragments were made when the rail was lying on its side. Prior to its overturning it appears that this rail had been spread, at least at its north end. The inner flange at pieces marked 1a and 2a was bent downward on the gauge side at a place 5 feet from the receiving end of the rail. This was done before the line of fracture between pieces 1a and 2a was formed, and constitutes evidence which is believed to show that spreading occurred prior to its overturning.

When lying upon its side the wheels of the train struck the web of the rail heavily at a place about 6 feet 9 inches from its receiving end. At this place the initial point of fracture was found to be located. The long, flattened, crescent-shaped break in the web under pieces marked 2 and 3, was apparently the first to be developed extending in each direction, north and south, from the initial point, which was close under the head on piece 3 near the line of rupture which separated it from piece 2. The lines of rupture separating the web and base were secondary, as were the fractures which detached pieces 1a, 4, 4a, and 5. Undoubtedly some of the smaller fragments were violently thrown about and received blows from different directions during the remaining stages of the derailment. There were wheel-flange marks on the web of rail No 4 and on the webs of some 25 other rails located in the track in a southerly direction beyond this point.

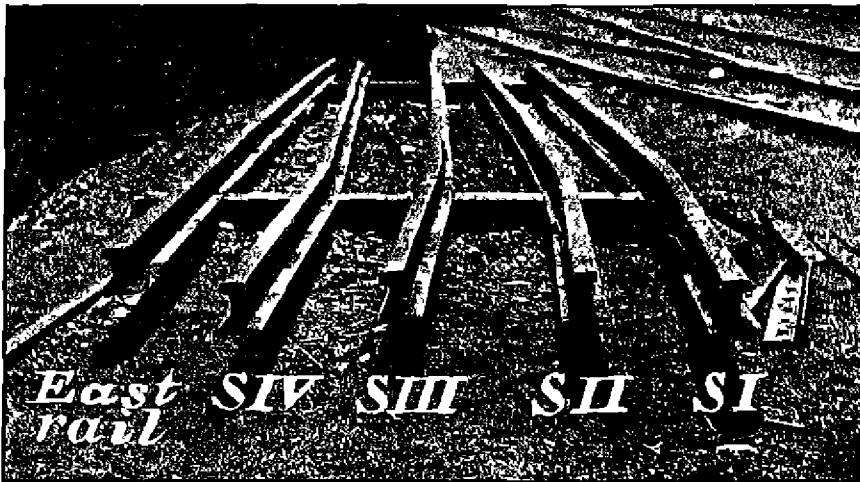
Figure No 3 shows these four rails, and a fifth one, the latter a rail from the east side of the track. Bends, in SI to SIV, some 7 to 8 feet from the receiving ends, appear in the cut. This east rail of the photograph was concave on the gauge side. The wheel-flange marks on the webs of rails SI to SIV were very pronounced, and were without a doubt made when the rail lay on its side with the head toward the west.

No 3 —Four bent rails from track next south of broken rail No 4. Rail on left side of cut came from east side of track. This rail was bent concave on the gauge side.

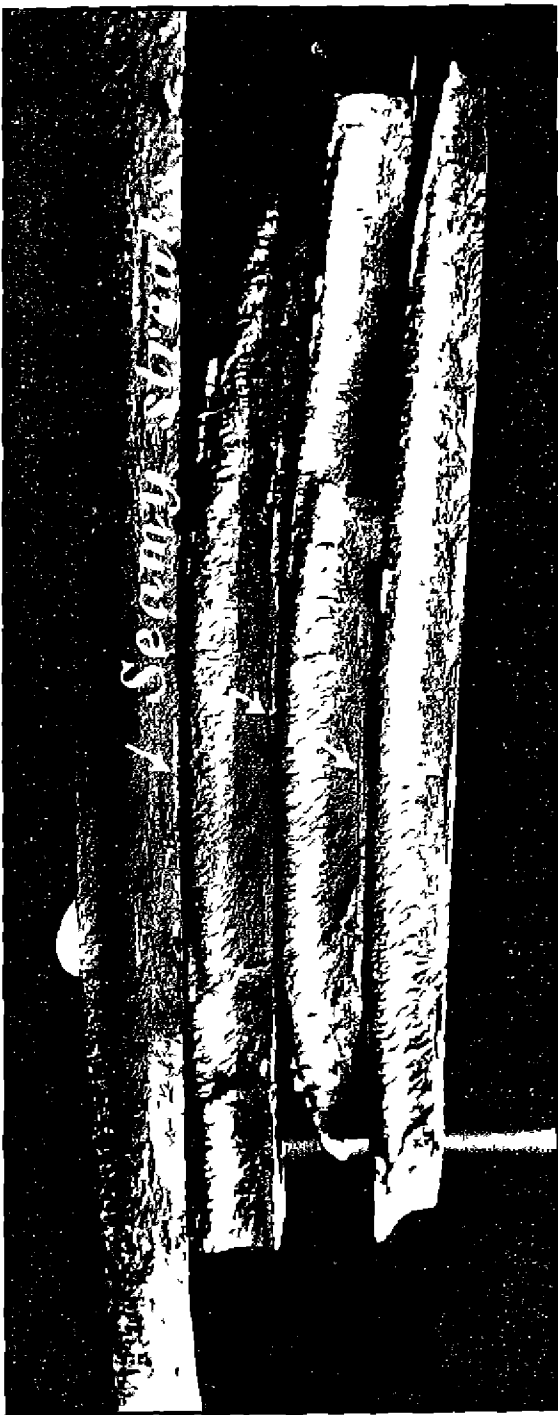
No 6—Pieces of flanges from rail No 4 Crosswise fractures of flanges developed after drop tests had been made, showing longitudinal seamy streaks

An examination for structural soundness of these pieces was subsequently made when the broken ends from the drop tests were returned to the Bureau of Standards. Streaks were noticeably less prevalent in this rail than have been found in many earlier examinations although streaks and seams had not in this rail been entirely eliminated. A number of short seamy streaks were revealed upon bending the flanges in a crosswise direction. Figure No. 6 shows four pieces of the flanges of this rail on the fractured surfaces of which appear short seamy streaks, along the lines of which fractures

took place. The surfaces of the seams were bright and lustrous and free from oxidation. These streaks were generally located near but at a short distance above the lower surface of the base.

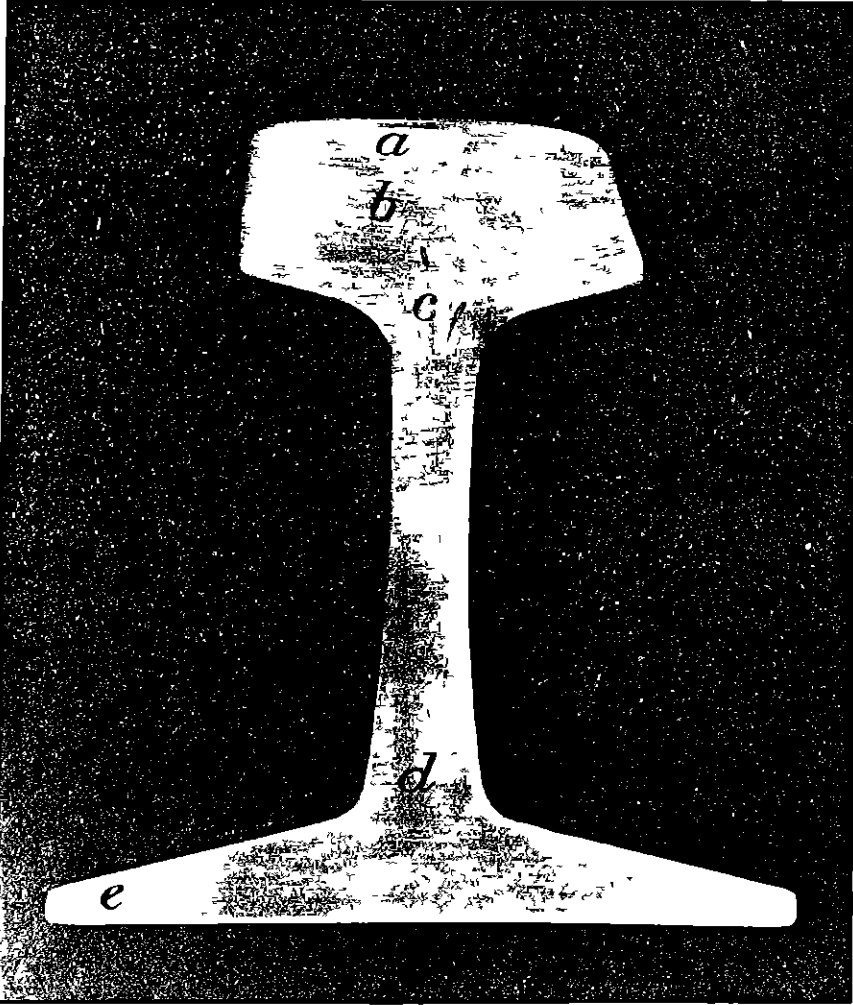
A cross section of the rail was polished and etched with tincture of iodine as shown by figure No. 7. There were markings on the

No. 7.—Cross section of rail No. 4 polished and etched with tincture of iodine showing markings in lower part of head and web. Chips for chemical analyses taken from places marked with the letters a, b, c, d, and e.

base which the photographic print does not bring into view—that is, markings which were comparatively few and small in size. The steel was more nearly structurally sound than has been witnessed in some rail steels examined on other occasions. The etching solution brought out markings in the lower part of the head and the upper part of the web which appear in the cut

This cross section also shows the flange wear that had taken place on the gauge side of the head. The flange wear is evidence of the outward thrust of the wheels of the train against this rail. The wear exhibited by the outer rail of the southbound track was much greater than that of the corresponding rail of the northbound track at this curve.

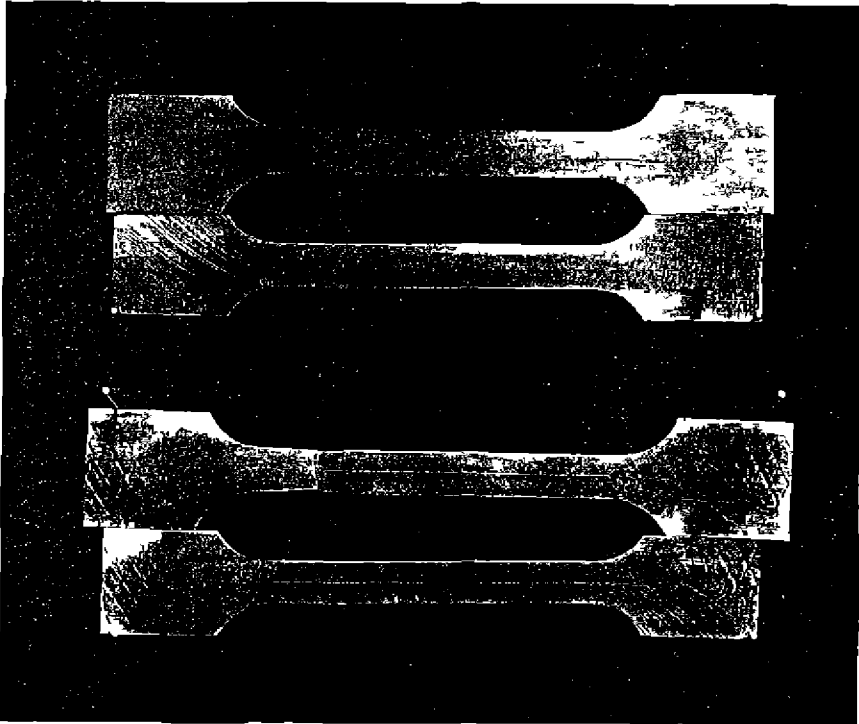
Figure No. 8 shows two of the specimens which were taken from the base of the rail as they appeared before and after fracture by tensile stresses.

Flange fractures of the base in a crosswise direction are known to be the most common fractures of rails when in service. These results show why such rail failures are overwhelmingly in the majority if the repetition of such results are needed to establish the cause.

No. 8—Tensile test pieces taken from base of rail No. 4 showing effect of streaks on extension of the metal. Appearance of specimens before and after testing. Upper piece of each pair longitudinal specimen elongation 14.5 per cent. Lower piece of each pair crosswise specimen elongation 4 per cent.

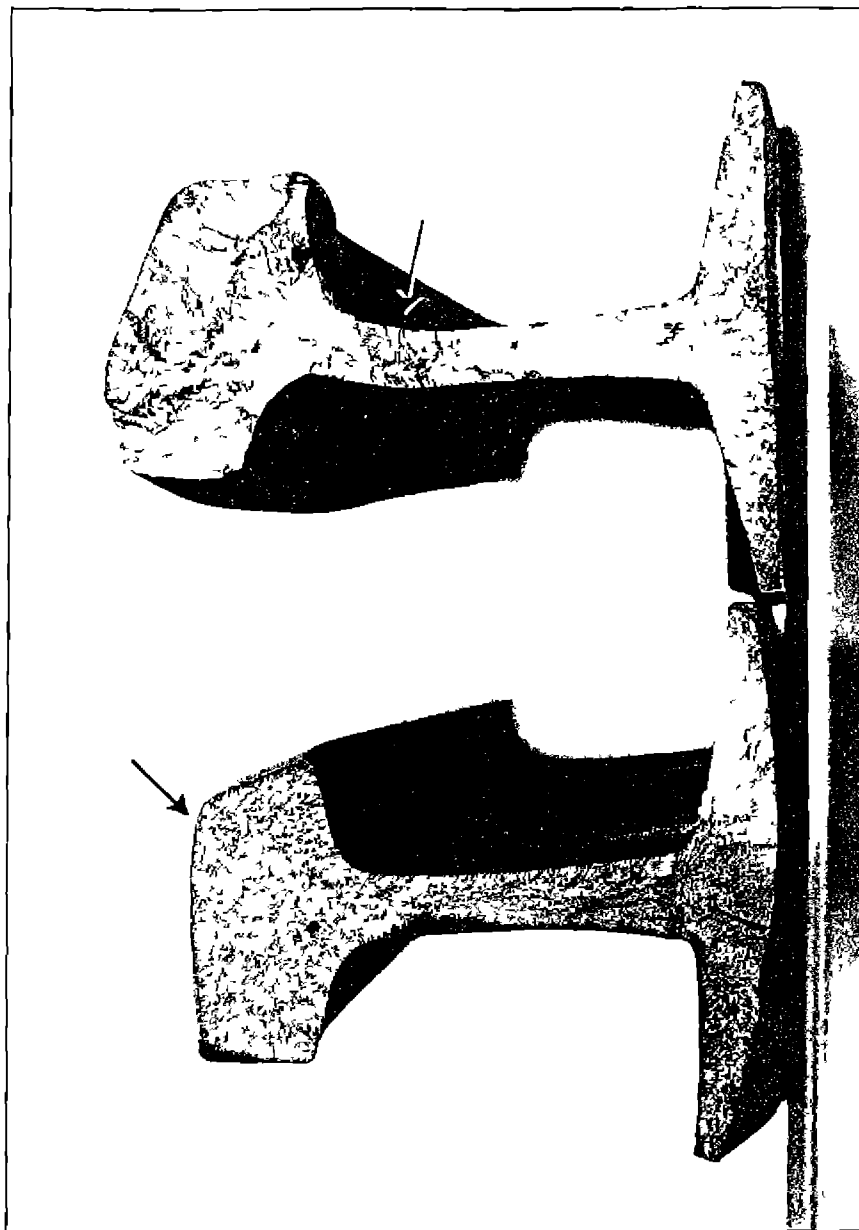
Figure No. 10 shows the fractured surfaces of the two drop-test specimens. The cross section on the right of the cut represents the test with the base down and on the web of which pointed out by the arrow may be seen the fine crack caused by the indentation of the letter 'F'. The crack did not reach through to the opposite surface of the web.

No. 10. Fractured sections of axle of trial No. 4 after impact in drop test. Cross section on the right shows cut tested with base down. Fine crack in web caused by indentation of roller. 'J' of brand mark indicated by arrow. Fracture fracture lies in at the crack. Cross section on left side of the cut shows cut tested with head down. Fracture lies in at corner of running surface and is indicated by arrow.

The cross section on the left of the cut shows the appearance of the fractured surface of the rail which was tested under the drop with the head down. Fracture started at the corner of the running surface of the head and the gauge side, indicated by the arrow marked on the cut. The crack in the base of this test piece shown from the under side of the base on figure No. 5, is here shown viewed on end.
