## INTERSTATE COMMERCE COMMISSION

### IN RE INVESTIGATION OF AN ACCIDENT WHICH OCCURRED ON THE NEW YORK CENTRAL AND MICHIGAN CENTRAL RAIL- ROADS AT PORTER, IND ON FEBRUARY 27 1921

MARCH 14 1921

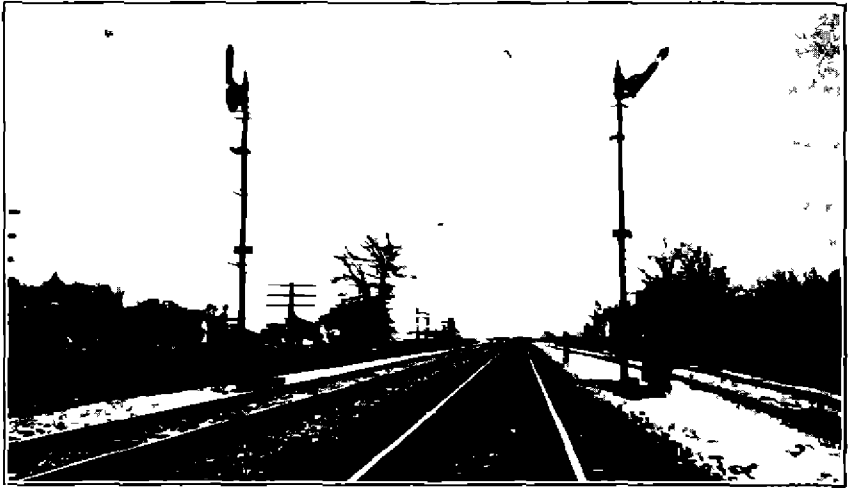
FIG. 1.—View looking east on Michigan Central tracks showing signal 2412

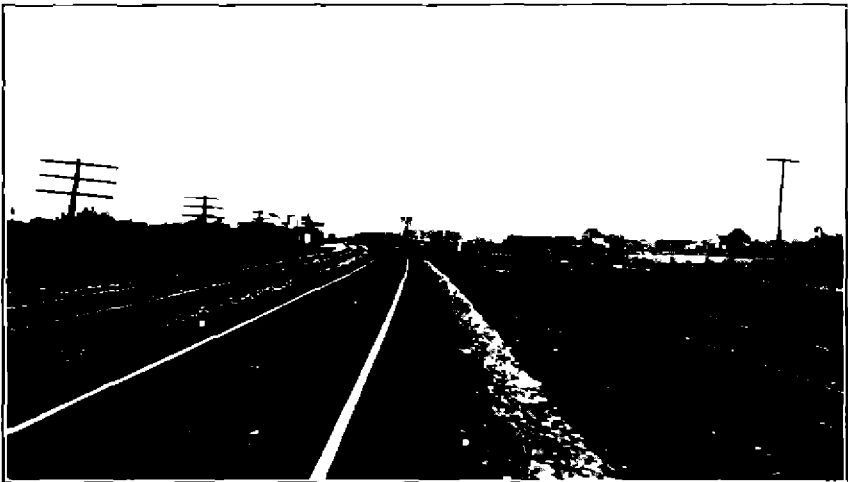
FIG. 2.—View of signal 35 had by Michigan Central engineman

The statements of eyewitnesses who observed the home signal at the time train No. 20 was approaching together with the investigation of the signal system indicate that both blades of the home signal were in the stop position and displayed red indications when train No. 20 approached and passed it.

The locations of the train-order and home signals were such that it would have been possible for the fireman to have mistaken the green indication of the train-order signal for a clear indication of the top blade of the home signal if the light on the latter was out or obscured by steam or smoke; however, with both blades of the home signal in the stop position as is shown by the evidence it would have been impossible for Fireman Block to see the indication he claims to have seen—two green lights above a red light. The possibility of a confusion of the signals from the engineman's side of the engine is much less than from the fireman's side on account of the signals being much closer when they first come within the engineman's range of vision.

Investigation disclosed that the home signal was more or less obscured by steam or smoke and its location is such that similar conditions may frequently exist due to the relative location of a water plug near by, also that the position of the train-order signal was such that there was possibility of confusing it with other signals. If the home signal was in this instance obscured to such an extent that the approaching engineman was unable to see it, then it was his duty to reduce speed or to stop if necessary and determine its indication before passing it and it was necessary for him to receive clear indications from both the home signal and the train-order signal before passing them nevertheless every effort should be made to so locate signals that they are not likely to become obscured by steam or smoke from engines or to be confusing to employees required to observe their indications. It is believed the location of both the eastbound home signal and the train-order signal on the Michigan Central Railroad at this point should be improved.

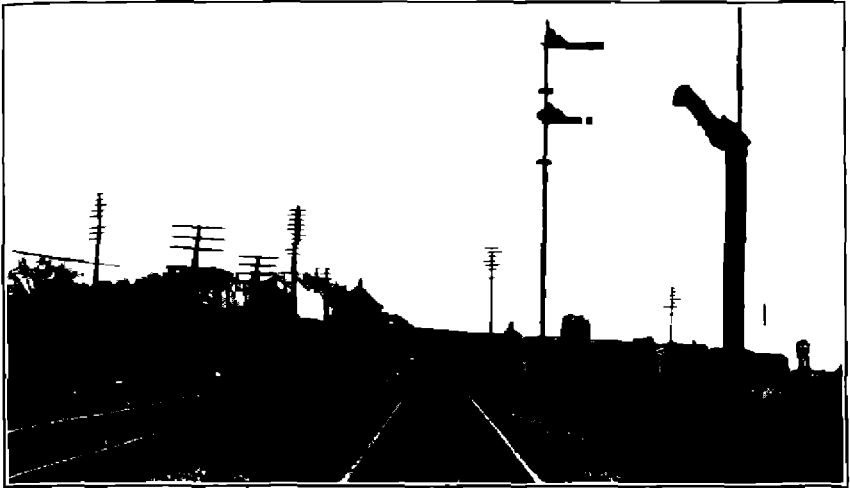
FIG. 3.—Signal 35—New York Central train on crossing

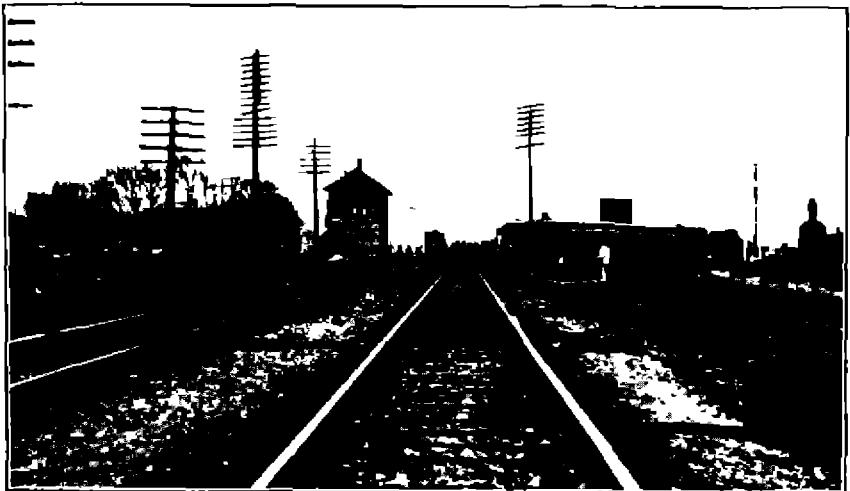
FIG. 4.—Drift east of signal 35
