INTERSTATE COMMERCE COMMISSION

REPORT OF THE CHIEF OF THE DIVISION OF SAFETY COVERING HIS INVESTIGATION OF AN ACCIDENT WHICH OCCURRED ON THE NEW YORK CENTRAL RAILROAD NEAR AMHERST, OHIO, MARCH 29, 1916

APRIL 25, 1916

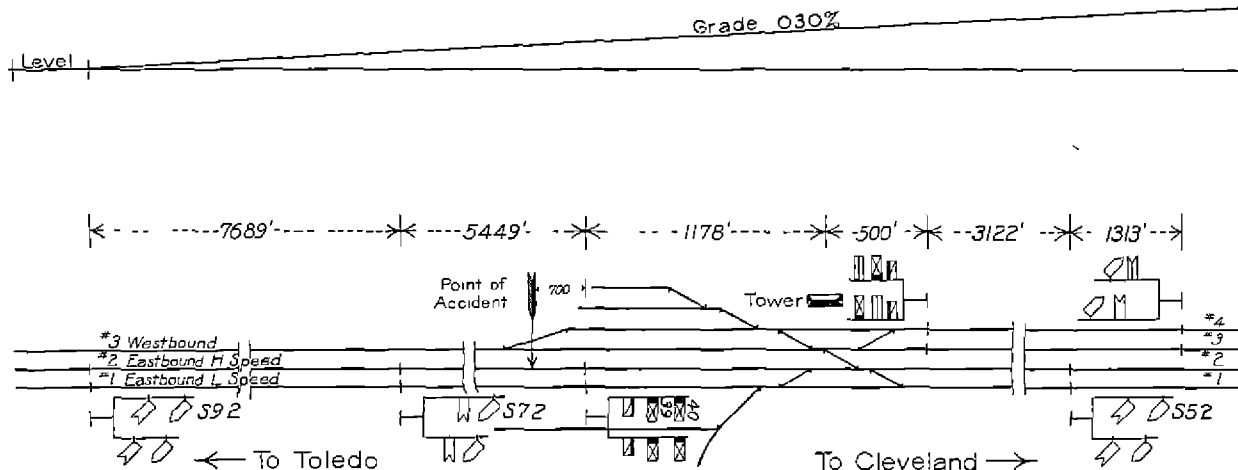
ILLUSTRATION No. 1 —Diagram showing track layout and signal locations in vicinity of accident

The accident occurred on the Toledo Division of the New York Central Railroad at a point about 1 mile west of Amherst, Ohio. The line at this point has three main tracks, and the general direction is east and west. The tracks numbered from north to south are 3, 2, and 1, track 3 being used by westbound trains, track 2 by high-speed and track 1 by low-speed eastbound trains. The movement of trains is governed by time-table and an automatic block signal system. The signals governing eastbound movements over this line are located on the south side of the track on bracket poles, the right-hand doll, or short mast, carrying the signals for track 1, those for track 2 being on the left-hand doll, the arrangement of tracks and locations of signals being shown by the accompanying diagram.

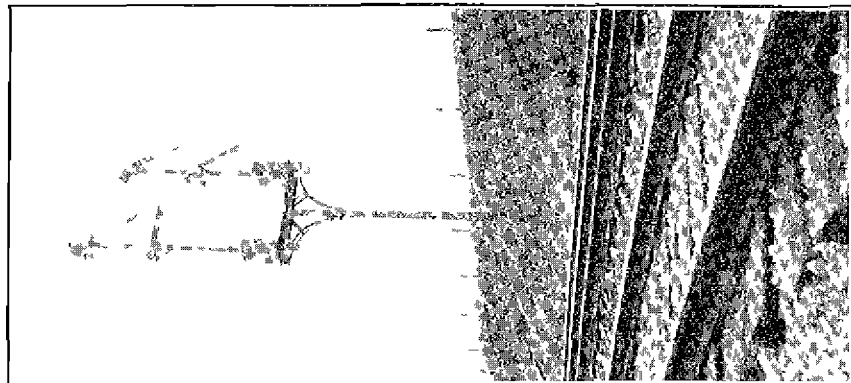
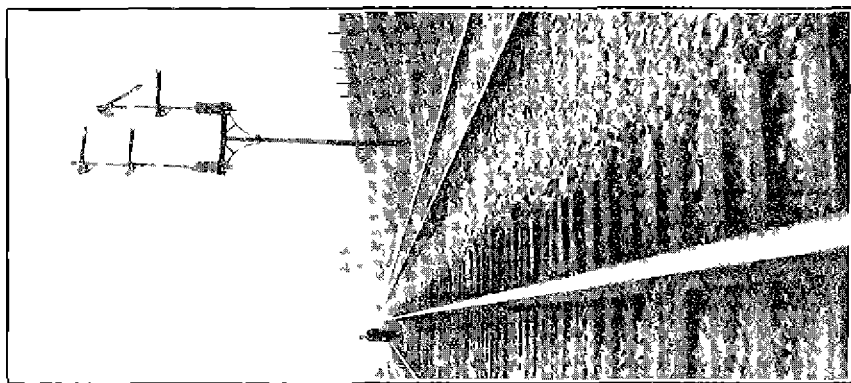
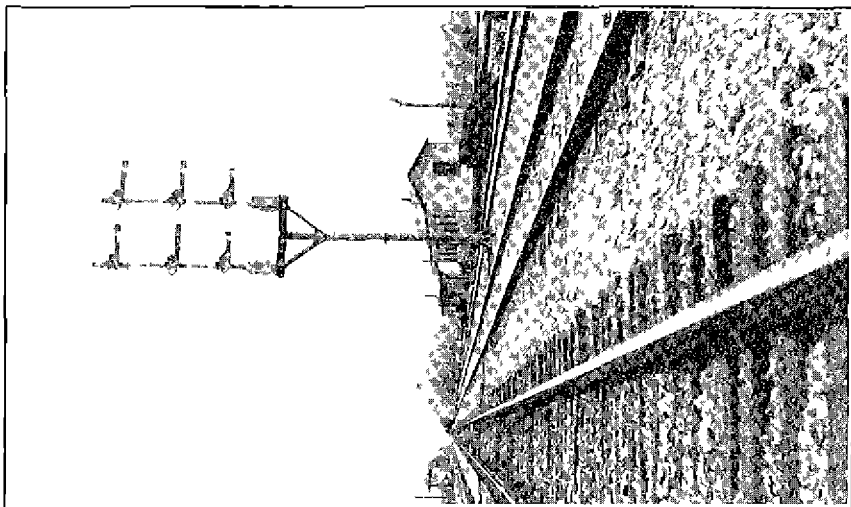
ILLUSTRATION No. 2.—Home interlocking signal with all arms in normal position, two views of automatic signals displaying stop and caution indications for track 2

Located 1,178 feet west of Amherst tower are the home interlocking signals governing eastbound trains. These signals are mounted on a bracket pole, each of the two dolls bearing three blades, the signals on the right-hand doll governing track 1 and those on the left-hand doll governing track 2. The top blade governing track 2 is signal 40 and is controlled by lever 40 in the interlocking tower. This signal governs through movements on track 2, the middle arm is signal 39 and governs the crossover movement from track 2 to track 1, while the bottom arm is known as the calling-on arm and is used for low-speed movements.

When the track between signals S9 2 and 40 is clear, and the route through the interlocking plant on track 2 is set up and free, both the home and distant arms on signal S9 2 are in clear position, and home signal S7 2 is also clear. The distant arm at S7 2 remains in caution position, however, until lever 40 in the tower is reversed and signal 40 clears to 45° or 90° position, then distant signal S7 2 also assumes clear position.

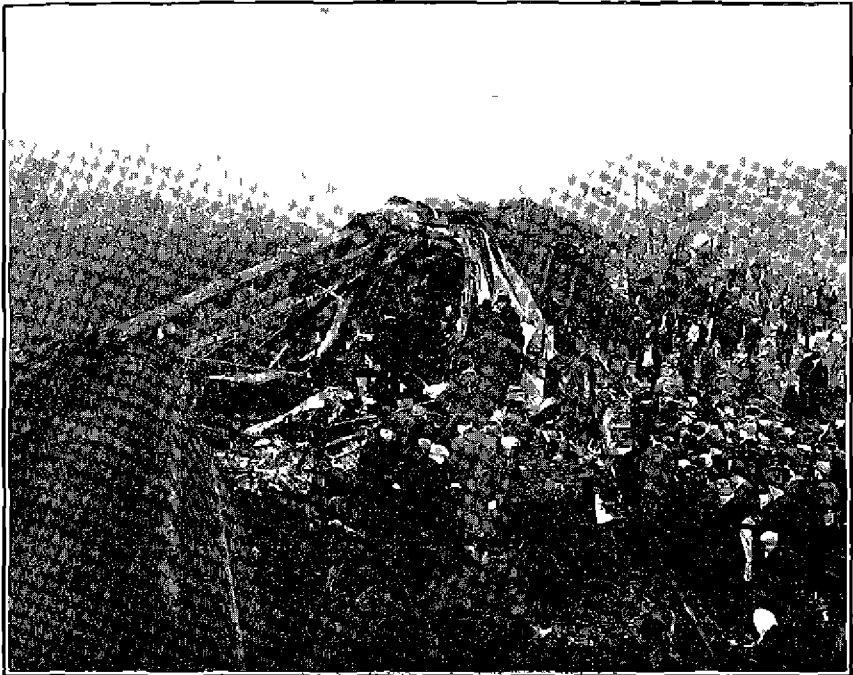
ILLUSTRATION No 3 —General view of wreck, looking west

The locomotive of train No 25 practically cut the club car in two, forcing one end of it westward, and through the superstructure of the steel coach, destroying the entire superstructure of the coach.

Train No 25 was derailed by the collision with the club car, the train continued on the roadbed, overturning several of the cars in train second No 86, finally coming to a stop with its locomotive about 700 feet west of the point where it first struck the club car. The locomotive and the first seven cars of train first No 86 and the two rear cars of train second No 86 remained upon the rails and were practically undamaged. The condition of the wreckage indicates that

the greatest damage and loss of life was caused by train No 25 colliding with the wreckage. Illustration No 3 is a general view of the wreck.

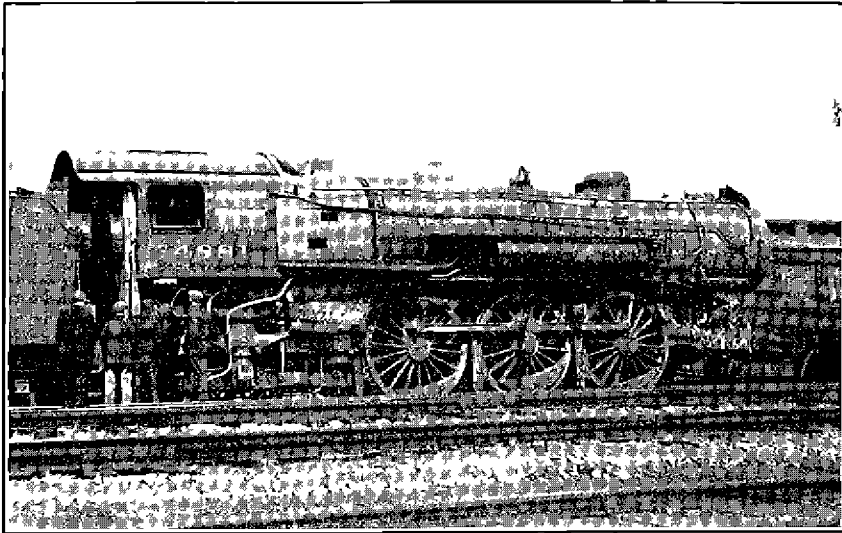
ILLUSTRATION No 4—Showing damaged condition of locomotive 4881 of train second No 86 after removal from wreckage

It is to be noted that the rear car of train first No. 86, in which all but two of the fatalities occurred, was a modern steel car built in 1914. It is thought that the collision between trains first and second No. 86 resulted in no great damage to this car, and that but few passengers were killed in this collision. It is believed that when train No. 25 struck the wooden club car, with steel underframe ends, the force of the impact carried one of these steel end castings length-

wise through the steel superstructure of coach 874, causing the greater number of deaths and serious injuries

This conclusion is borne out by the fact that, as shown in illustration No 4, locomotive 4881, hauling train second No 86, was not seri-

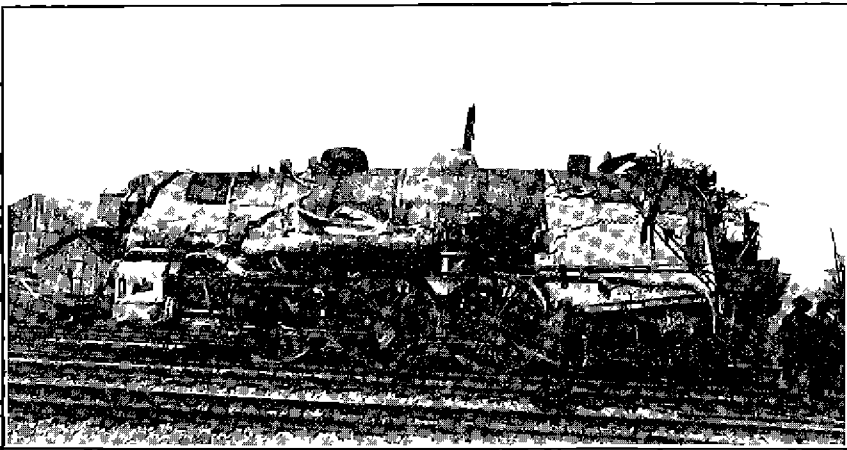
ILLUSTRATION No 5—Showing damaged condition of locomotive 4813 of train No 25 after removal from wreckage

ously damaged, by illustration No 5, showing the seriously damaged condition of locomotive 4813, hauling train No 25, and by the further
