INTERSTATE COMMERCE COMMISSION

REPORT OF THE CHIEF OF THE BUREAU OF SAFETY COVERING THE INVESTIGATION OF AN ACCIDENT WHICH OCCURRED ON THE NEW YORK CENTRAL RAILROAD NEAR WATERLOO IND, MARCH 21, 1917

DECEMBER 23 1918

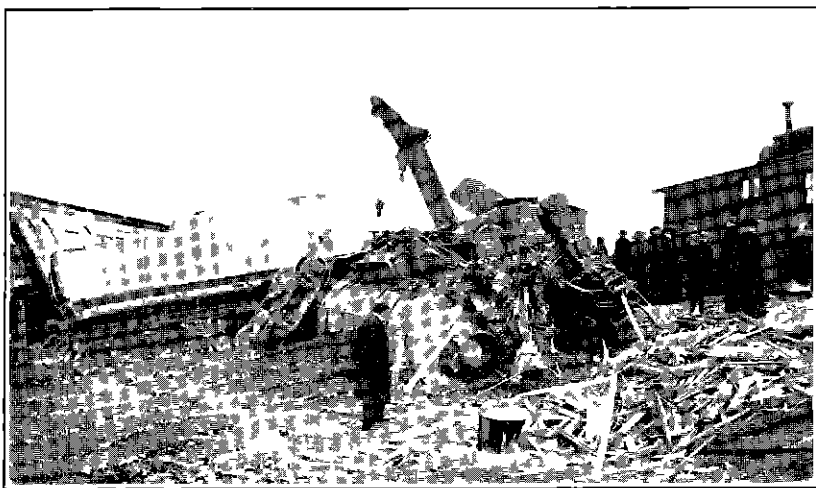
11-1—Engine and tender of passenger train. View looking east.

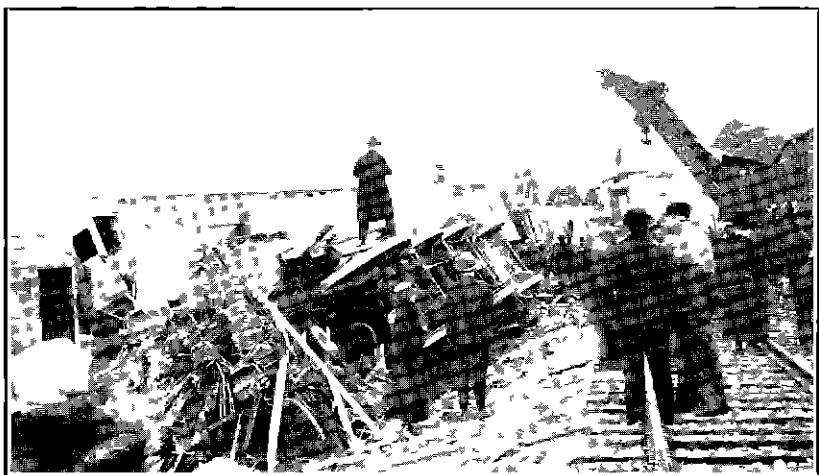
11-2—Underside of engine of passenger train. Fourth car of freight train refrigerator car No. 141897, over on westbound track.

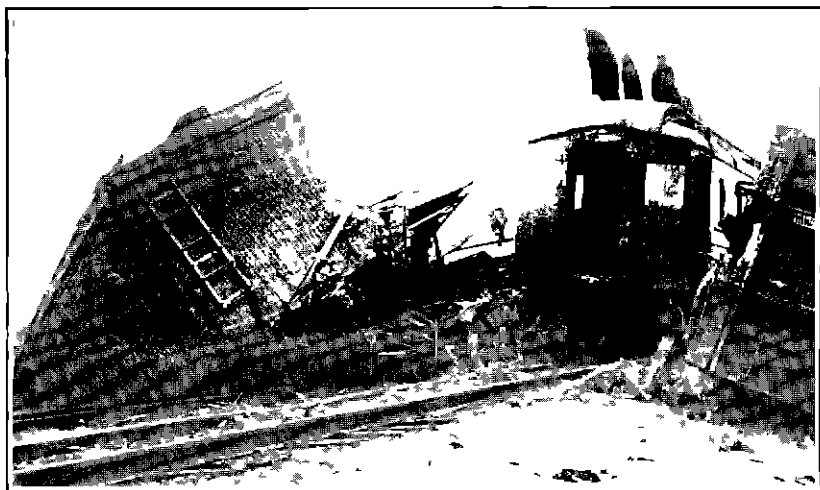
FIG. 3—Third car of freight train wrecked by N. E. T. and Southern Railway Co. at
 1000 ft.

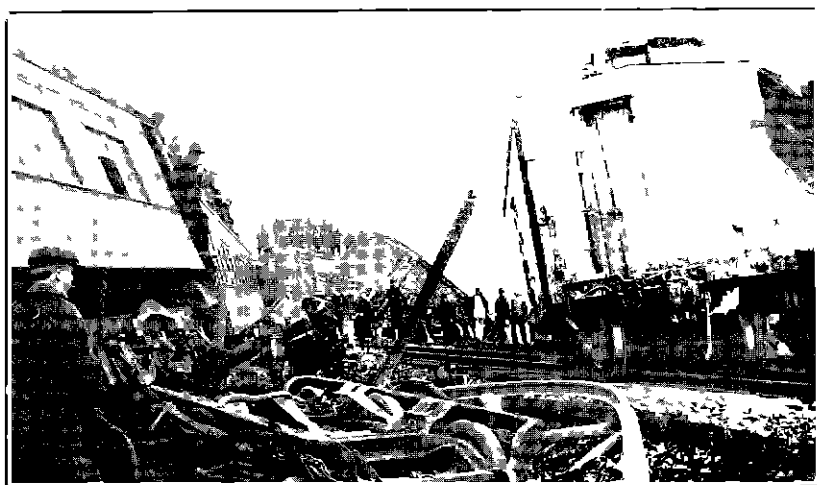
FIG. 4—Fourth car of freight train wrecked by N. E. T. and Southern Railway Co. at
 No. 26223 stock car of train in the foreground.

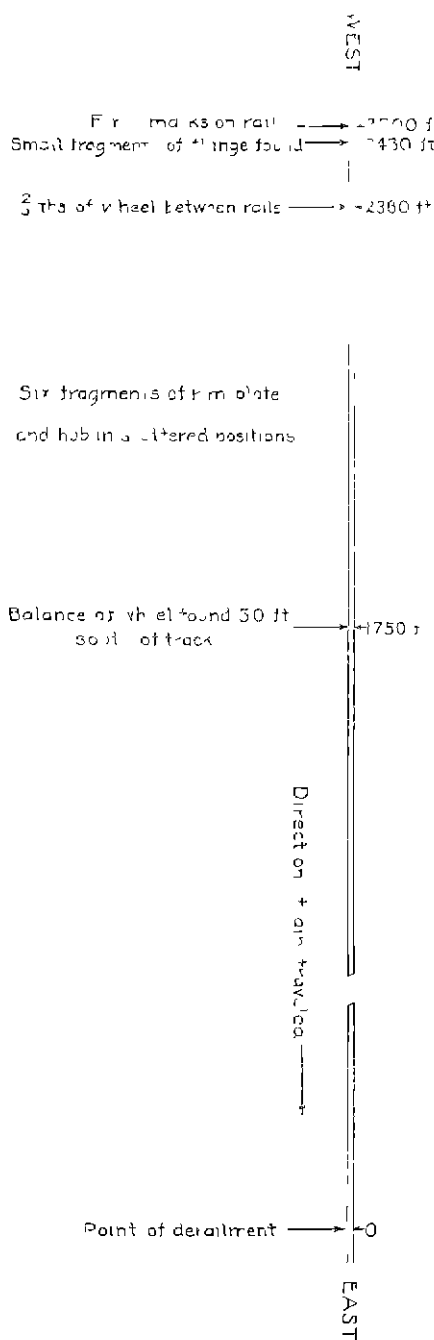
Diagram of the track, figure No. 5, shows the relative positions which the fragments occupied after the accident. The first marks found were on the south end 2500 feet west of the point of derailment. Immediately beyond these marks a small fragment of the flange was found. Next in order a large fragment comprising about two-fifths of the wheel was found between the rails about 120 feet east of the first marks.

Next beyond this point six fragments of the rim, plates and hub were scattered along the track. Finally, at a distance of 1700 feet west of the point of derailment the balance of the wheel was detached from the axle and came to rest 50 feet from the track on the south side. The track was examined for a distance of 2 miles west of the scene of the accident but no further evidence was found attaching to it. Parts of the flange were not recovered.

The relative positions occupied by the fragments furnish evidence upon the manner of failure and the sequence in which the lines of rupture were developed. Fragmentation seemed to have begun at the rim, the earliest recovered fragment being a small piece of the flange. A large fragment was next detached representing about two-fifths of the body of the wheel. The balance of the wheel remained on the axle for a short time thereafter since at this stage more than one-half of the hub covering the wheel seat was unbroken.

Fig 5.—Diagram showing the relative positions of the fragments of broken wheel No. 91051, as they were found after the accident

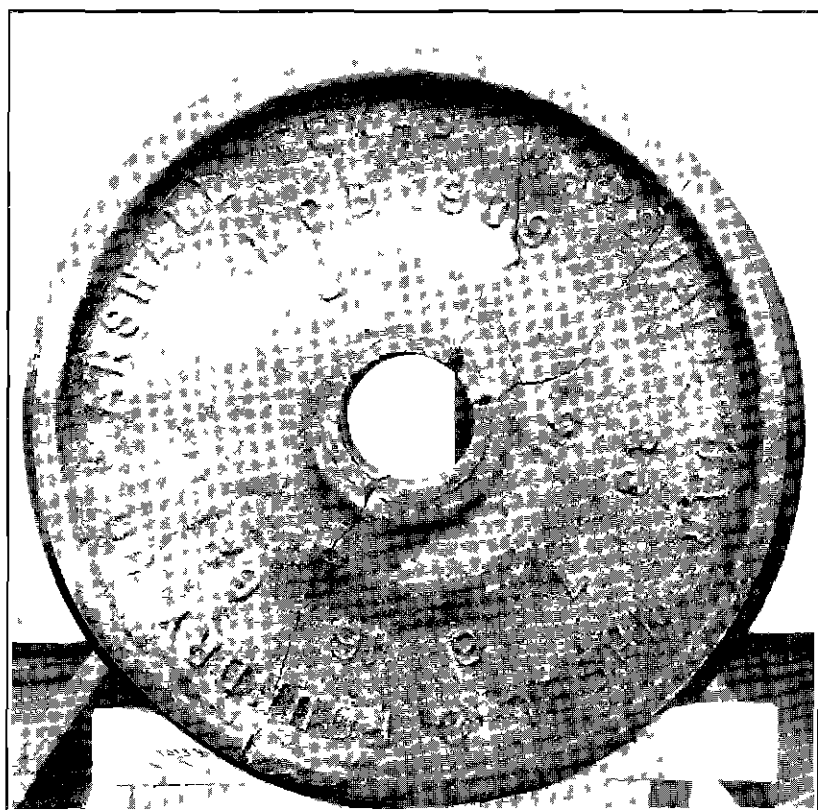
The lines of rupture on the outer and the inner faces of the wheel are shown by figures Nos. 6 and 7. The wheel broke into two principal fragments, between which there was a sector which was broken into a number of small pieces. Figure No. 8 shows the local shattering of the rim at the circumference of the small sector. Parts of the flange were not recovered. It is regarded as probable that the initial rupture of the wheel occurred within the limits of this shattered zone of the tread and flange. Fracture of the wheel from the hub, or core leg opening extending outward would not be expected to result in such a degree of fragmentation as here witnessed. The strength of the rim would call for an intact plate at the time of being broken into a number of small fragments to furnish the necessary reactive force.

FIG. 6. Broken wheel No. 949, outside face. Shown, radial lines of rupture, delineating "two main fragments" with section of "null" in center.

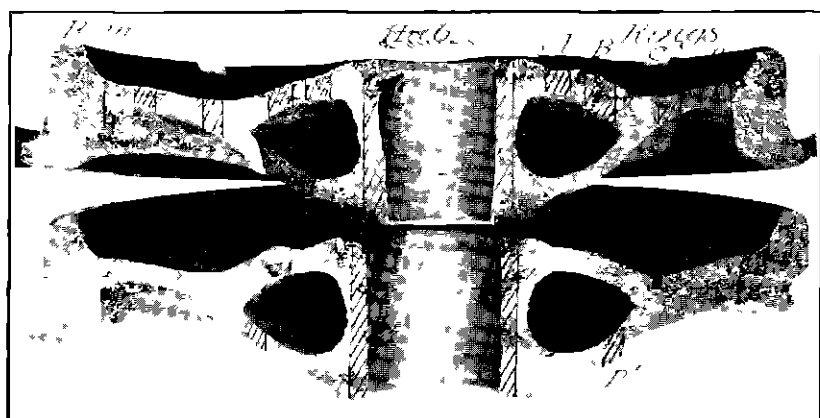
FIG. 10.—Fracture lines of rim, plates, and hub of broken wheel No. 9404. Lines of rupture passed through center of and edges of plates. Spontaneous fracture of hub. Positions of rings sketched on cut, which were detached from inside of the wheel.

Figure No. 10 shows the appearance of the fractured surfaces of the rim plates and hub. A normal depth of chill was presented with a progressive gradation from the white iron of the tread through mottled iron to gray in the plates and hub. The metal at the outer end of the hub in both this wheel and its mate was spongy. In other places the metal was sound. In the examination of the mate of the broken wheel concentric rings were taken out in the determinations of the state of internal strains. The positions of these rings are for convenience sketched on this cut.

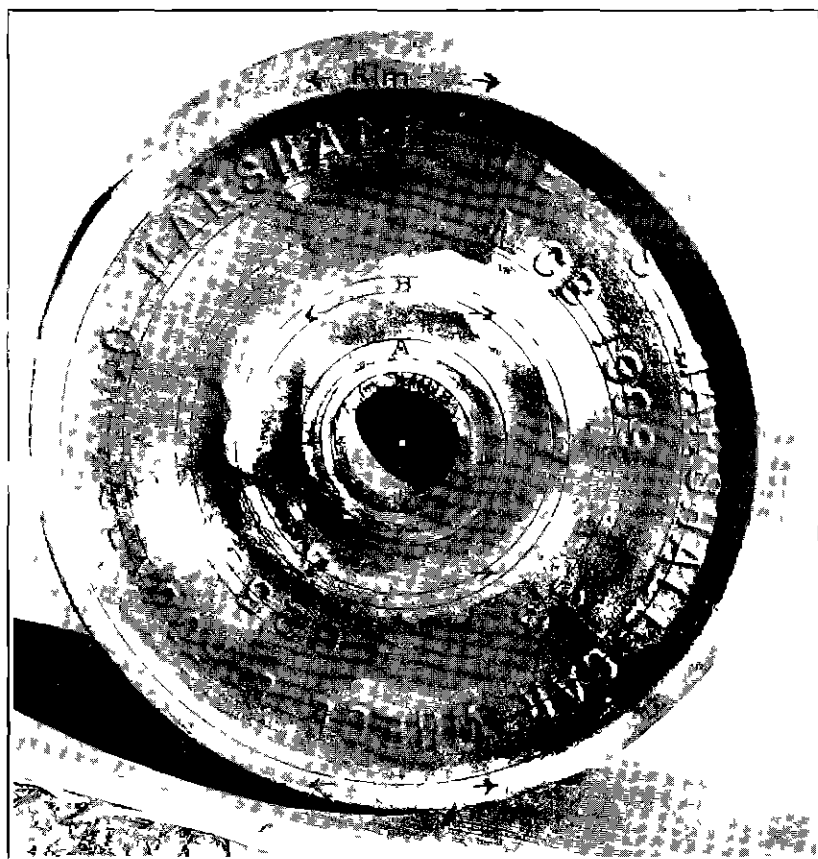
FIG. 11.—Cut used to represent wheel N. in figure of the token wheel, showing positions of concentric rings detached therefrom. The center of wheel is at length 1. Outside face of wheel.

The measured strains and their equivalent stresses which were released on the outside face of the hub, plate, and rim of figure No. 11 are entered on Table No. 2.

Strains of compression prevailed in the metal of the hub in the inner ring A and in the rim. Rings C and D were in tension and one chord of ring B. The other chord of ring B appeared to have been in compression, its value, however, was such as to cast a doubt upon the reliability of the determination. The metal of the plate, it may be said, was generally in a state of tension.

It will be noted that the internal stresses of compression at the hub were 20,040 and 13,560 pounds per square inch on gauged lengths *a* and *b* respectively, yielding an average value of 16,800 pounds per square inch. In the ring next the hub the compressive stresses had an average value of 4,590 pounds per square inch. In order to balance these compressive stresses at the hub both inside and outside plates were in a state of initial tension. At the rim there was a compressive stress of 4,420 pounds per square inch at one chord, while at the other chord the stress was negligible in value.

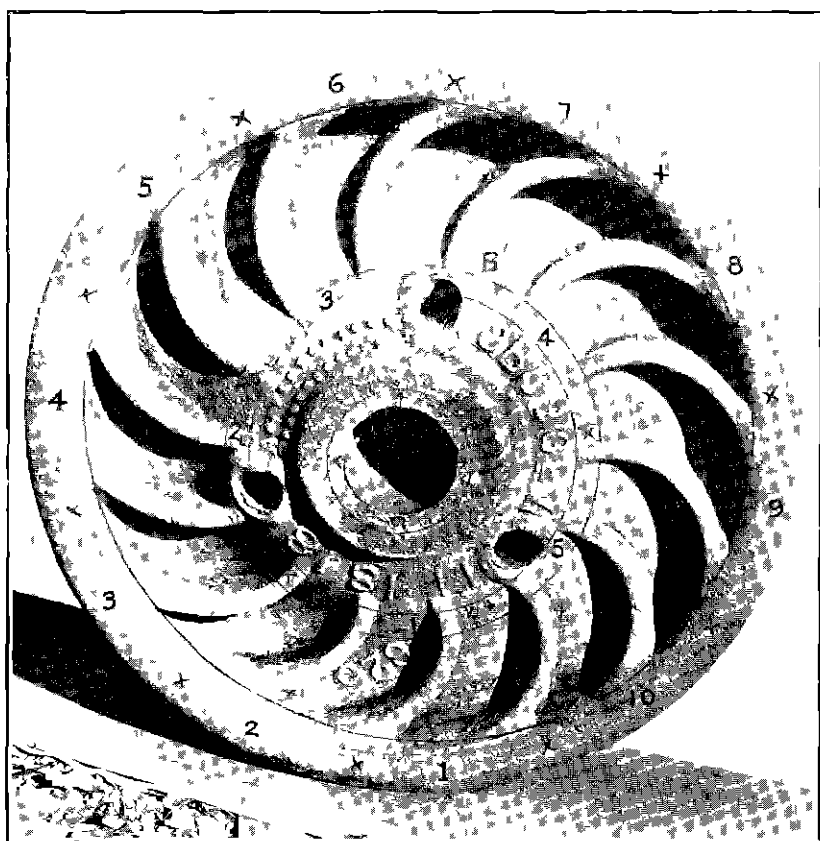
FIG. 12.—Cut used to represent wheel No. 90006, inside of the broken wheel, showing positions of eccentric pins detached therefrom, with locations of curved teeth. (Inside face of wheel.)

The strains and stresses of the inside face of the wheel are given on Table No. 3 referring to the gauged lengths which are shown on figure No. 12.

At the hub the compressive stresses were 23,910 and 27,030 pounds per square inch, respectively, on diameters at right angles to each other. The average of these two values is 25,470 pounds per square inch. On ring B's chord gauged lengths were established. Each

chord of this ring was in a state of initial tension, the maximum value of which was 4 080 pounds per square inch. At the rim 4 of the gauged lengths showed a state of tension, and 6 a state of compression. The tensile stresses on this face of the rim were abreast the higher value of compression which was found on the opposite face. The tendency of the internal strains of fabric in the hub and plates to reduce those at the wheel seat and to augment those in the plate created when the wheel is pressed upon its axle will be noted.

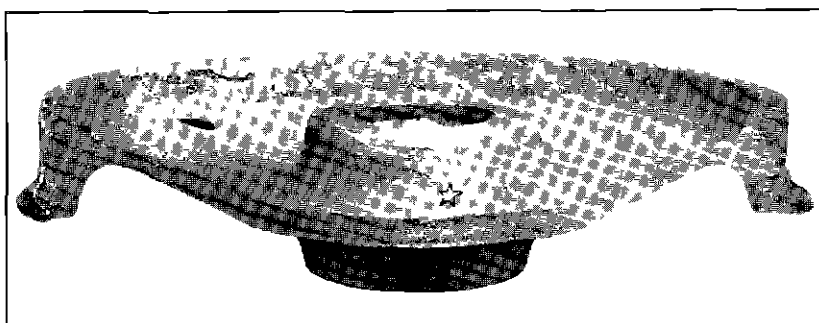
FIG. 14.—Fractured forged steel wheel. Incipient point of rupture on the outside of the plate in the hub indicated by a line sketched on the cut.

Forged steel wheels have exhibited fractures attributable to repeated flange blows. Figure No. 14 illustrates such a fracture in a forged steel wheel. The initial point of rupture is indicated by a star sketched on the cut. From this point the line of rupture extended in each direction until the fracture of the plate and rim was complete. A hot rim and cool plate intensify the radial strains of tension in the latter while the internal strains of compression acquired at the tread due to the cold-rolling action of a forged steel wheel would still further increase the strains in the plate. The rigidity of the metal of the tread of a chilled iron wheel probably preserves it against change of internal strains augmenting those of the plates by service conditions. Upon this feature, however, we are without experimental evidence.
