## INTERSTATE COMMERCE COMMISSION

### REPORT OF THE DIRECTOR OF THE BUREAU OF SAFETY IN RE INVESTIGATION OF AN ACCIDENT WHICH OCCURRED ON THE NEW YORK CENTRAL RAILROAD AT WATKINS GLEN, N. Y., ON MARCH 11, 1928

JANUARY 3, 1929.

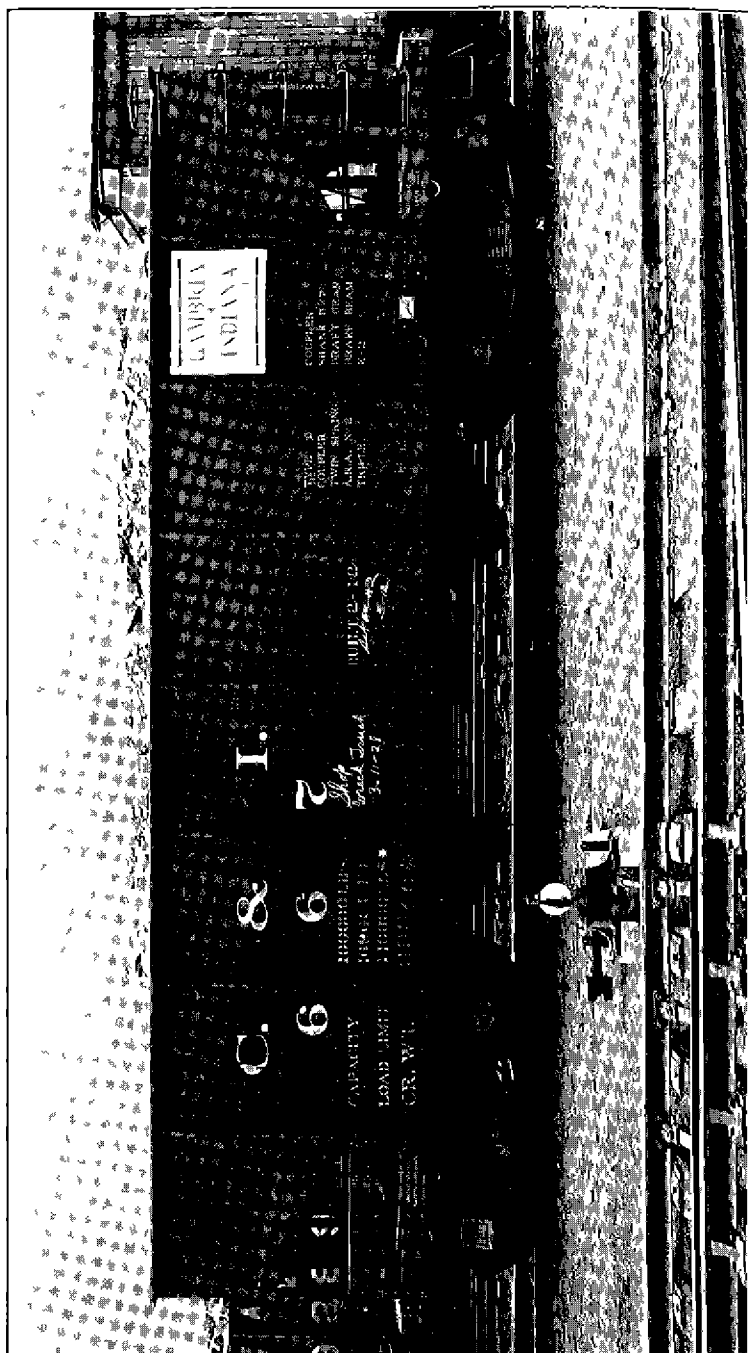
Figure No 1 is a view of this car, with a new truck, after rerailing.

FIGURE 1—Cambria & Indiana Railroad coal car No 667 with new truck, after rerailing

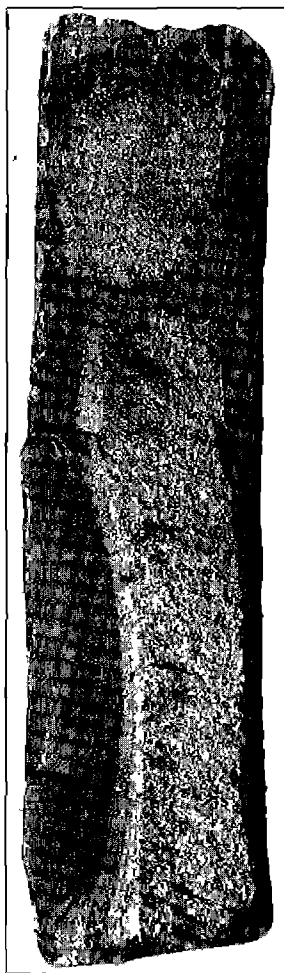
Each of these arch bars was made of steel, 5 inches wide by  $1\frac{1}{4}$  inches thick in cross section dimensions respectively. The fractures were progressive, originating at the upper outside corners of the bars directly under the edges of the column castings, at the angle made by the horizontal and diagonal parts of these members.

Figure No. 2 shows the appearance of the fractured surface of the bar from the truck of car No 667. At its deepest place the progressive fracture had reached to the middle of the thickness of the bar; crosswise to nearly its full width. This part of the bar was dark colored, had a smooth surface with a rippled boundary, presenting the usual characteristics of a progressive fracture. The portion of the bar which failed at the time of the accident was granular in appearance. Approximately, one third of the cross section of the bar was separated by the progressive fracture.

FIGURE 2.—Fractured surface of steel bar of car No. 607 showing extent of progressive fracture which occurred in service

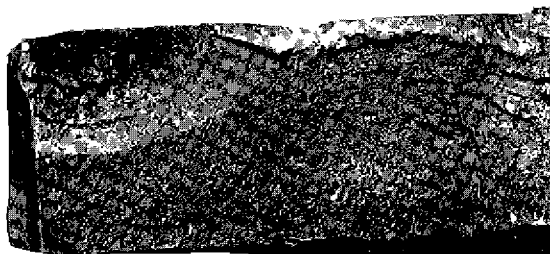
An incipient crack was subsequently found in the lower arch bar in one of the truck frames of the car next the caboose, Cambria & Indiana coal car No 622.

Figure No 3 shows the appearance of the incipient fracture in the arch bar from car No 622. Its progressive character is shown. It began at the upper corner of the bar, extended radially, and reached a depth of half the thickness of the bar when final rupture occurred. The final part was fine granular, radiating from the progressive portion of the fracture.

FIGURE 3—Incipient fracture at corner of steel arch bar of car No 622

The presence of an incipient fracture in a truck frame affords a potential opportunity for an accident.

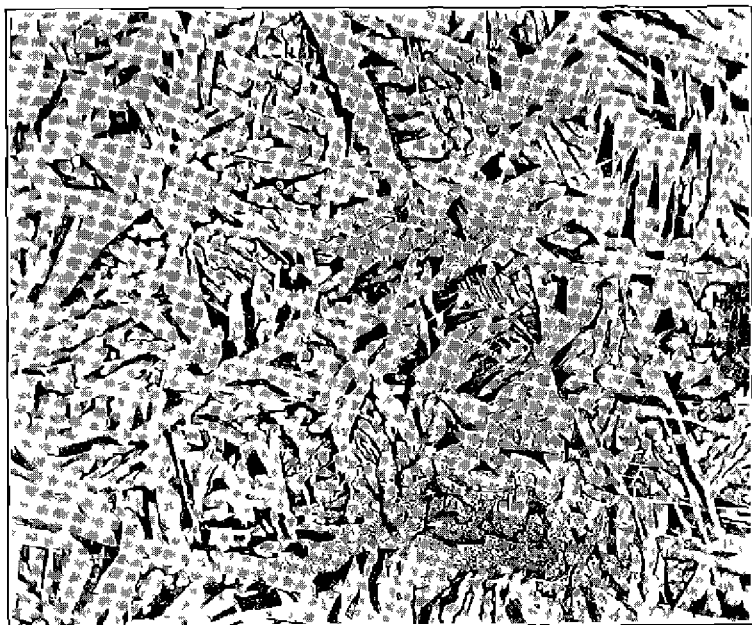
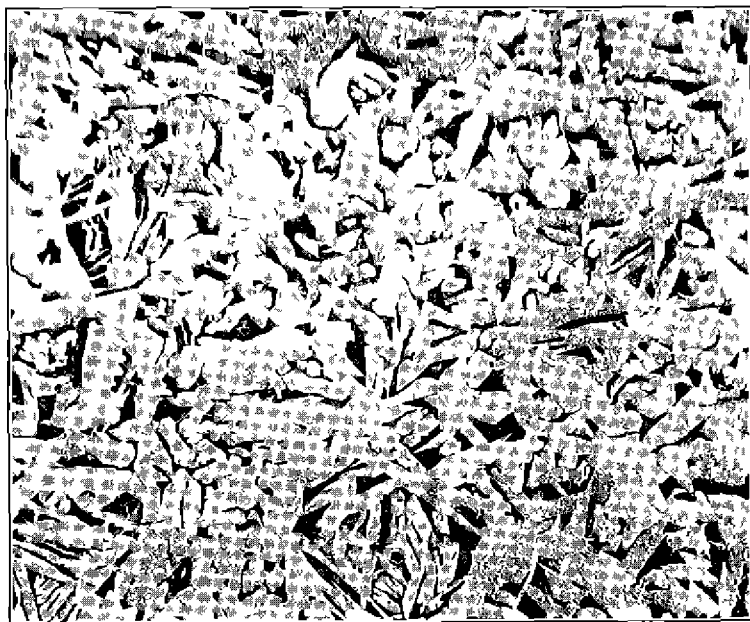
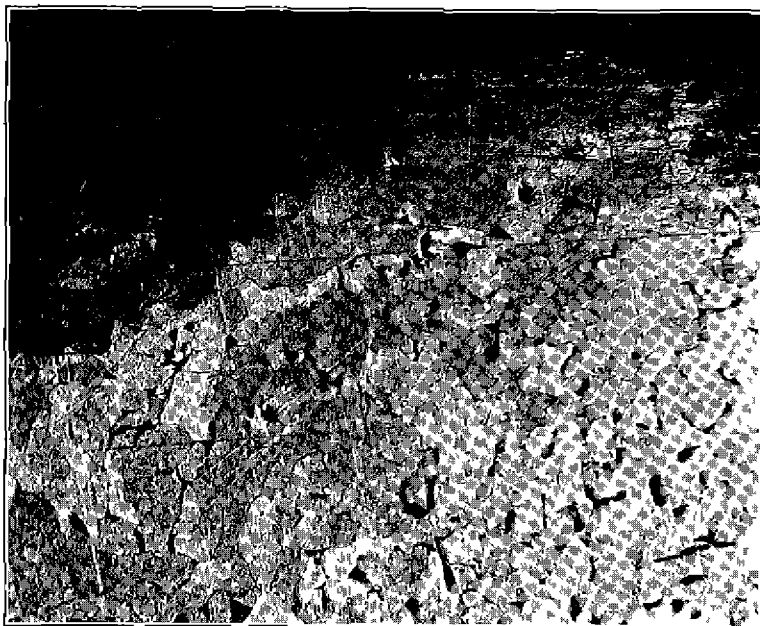
The microstructure of the metal of the arch bars, 3 per cent nitric-alcohol etch, vertical illumination, 100 diameters magnification, is shown by Figures Nos. 4 to 7, inclusive.

There was no structural evidence of work done during fabrication which would attach responsibility for the fracture of the bars to either heat or mechanical treatment.

FIGURE 4 —Microstructure of arch bar, car No 667, outside Magnification 100 diameters

FIGURE 5 —Microstructure of arch bar, car No 667, inside Magnification 100 diameters

FIGURE 6—Microstructure of rich bit coal No. 622, outside Magnification 100 diameters

FIGURE 7—Microstructure of rich bit coal No. 622, inside Magnification 100 diameters

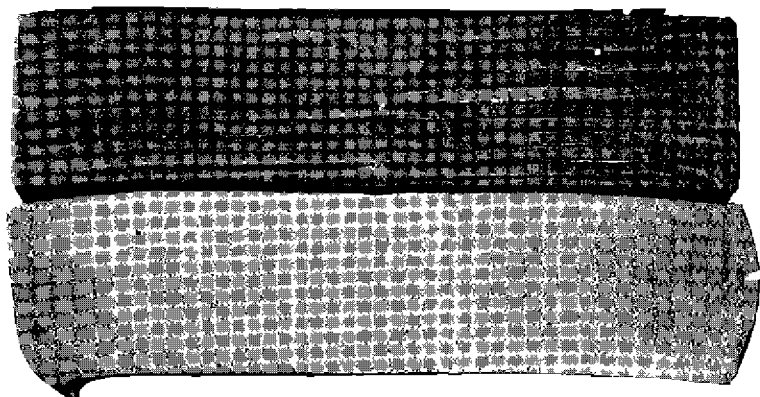
FIGURE 9—Appearance of rich bars of car No 667 after pickling. Upper figure of the cut, cross section of wrought iron bar. Lower figure of the cut, cross section of steel bar

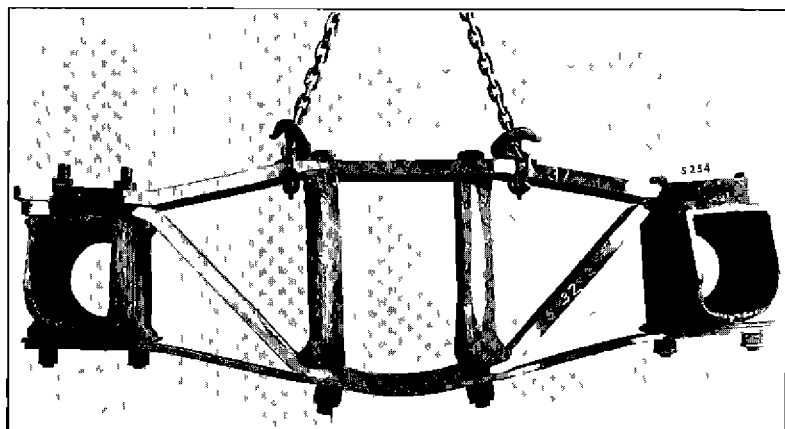
The manner of failure was the same in each of these frames. The arch bars remained intact. Failure occurred by reason of the shearing of the axle-box bolts, the shearing planes being between the upper and lower arch bars.

It was not apparent, from triaxial readings taken immediately prior to the shearing of the axle-box bolts, that the yield points of the bars were reached up to the time of ultimate strength of the frames. The bolt holes in each bar were permanently elongated. The shearing of the bolts relieved the strains of compression and tension, respectively, in the upper and lower arch bars whereupon their ends slid past each other, in the case of the new 50-ton frame, a distance of 1 inch.

Figure No. 10 illustrates the appearance of the new 50-ton frame after the test. Triaxial measurements were made on the bars where the gauged lengths 31, 32, and 33 were indicated by chalk marks.

FIGURE 10.—Appearance of new arch bar frame for 50-ton car after test. Axle box bolts sheared, on left side. Upper and lower arch bars slid by each other.

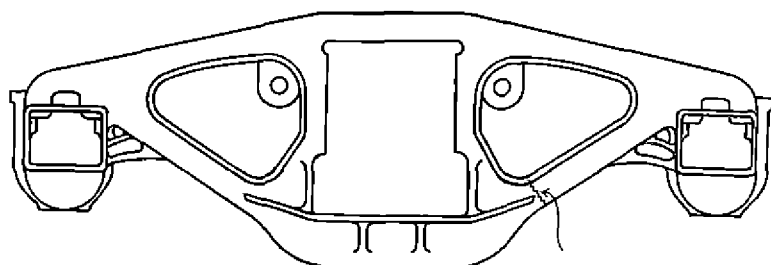
The fractures of the first and second frames were at chaplets in the diagonal tension members, through sound metal. The fracture of the third frame occurred in the drag side of the casting at some small blow holes and sand inclusions.

Figure No. 11 represents diagrammatically the outlines of these cast-steel frames.

FIGURE 11.—Diagrammatic outlines of cast steel truck frames
