## INTERSTATE COMMERCE COMMISSION

REPORT OF THE DIRECTOR OF THE BUREAU OF SAFETY IN RE  
INVESTIGATION OF AN ACCIDENT WHICH OCCURRED ON THE  
NEW YORK, CHICAGO & ST. LOUIS RAILROAD AT EDWARDS-  
VILLE, ILL., ON MARCH 26, 1929.

July 30, 1929.

No. 1513  
 N Y C & St L F R  
 Edwardsville, Ill.  
 March 26, 1929

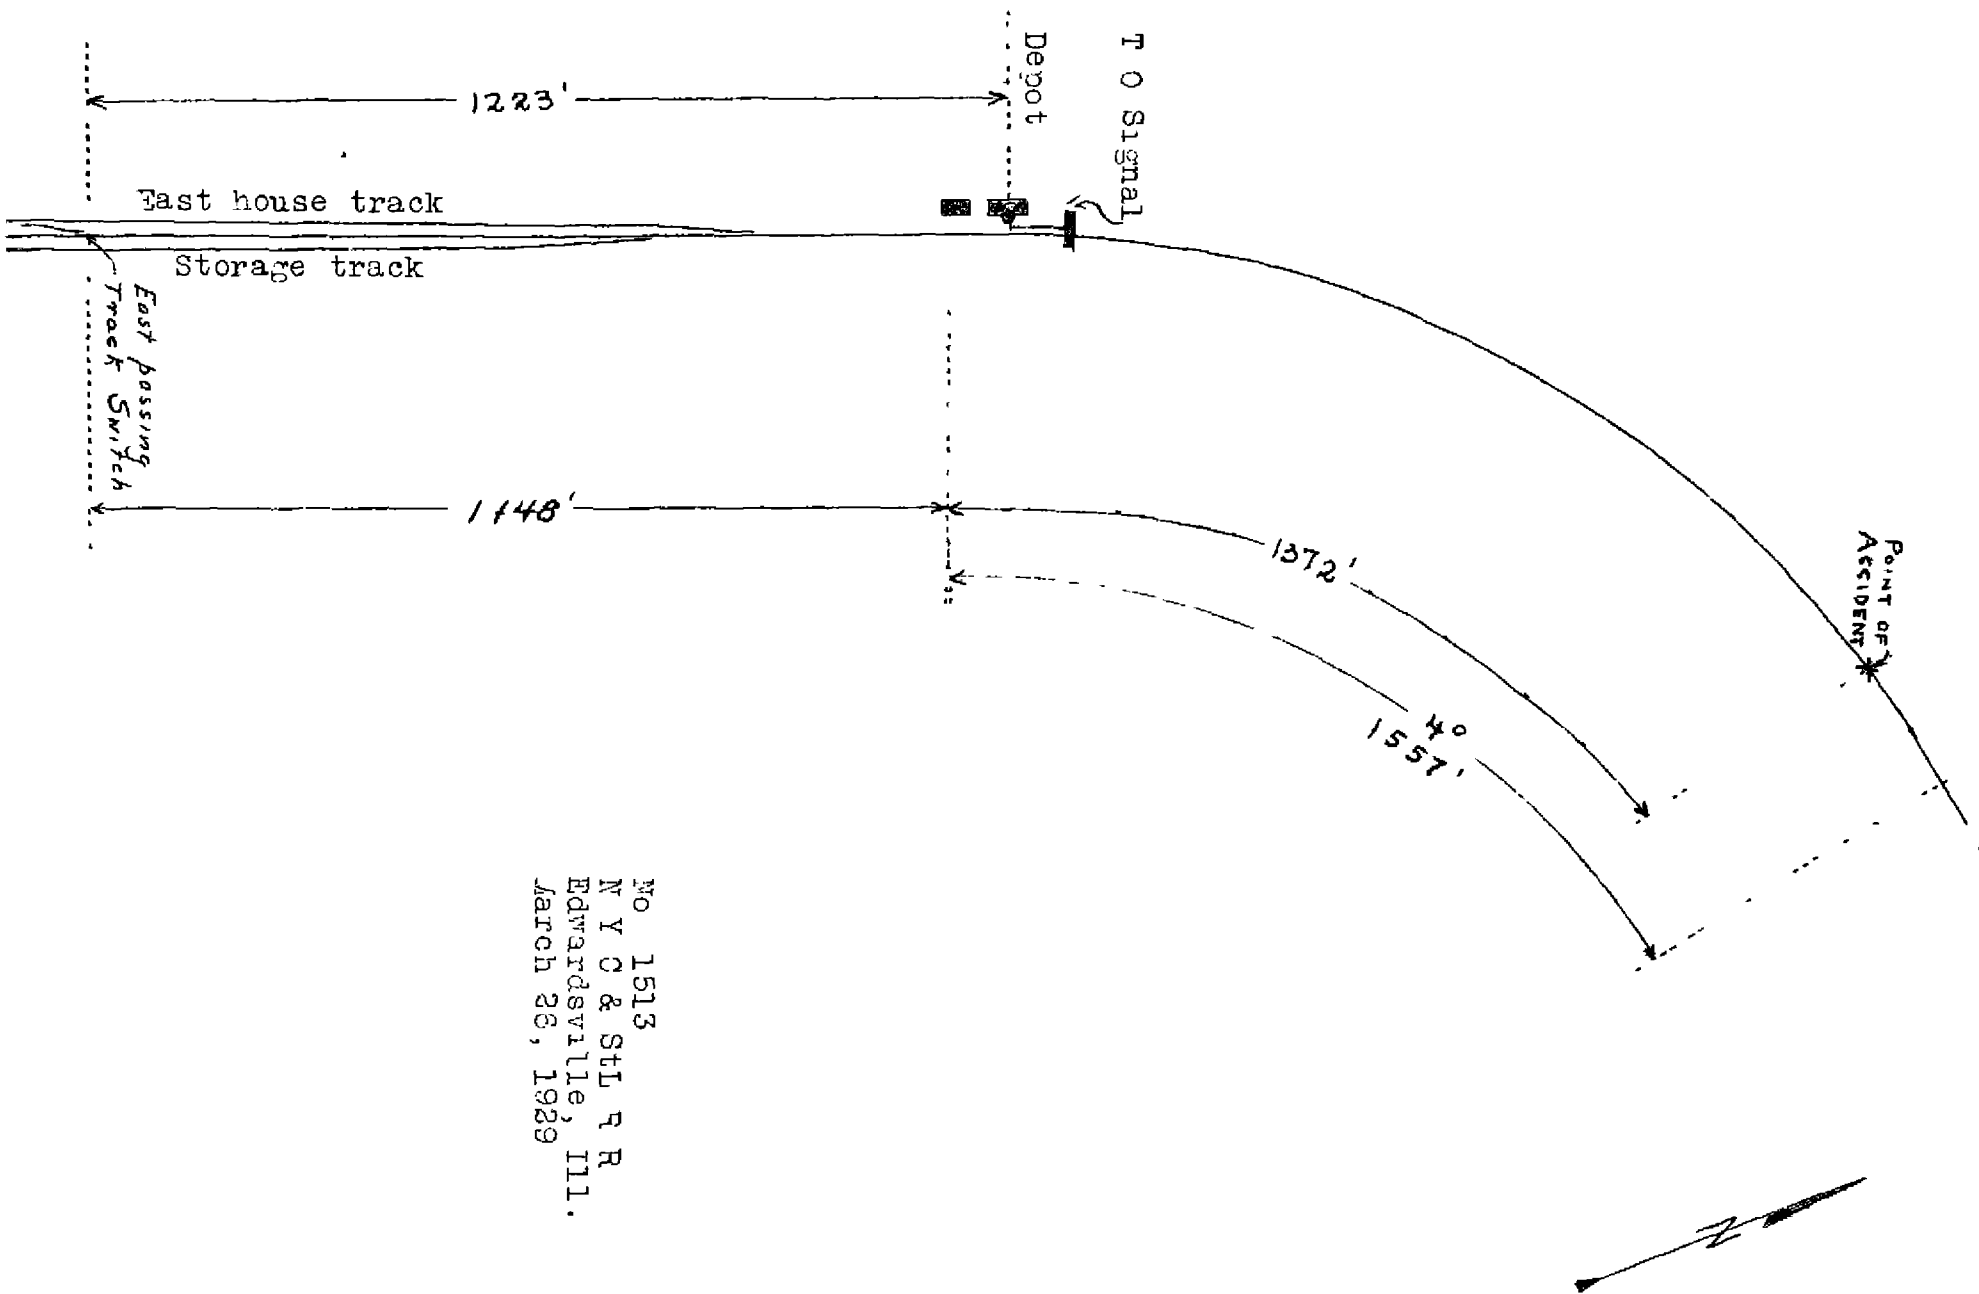
On account of buildings and trees on the inside of the curve neither engine crew could see the opposing engine until within a few hundred feet of each other.
