INTERSTATE COMMERCE COMMISSION.

REPORT OF THE CHIEF OF THE BUREAU OF SAFETY COVERING INVESTIGATION OF AN ACCIDENT WHICH OCCURRED ON THE NEW YORK, NEW HAVEN & HARTFORD RAILROAD NEAR EAST PORT CHESTER, CONN, ON JULY 31, 1919

OCTOBER 30, 1919

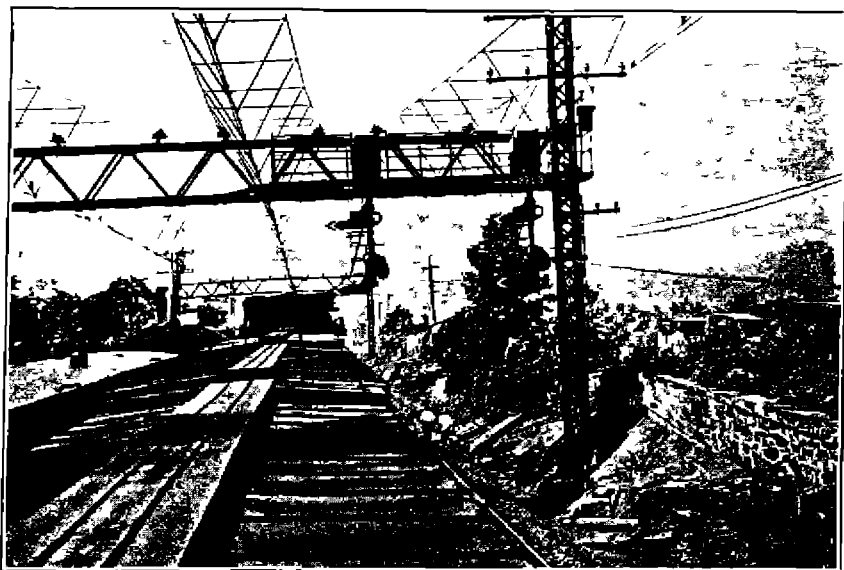
the box car immediately ahead of it. Illustration No 2 is a view taken from the top of the cars composing the rear portion of train MH 3, and gives a general idea of the arrangement of the signals, power transmission wires etc.

No. 2 —View of signal 2701, showing general arrangement of signals, power transmission wires, etc

The testimony of the crew of extra 429, which was moving westward on track 3 just a few feet in advance of train MH 3, which was approaching on track 1, that signal 2701 was in the stop position for train MH 3 together with the fact that the signals worked properly without any repairs after the tracks were cleared and the fuses replaced is conclusive evidence that the signals did not fail to give the proper indications.
