## INTERSTATE COMMERCE COMMISSION

### REPORT OF THE DIRECTOR OF THE BUREAU OF SAFETY IN RE INVESTIGATION OF AN ACCIDENT WHICH OCCURRED ON THE NEW YORK, NEW HAVEN & HARTFORD RAILROAD AT READ- VILLE, MASS , ON SEPTEMBER 11, 1923

OCTOBER 10, 1923

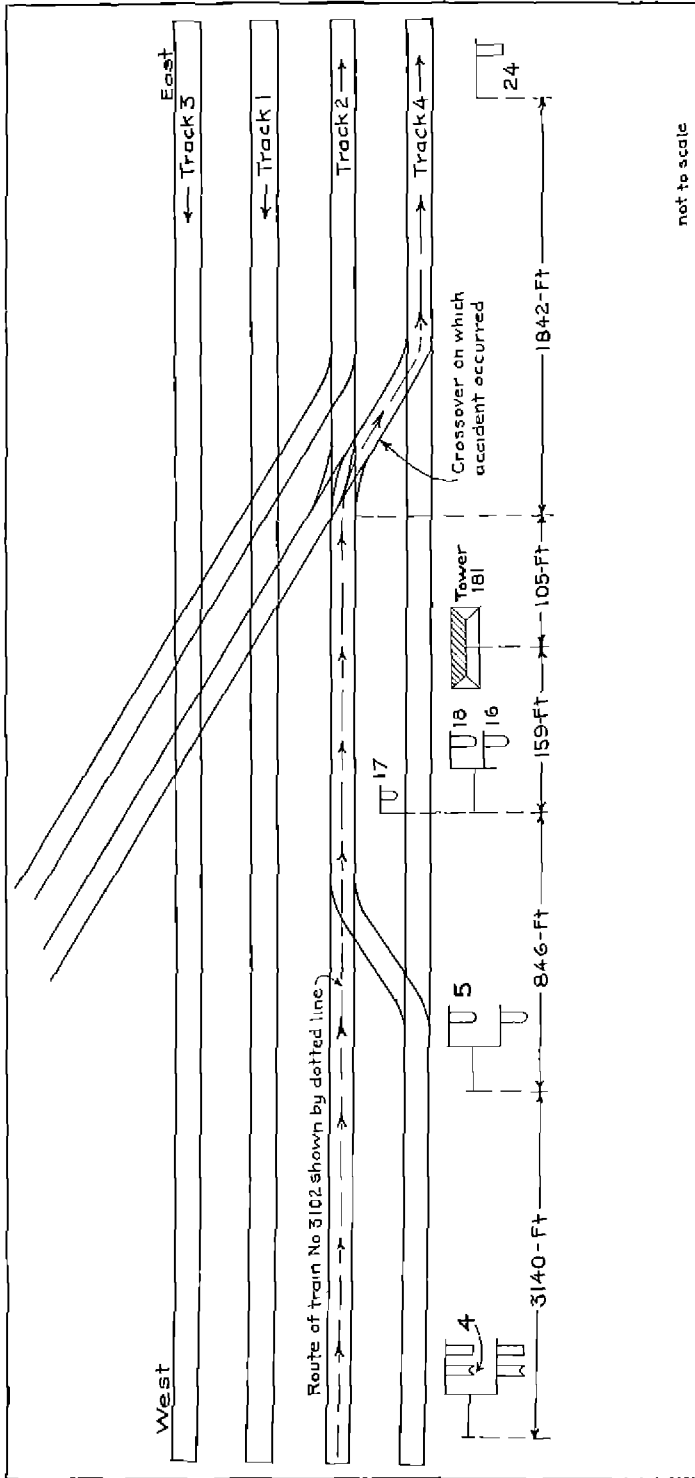
FIG No 1 —Diagram showing relative location of tracks and signals involved

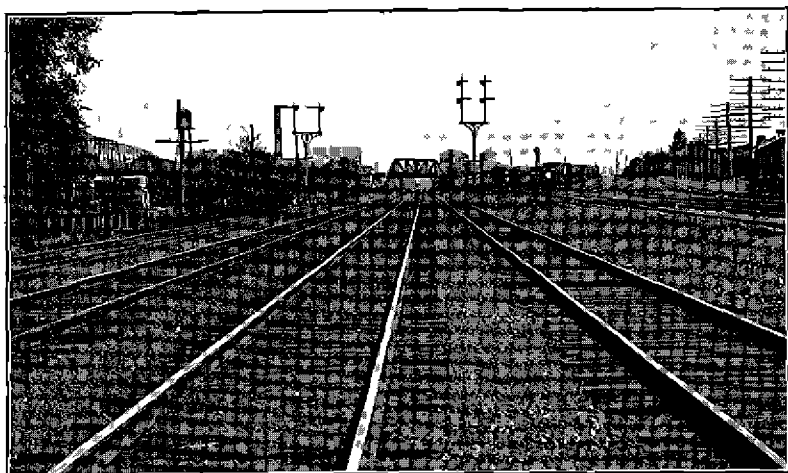
FIG. No. 2—View approaching semiautomatic distant signal 4

encounter the following signal indications. A caution indication at semiautomatic distant signal 4, which is 4,145 feet west of tower 181, a clear indication at interlocking home signal 5, which is 1,005 feet

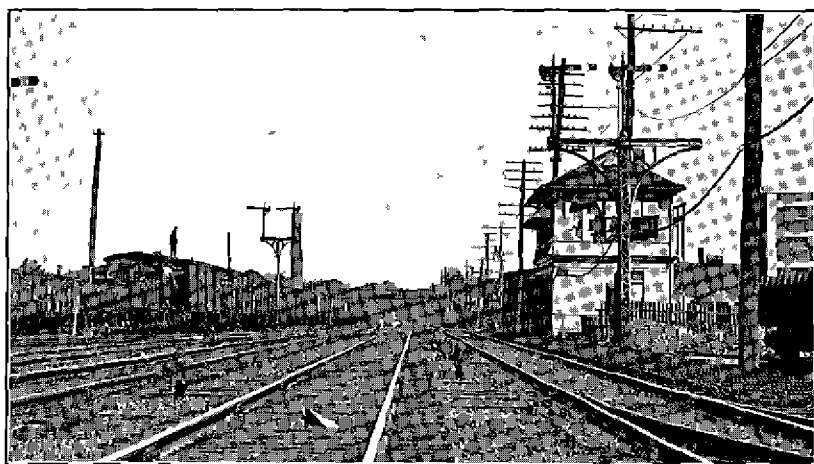
FIG. No. 3—Close up view of home signal 18 dwarf signal 17 is second signal to the right of track 2

west of the tower and governs only to signal 18 a stop indication at interlocking home signal 18, which is 159 feet west of the tower and governs the straight route on track 2, a caution indication at dwarf signal 17, located between tracks 2 and 4 opposite signal 18, this

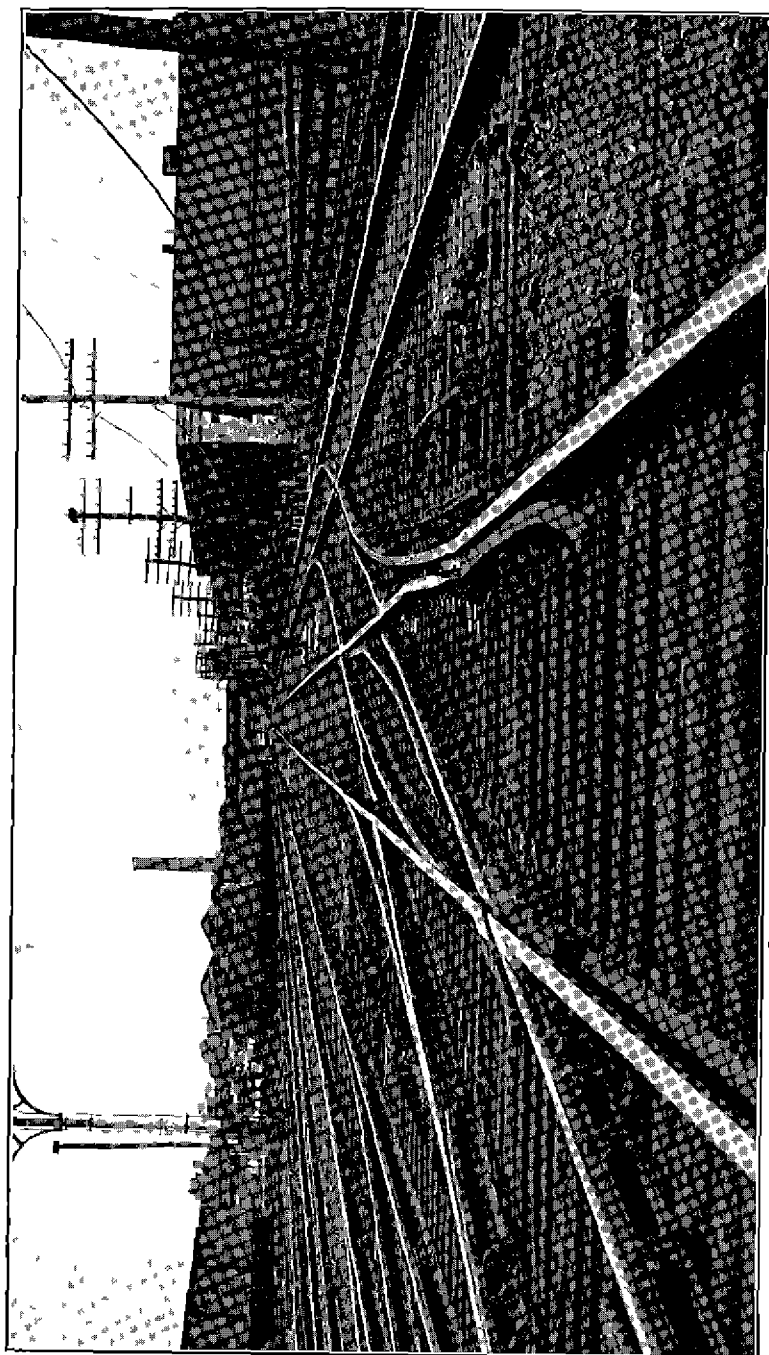
FIG No 4—View showing No 8 crossover on which derailment occurred

The tracks of the Dedham branch connect with those of the main line at tower 181, and the switch at the west end of the crossover connecting tracks 2 and 4 is of the double-slip type. This crossover has a length from point to point of 153 feet 5 inches, while the curvature of the turnout is  $8^{\circ} 28'$ . No operating difficulties of importance would be encountered should it be desired to install a No 20 crossover at this point.

This accident was caused by the operation of train No. 3102 through a short crossover at an excessive rate of speed.

That in the absence of such automatic control apparatus, on tracks where high speed trains are run, switches should not be set to divert a high speed train from one track to another at a crossover which is not safe for high speed, until after the train has been brought to a stop.

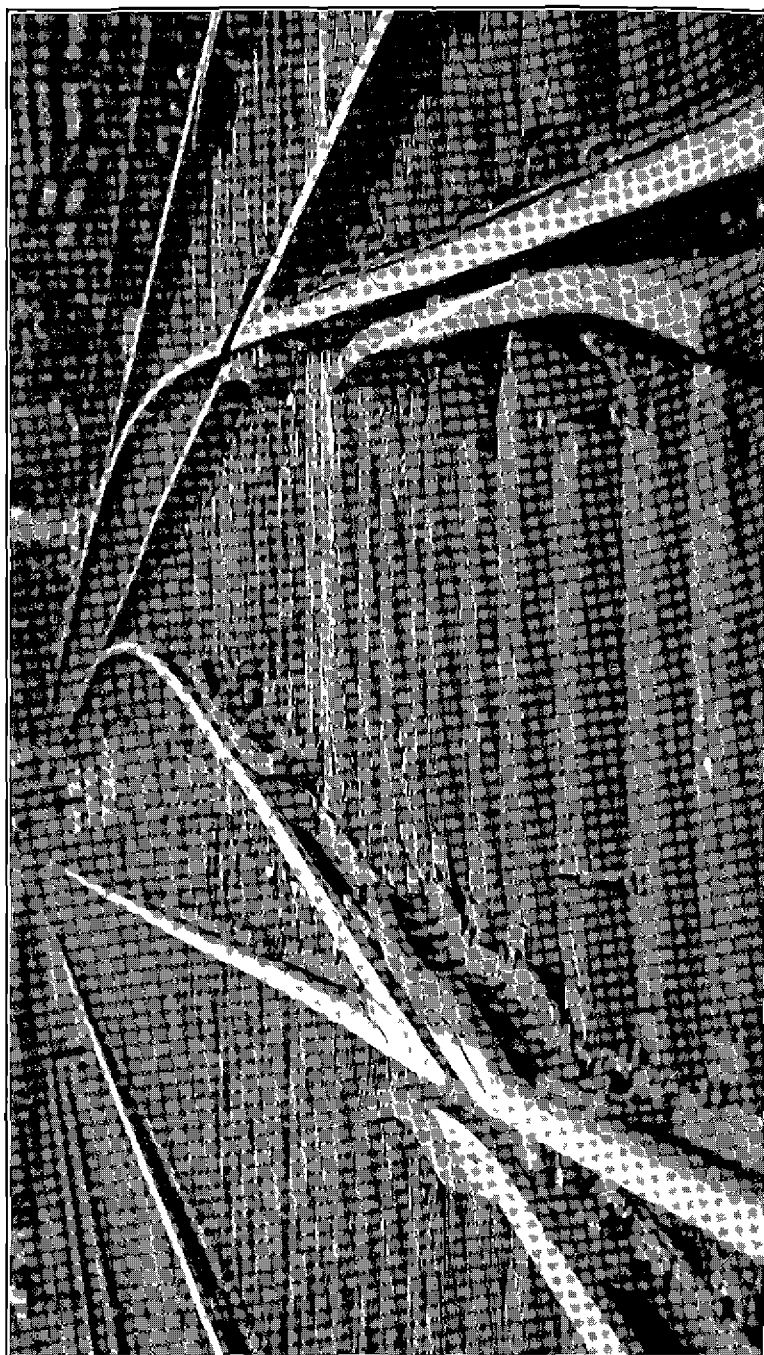
Fig. No. 3—Crossover in vicinity of frog, white streak on guard rail indicates first mark of derailment

Division Engineer Ruff said he reached the scene less than an hour after the occurrence of the accident, and found the track to be in good condition throughout. The first mark of derailment was on the right side of the guard rail opposite the frog in track 2, and about 2 feet west of the point of the frog, this wheel then mounted the guard rail, while the opposite wheel struck the point of the frog and mounted it. The track at this point was not disturbed in the accident.
