Railroad accident investigation from report CV 147 no. 651 2005

On December 18, 1919, there was a head-end collision between two passenger trains on the Norfolk & Western Railroad at Walton, Va., which resulted in the death of 5 passengers and the injury of 10 passengers and 7 employees. After investigation of this accident I respectfully submit the following report:

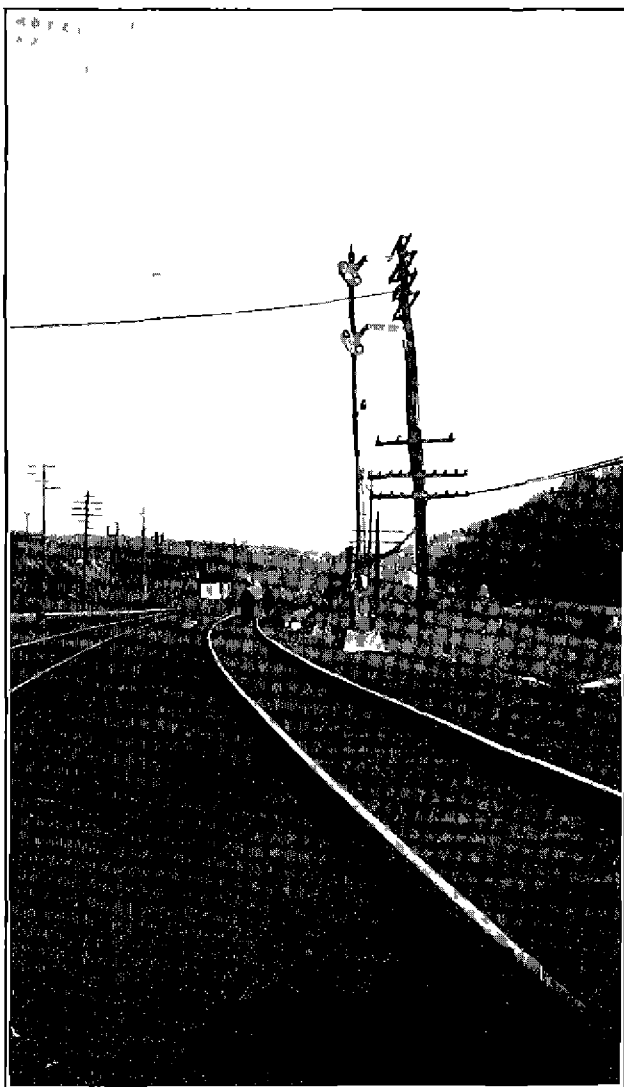
FIG. 1 —Interlocking signal 14-T, governing eastbound movements on Bristol line at junction with three track portion of road

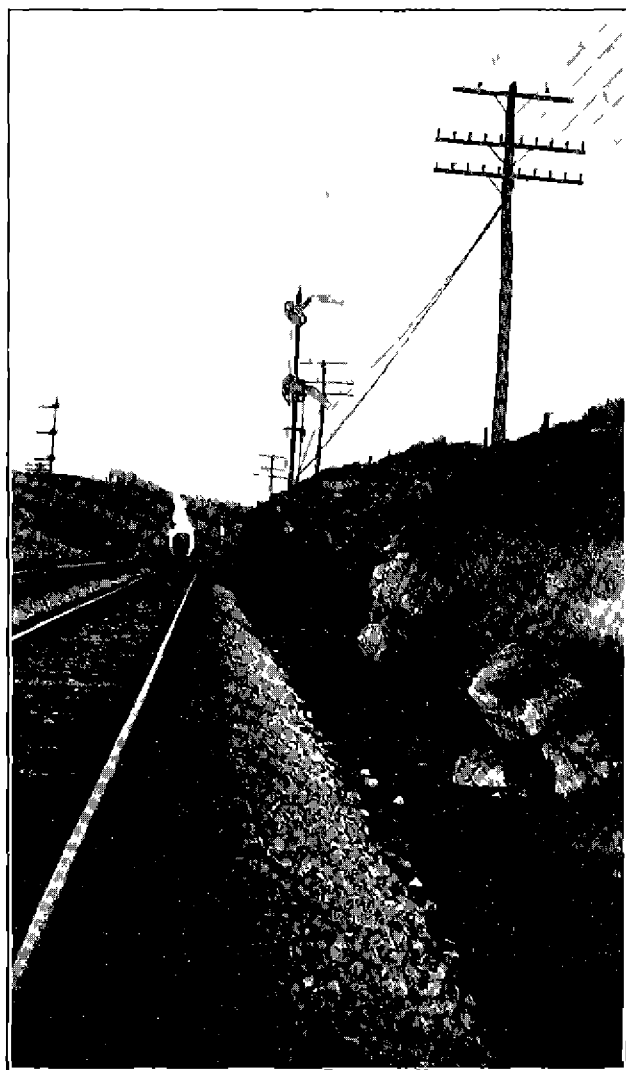
yond the interlocking signal when the latter is in the stop position and when the crossover switch is properly lined up for an eastbound movement from the Bristol line. Illustration No 2 shows signal 8-L with the calling-on signal displaying a permissive indication. The signals at this point are electrically lighted. The night color indications of these two signals are as follows. Both signals, red, stop, top signal red and bottom signal yellow, proceed with great caution, top signal green and bottom signal red, proceed.

FIG. 2.—Interlocking signal 8-L, which protects crossover switch connecting middle track with eastbound main track.

With interlocking signal 8-L displaying a stop indication Engineman Hooper knew positively that the track ahead was occupied by a preceding train or obstructed in some other manner, and although he received a permissive indication of the calling-on arm at signal 8-L, giving him the right to pass the interlocking signal in the stop position, the only definite information this permissive indication gave was that the switches were properly lined up for the movement of his train. It was still necessary for him, as required by rule 708, to proceed with great caution and to watch out for a train ahead or some other obstruction which would endanger the passing of his train. Under such circumstances there can be no excuse for his fail-

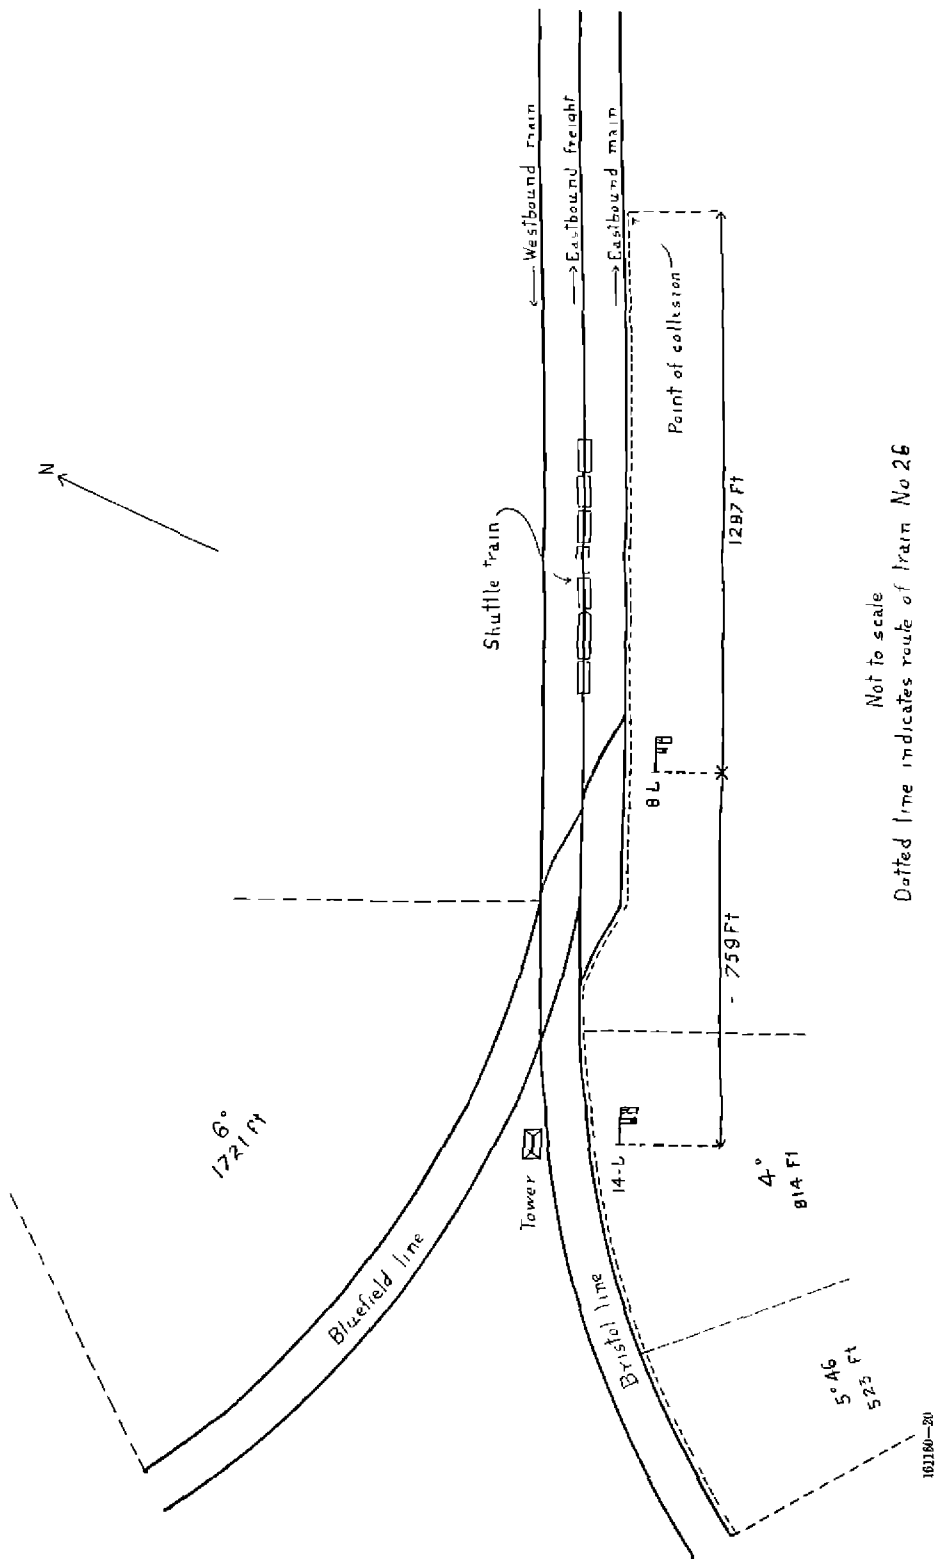
Not to scale
 Dotted line indicates route of Train No 26
