INTERSTATE COMMERCE COMMISSION

REPORT OF THE CHIEF INSPECTOR OF SAFETY APPLIANCES COVERING HIS INVESTIGATION OF AN ACCIDENT WHICH OCCURRED ON THE NORTHERN PACIFIC RAILWAY NEAR LAKE- VIEW, WASH , ON MAY 12, 1913

July 10, 1913

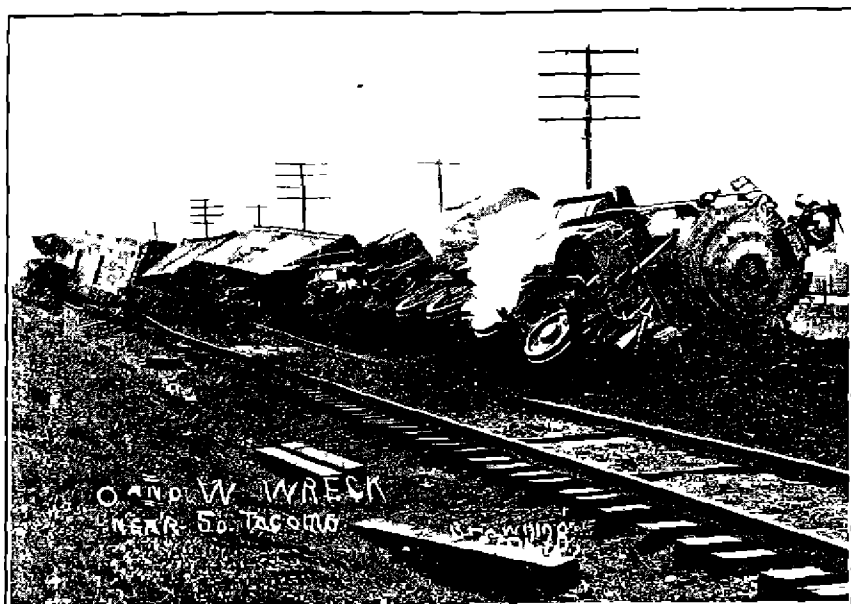
The engine, tender, and first seven cars were derailed, together with the forward trucks of the dining car the balance of the train remaining on the rails. Illustration No 1 shows the position of the engine, tender, refrigerator cars, and the combination car. Illustration No 2 is a view taken from the roof of the dining car and shows the manner in which the coaches came to rest. The forward end of the first coach was crushed on the north side a distance of about 20 feet by the rear end of the combination car, the south side of the coach, with the exception of the vestibule, being practically intact. The position of this coach and the combination car after the accident seemed to indicate that when the trucks were knocked from

No 1—General view of accident looking in westerly direction

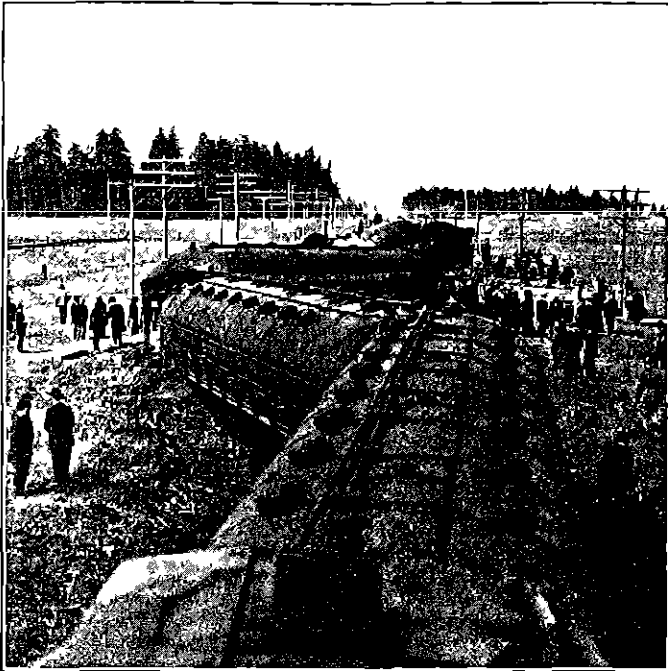
No. 2 —View looking in easterly direction, taken from roof of dining car

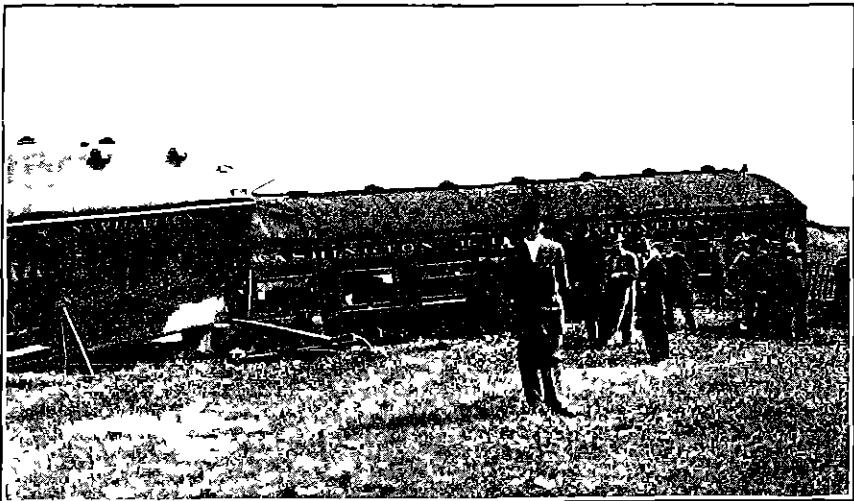
No. 3 —Side of steel coach crushed on forward end by steel combination car

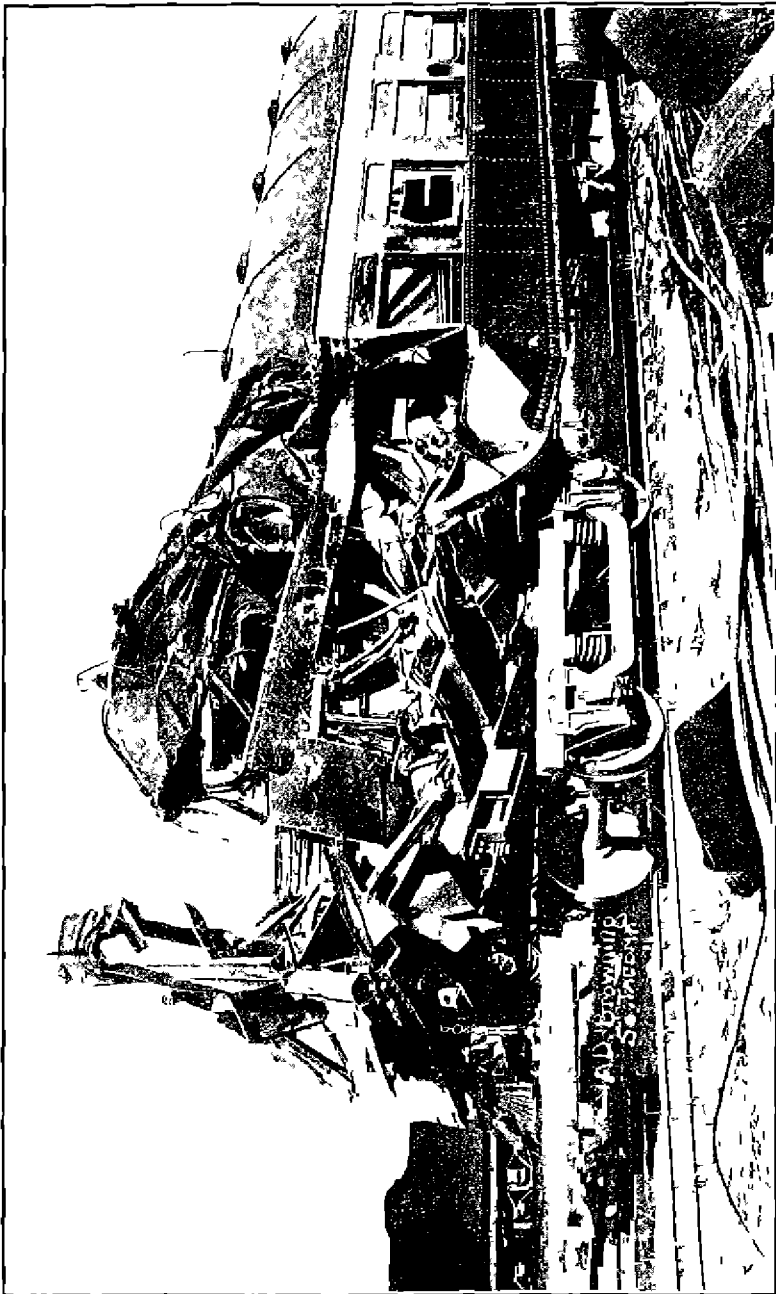
No. 1 Steel coach after removal from scene of accident

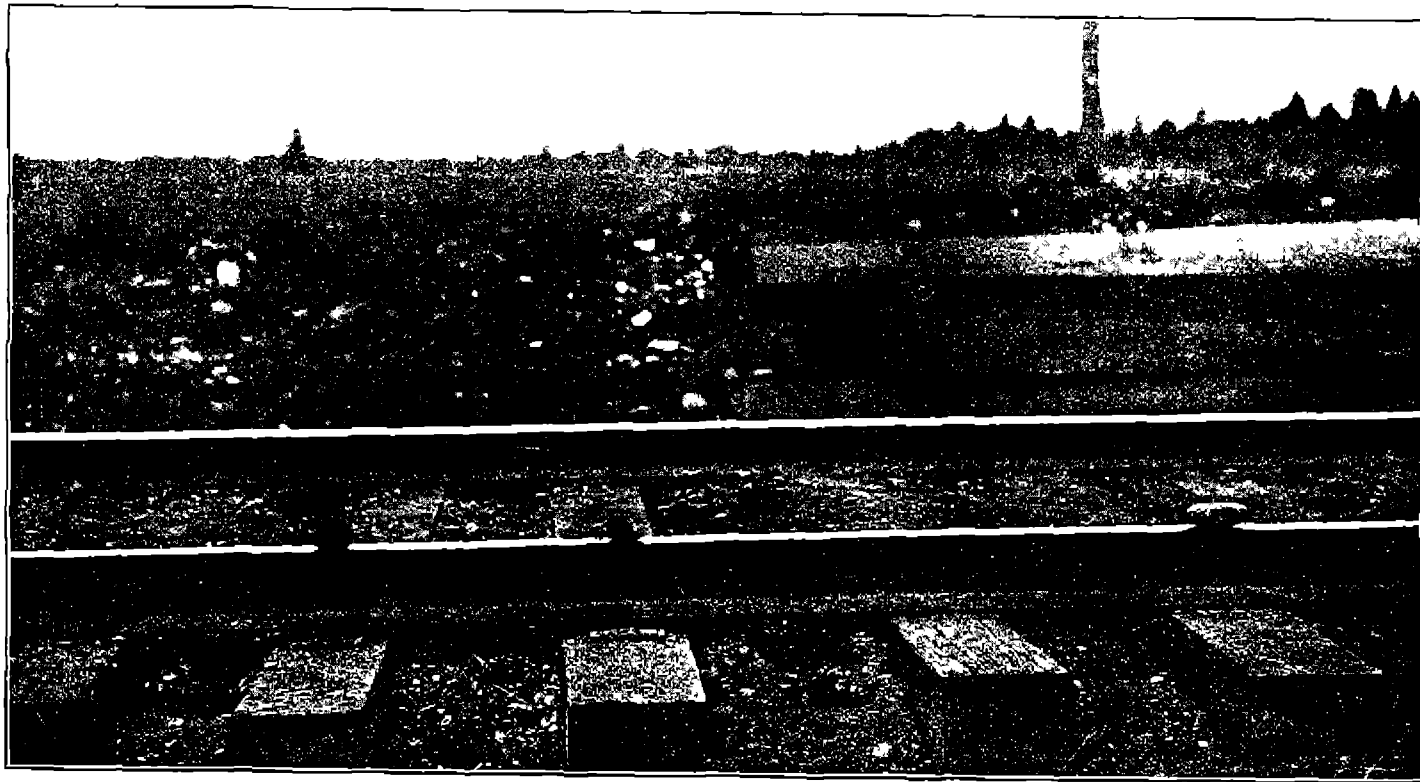
On the day of the accident section men were engaged in making the annual renewal of ties. Examination of the track showed that in a distance of 16 rail lengths west of the point of derailment 46 ties had been replaced very few of which were spiked. The tamping of these ties had not been completed, and several of them had settled away from the rails, this settling apparently being due to the fact that several trains had passed over the track after they had been put in. Illustration No. 6 is a view of the track at a point about 185 feet west of the dining car, and shows how the new ties settled away from the rail. Just east of where the locomotive stopped were found additional ties with the ballast removed and the spikes drawn preparatory to removal. This condition can be seen by examination of illustration No. 1. All the spikes were found to have been drawn from both ties at the rail joint which connected rail A with the rail next to it on the west. The spikes were also drawn and the ballast removed from three other ties under rail A as well as from the first tie under the receiving end of rail B. From this point eastward no detailed information was obtainable on account of the roadbed being torn up by the derailment. The examination also disclosed the fact that many tie plates were embedded even with and in some cases below, the tops of the ties.

No 6—View showing how new ties settled away from rails, on account of tamping and spiking not being completed
