INTERSTATE COMMERCE COMMISSION

REPORT OF THE CHIEF OF THE BUREAU OF SAFETY IN RE INVESTIGATION OF AN ACCIDENT WHICH OCCURRED ON THE LINE OF THE OREGON-WASHINGTON RAILROAD & NAVIGATION COMPANY NEAR CELILO, OREG, ON DECEMBER 1, 1921

MARCH 2, 1922

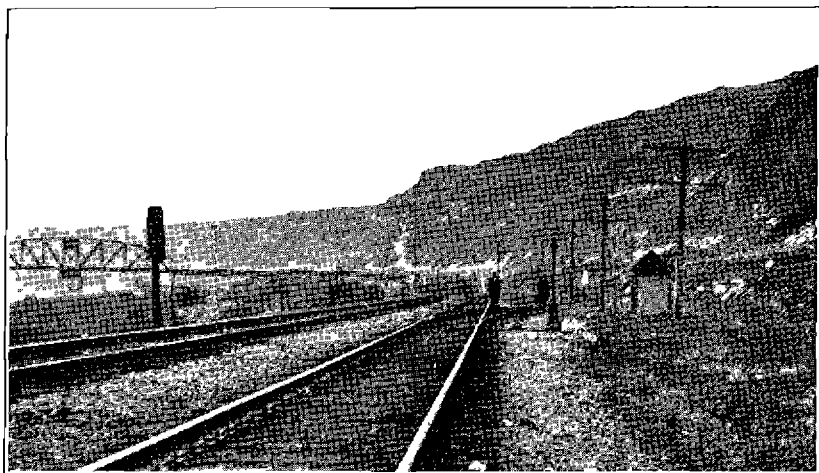
FIG 1—LOOKING EAST TOWARD MAIN LINE SWITCH AT OREGON TRUNK CONNECTION TELEPHONE BOOTH ON RIGHT

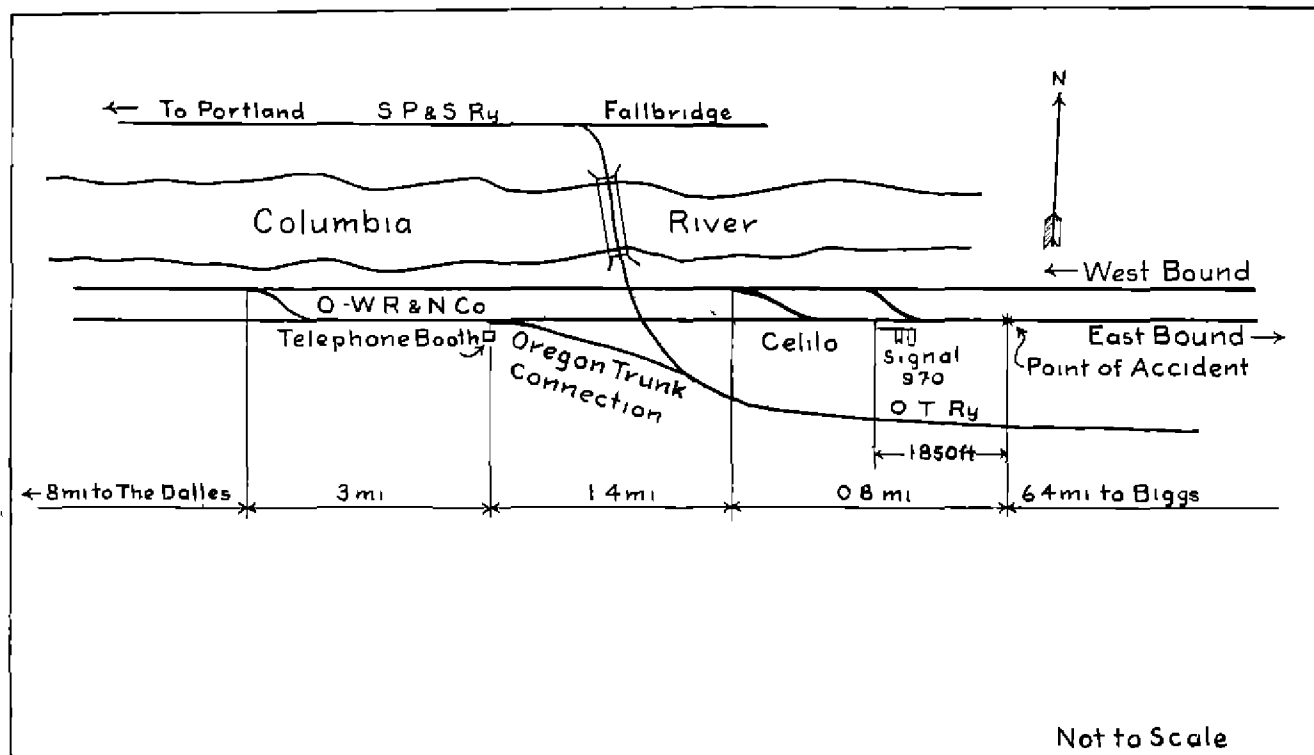
FIG 2—TRACK LAYOUT IN VICINITY OF OREGON TRUNK CONNECTION

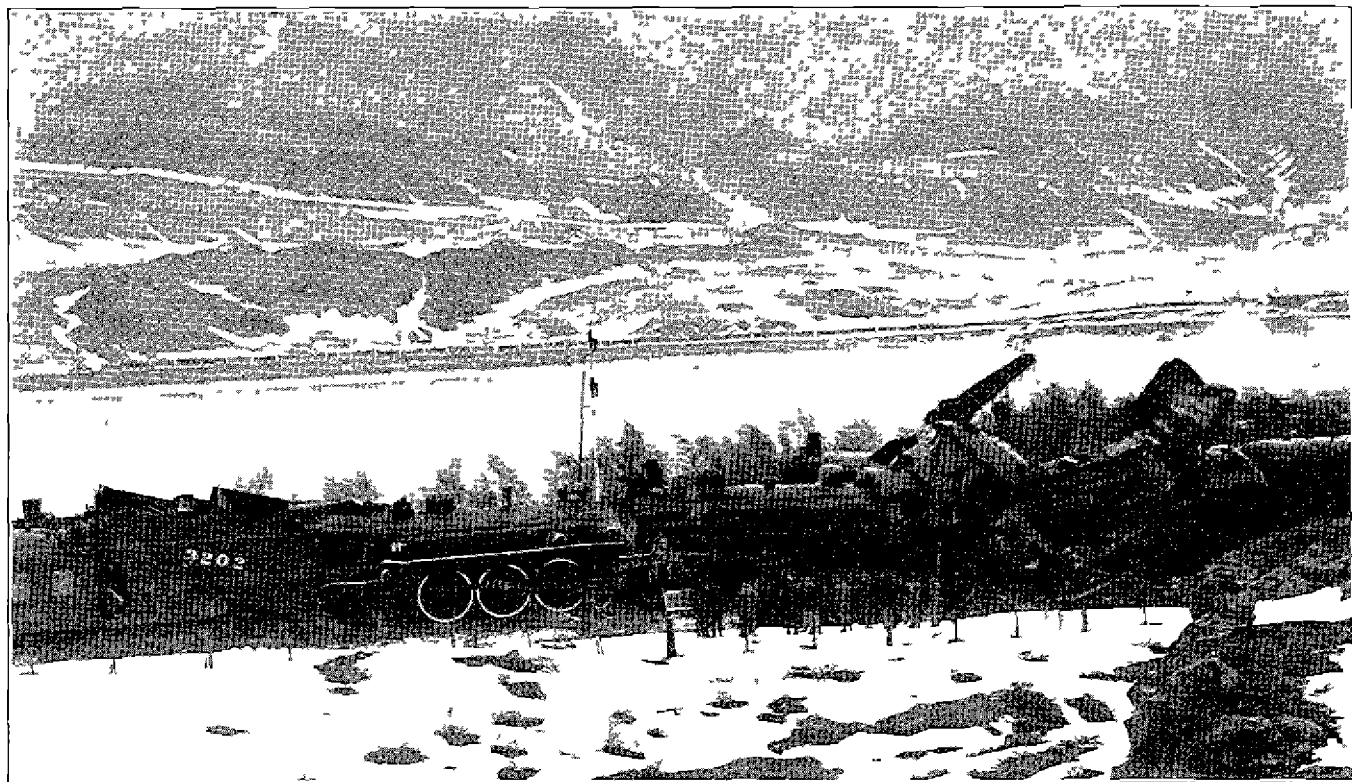
FIG 3 -GENERAL VIEW OF WRECKAGE NOTE TELESCOPING OF STEEL MAIL CARS BY DIFFERENT TYPES OF TENDERS

Engine 3211 was considerably damaged while the steel mail car was telescoped practically its entire length by the tender, which was of the Vanderbilt type, the second car was only slightly damaged, the third car came to rest on its side across the westbound main track in a badly damaged condition, while the fourth car had its front end telescoped about 12 feet. Engine 3202, of train No 12, was quite badly damaged, while the tender, which was of the usual square-end

type, telescoped the front end of the first car a distance of about 18 feet. The second, fourth, and fifth cars were considerably damaged, the head end of the fifth car, a wooden tourist car, being telescoped a distance of about 18 feet. The employee killed was the fireman of extra 3211.
