INTERSTATE COMMERCE COMMISSION.

REPORT OF THE CHIEF INSPECTOR OF SAFETY APPLIANCES IN RE INVESTIGATION OF ACCIDENT ON THE PACIFIC ELECTRIC RAILWAY, NEAR LOS ANGELES, CAL, ON JULY 13, 1913.

AUGUST 6, 1913

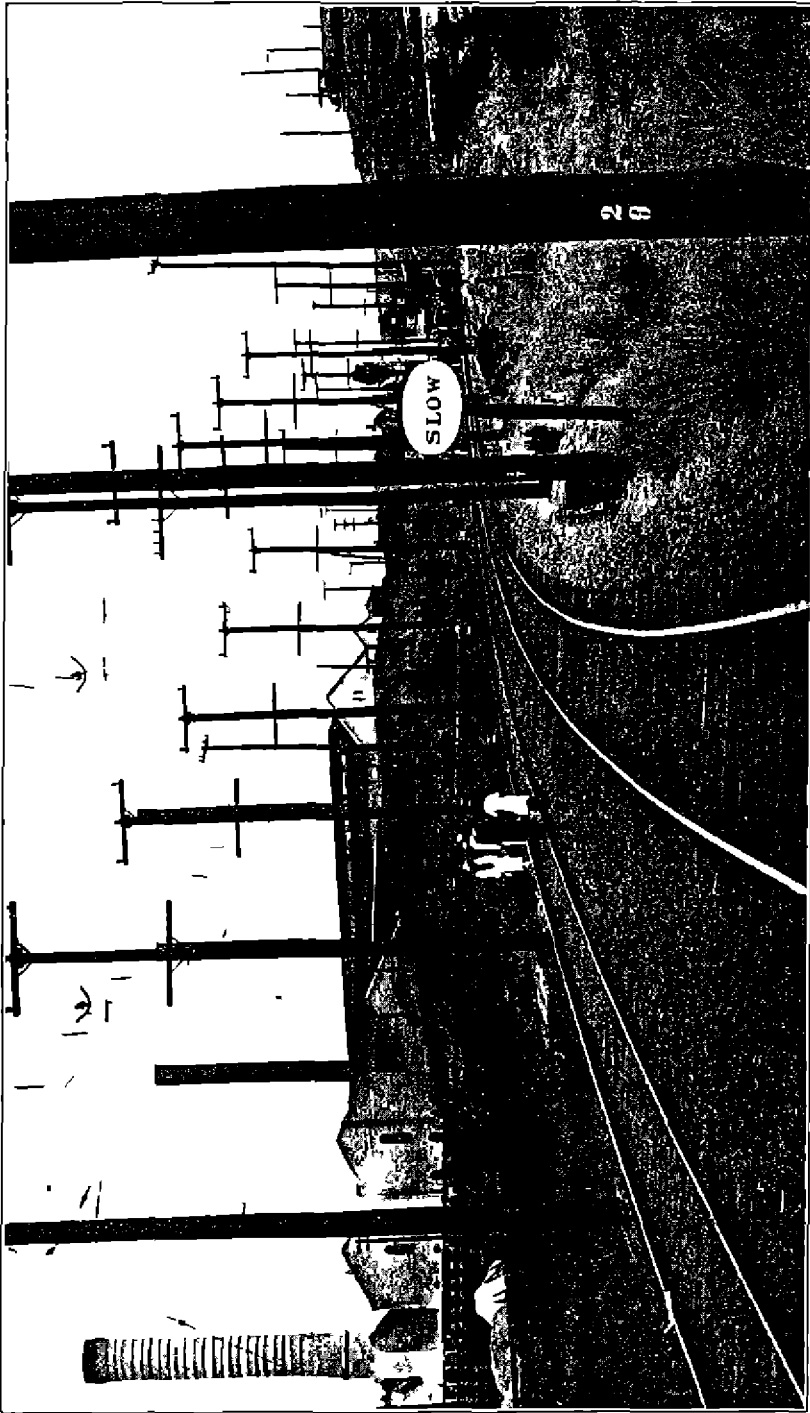
The track is straight for a distance of about 180 feet west of the point where the accident occurred, and then there is a curve of about $2\frac{1}{2}^{\circ}$, 639 feet in length, diverging toward the south. A slow board is located on this curve, 609 feet from the point where the collision occurred and 1,000 feet from the junction at Vineyard. Approaching from the west the view of the track at the point of collision was obstructed by the bank of a cut and by poles lining the track.

General view of track approaching scene of accident, showing slow board, bank of cut, and trolley poles along the track

In this case it is believed that the flagman did not go back the required distance, the evidence indicating that he had not reached the slow board which was only 609 feet from the rear end of the standing train, and although he had both fusees and torpedoes with him he did not use either.

Had the motorman of extra 874 observed the speed restriction in effect at this point the accident probably would have been averted, in spite of short flagging. The evidence indicates that the speed of the train when it passed the slow board was in excess of 30 miles per hour and it was undoubtedly more than 10 miles per hour when the collision occurred. On July 16 tests were made with a train of three cars of the 800 class to determine the distance within which a train of this character could be brought to a stop. During these tests there were about 30 people in the train, and the speed in each case was 41 miles per hour. In the first test the current was shut off at the slow board and immediately a 10-pound reduction was made, resulting in a service application of the brakes, and the train was brought to a full stop in 425 feet. In the second test an emergency application of the brakes was made at the slow board and the train was brought to a full stop in 400 feet. As a result of these tests, it is believed that had the motorman of extra 874 applied the brakes at the slow board the train would have been stopped in time to avert the collision, the distance between the slow board and the point where the accident occurred being sufficient to allow for the greater distance required for stopping the loaded train as compared with the train used in these tests.
