INTERSTATE COMMERCE COMMISSION

REPORT OF THE DIRECTOR OF THE BUREAU OF SAFETY IN RE INVESTIGATION OF AN ACCIDENT WHICH OCCURRED ON THE PENNSYLVANIA RAILROAD NEAR DELAIR JUNCTION, N J, ON APRIL 8, 1926

SEPTEMBER 11, 1926

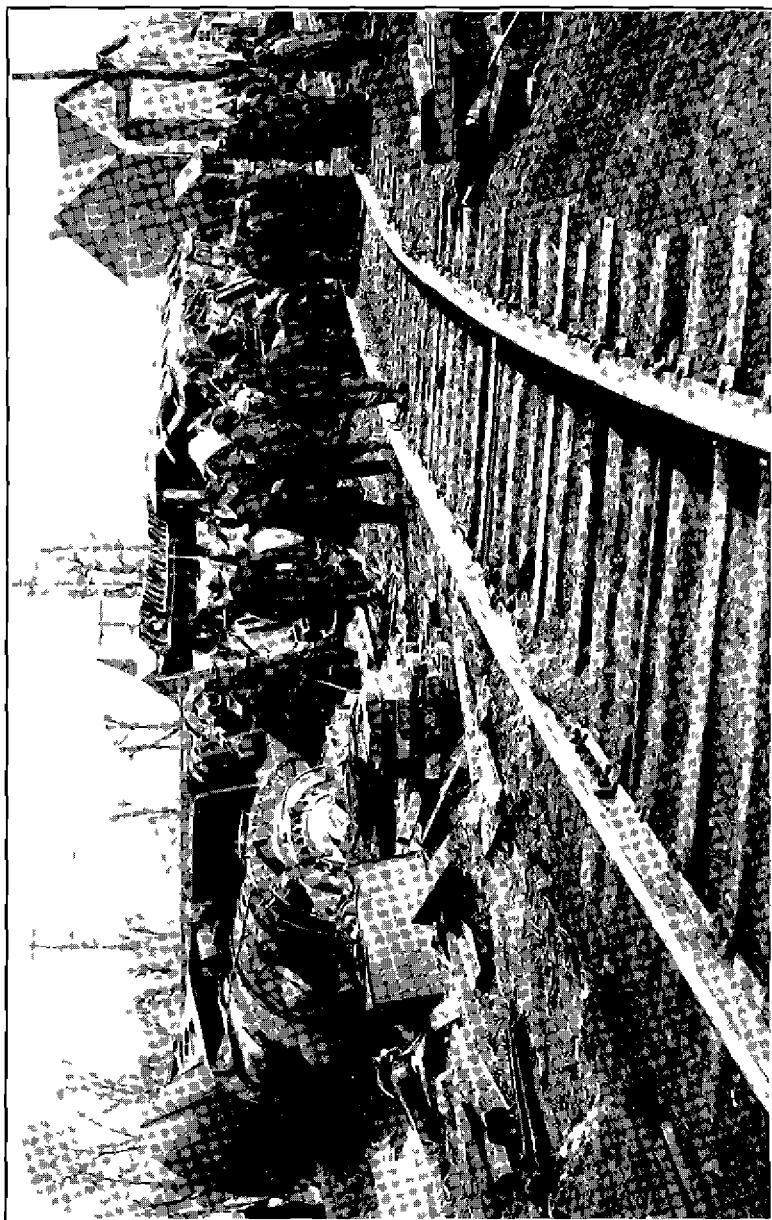
The engine and first four cars were entirely derailed the engine coming to rest on its right side on the outside of the curve about 120 feet beyond the point of derailment. The first car in the train a steel-underframe car with a wooden superstructure sheathed with steel, had its superstructure nearly demolished. The second car was partly overturned, while the head end of the third car came to rest about opposite the head end of the engine, the superstructures of these two cars were considerably damaged. The employees killed were the engineman and fireman.

FIG. 1.—General view of scene of accident. Damaged engine, lying on its side and forward end of the train. Track with the rods, the plating, and double-spiked, inside.

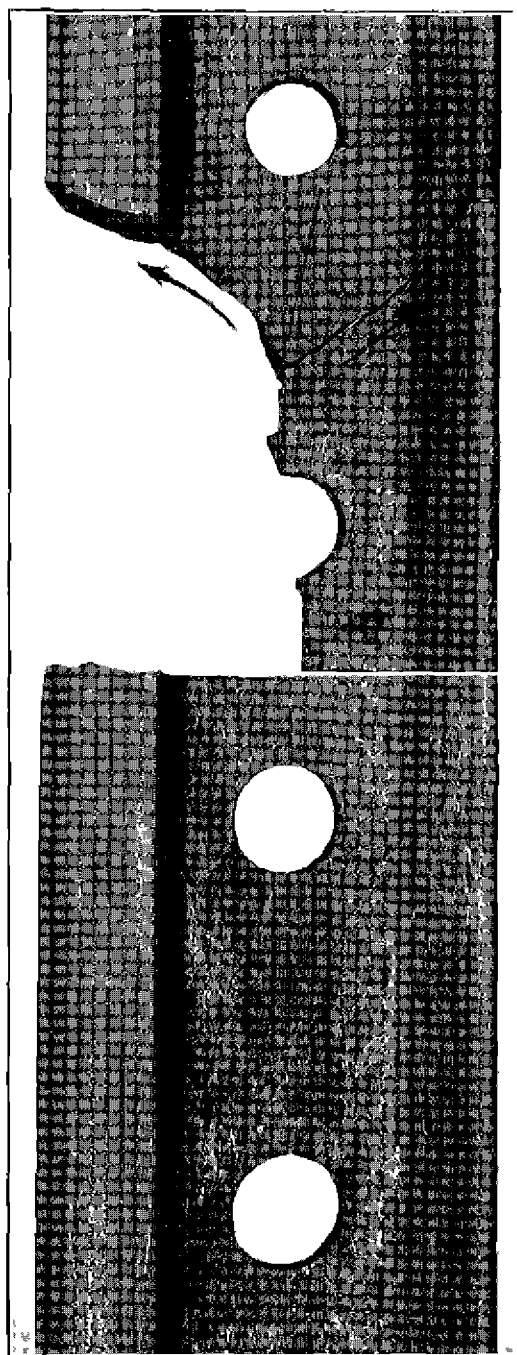
There was a preexisting bolt-hole fracture in this end of the rail which separated the web, extending from the end of the rail to the second bolt hole. This fracture bifurcated between the first and second bolt holes, the branches of which extended obliquely upward and downward, respectively, and thus effected the complete fracture of the rail. This extension of the preexisting bolt-hole fracture in which the entire cross section of the rail was broken and a piece of the head detached, is believed to have been the immediate cause of the accident.

The continuity of the track was interrupted and a gap 6 inches long made by a fragment of the head of the rail being detached directly over the preexisting bolt-hole fracture. In the formation of this gap in the track it is believed that two trains were involved—extra No. 3740, which preceded No. 1077 nine minutes, and the derailed train. All the evidence available supports this explanation of the proximate cause of the accident. The character of the fracture was such that the electric-signal circuit was not affected by it, the bond wires spanning the gap.

Figure No 2 shows the appearance of the leaving end of the Cambria rail and the receiving end of the P S Co rail. A bolt-hole fracture had separated the metal of the web of the Cambria rail on each side of the first bolt hole. This part of the fracture was of earlier origin. It presented a darkened and somewhat battered surface. The fracture bifurcated between the bolt holes with branches extending upward and downward respectively, thus completing the fracture of the rail. The surfaces of these branches showed fresh breaks. Their formation is attributed to the train which immediately preceded train No 1077.

A fine crack will be noticed extending obliquely downward from the root of the bifurcated fracture to the second bolt hole. This crack further indicated the existence of a fracture in the web prior to the present accident. No force acting simultaneous with or subsequent to that which caused the bifurcated fracture can be conceived which would account for the presence of this fine crack.

The 6-inch gap in the track is also indicated by Figure No 2. The fragment which filled the gap was not recovered. Oblique marks, previously referred to, were shown on the heads of these two rails, in alignment with each other. The receiving end of the P S Co rail was slightly battered. These marks tangent to the curvature of the track, were doubtless made by the derailed train and prior to the general breaking up of the track. The 6-inch missing fragment was doubtless knocked out or joggled out of its place just before the oblique marks on the heads of these rails were made.

FIG. 2.—Leaving, end of Columbia 1905 rail showing preexisting bolt hole fracture with crack extending to second bolt hole. New fracture bifurcated separating head web and base. Missing fragment of head 6 inches long. Cut also shows receiving end of P. S. Co. 1897 rail.

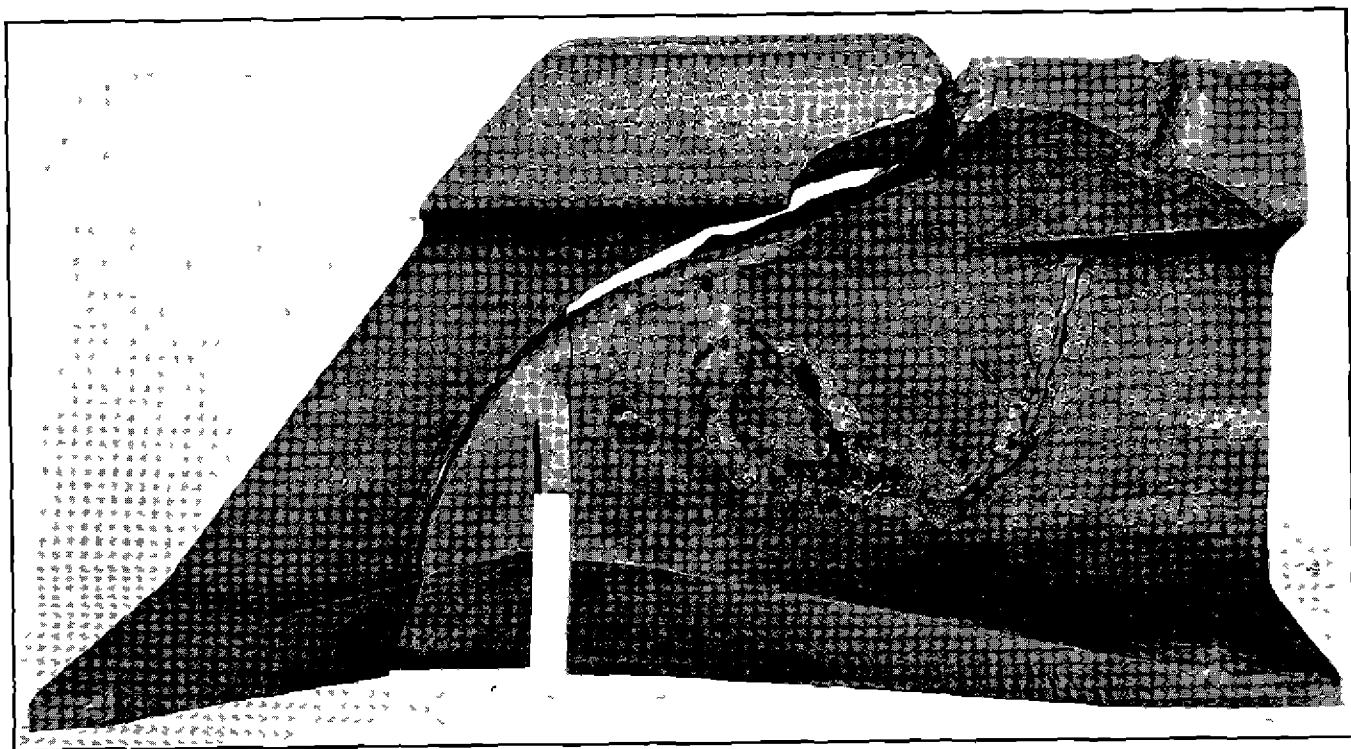
Figure No 3 illustrates a peculiar fracture which occurred 3 feet 10 inches from its leaving end. A crescent-shaped piece was detached from the inner flange of the base followed by an oblique fracture, originating in the base which thence extended upward through the web and head. This is the fracture which was described as new and bright by the supervisor of track.

The crescent-shaped fracture in plan was parabolic, the vertex being at the fillet of the web and the base of the rail. This base fracture had its origin at the fillet extending downward to the under-surface of the base. The oblique fracture which extended from bottom to top of the rail, originated in the base about 1 inch from the vertex of the crescent-shaped fragment. From its point of inception it traveled outwardly to the edge of the outer flange of the base, and also upwardly through the web and head. In point of time this part of the composite fracture took place after the crescent-shaped break.

This composite fracture as a whole is attributed to conditions which prevailed during the period of derailment of train No 1077. Normal track stresses are negligible factors in straining the inside

fillet of the base, eliminating from consideration antecedent strains as having an influence on the formation of this crescent-shaped fracture. The oblique upward fracture through the balance of the cross section of the rail had its origin near the lower surface of the base and at the surface of the crescent-shaped fracture. This was a tension fracture, necessitating the prior formation of the crescent-shaped break to furnish opportunity for the locus of its nucleus.

FIG. 3—Cambria 1903 rail. Composite fracture 3 feet 10 inches from leaving end. Crescent shaped fragment detached from inner flange of base. Oblique fracture, originating in base, extending upward through web and head. Pin bent by touch after the accident. Sample for microstructure taken from base.

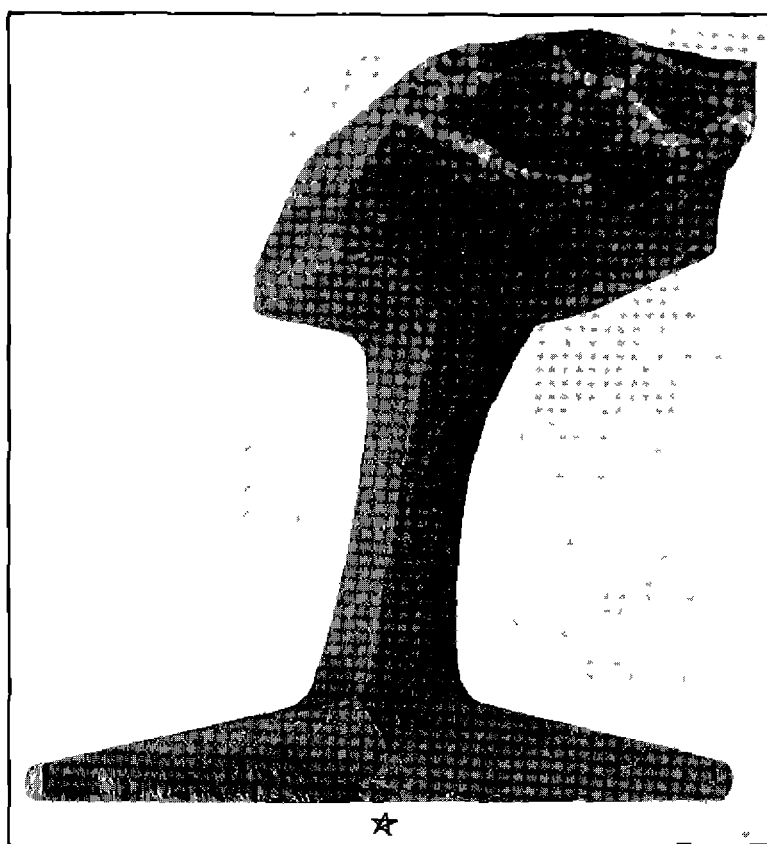
Figure No. 4 is an end view of the composite fracture, showing part of the surface of the crescent-shaped break and the surface of the oblique fracture. The nucleus of the latter is indicated by a star on the cut.

FIG. 4—Cambria 1903 rail. End view of fractured surface 3 feet 10 inches from leaving end. Showing part of crescent-shaped fracture and surface of oblique fracture originating at middle of width of base, thence extending outward and upward, completing the fracture of the rail.

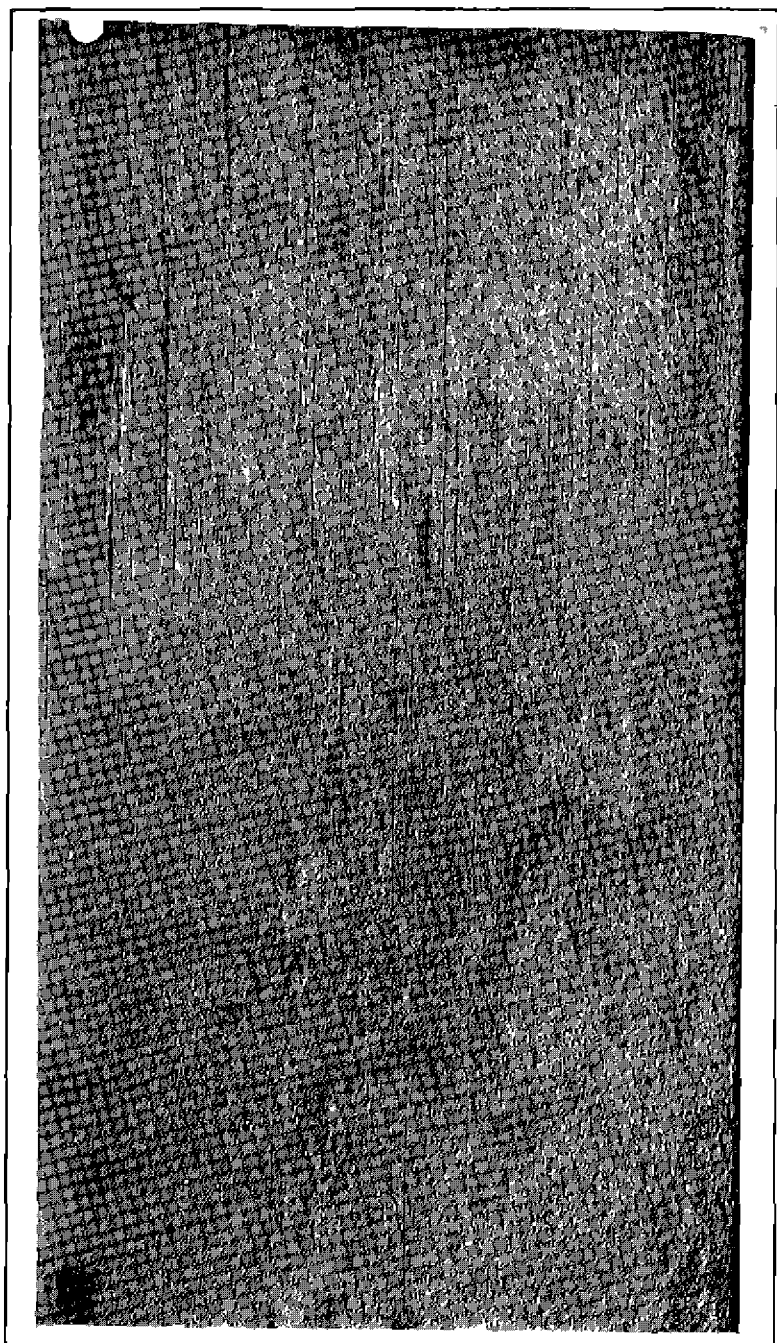
Figure No. 5 shows the base of the Cambria rail, near its leaving end, as it appeared after pickling in hot hydrochloric acid. Longitudinal surface seams were revealed by the pickling bath. They were of shallow depth and practically effaced by abrasive action where the rail rested on a tie plate. Surface seams in the base lead to the formation of crescent-shaped fragments, the origins of which are at the seams. Such fractures commonly extend along the seams for a distance before deflecting toward the edges of the flanges of the rails.

A semicircular notch will be noted in one corner of the base of the rail illustrated by Figure No. 5. This represents a drilled hole, one-quarter inch diameter, near the edge of the flange, apparently intended to receive a bond wire for signal purposes. It chanced that this section for pickling was sawed off midway this drilled hole.

A drilled hole near the edge of the flange is a menace to the integrity of the rail. A fractured rail came to notice, caused by the presence of a drilled hole in the edge of the flange, a counterpart of the hole here illustrated. It so chanced that the rail, one of 85 pounds section, fractured before the eye of an observer. The fracture appeared to happen under the last car and last truck of the train. Danger lurks in such rails.

FIG. 5.—Cambria 1903 rail. View of base near leaving end. Appearance of surface after pickling in hot hydrochloric acid. Surface so much recovered by pickling, nearly covered on part of base, which rested on the plate. Drilled hole $\frac{1}{4}$ inch diameter for a cable of 11 wires.
