INTERSTATE COMMERCE COMMISSION

REPORT OF THE CHIEF OF THE BUREAU OF SAFETY COVERING THE INVESTIGATION OF AN ACCIDENT WHICH OCCURRED ON THE PENNSYLVANIA RAILROAD NEAR EDINBURG, IND , ON SEPTEMBER 17, 1921

NOVEMBER 26, 1921

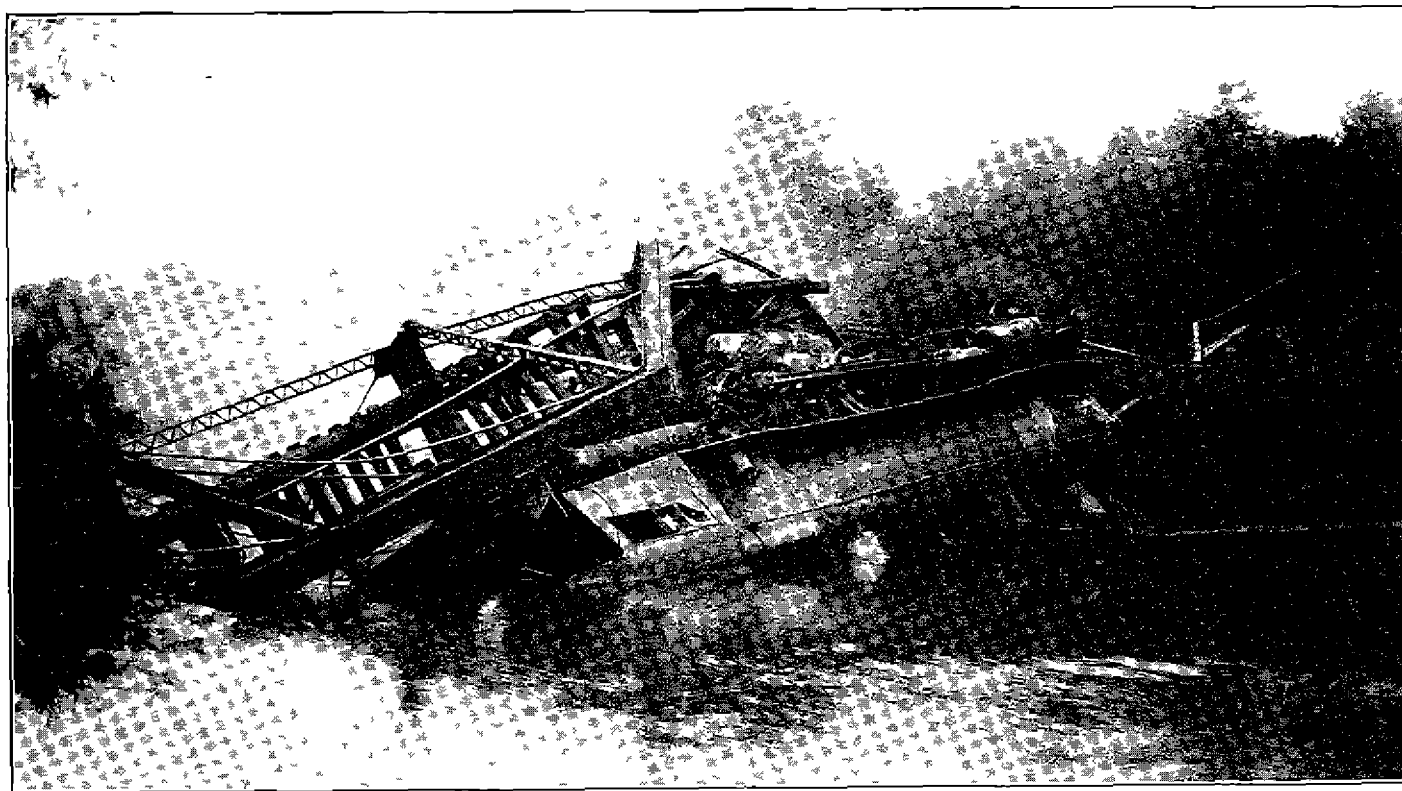
Engine 8579 was derailed to the right, turning almost bottom up as it dropped into the river, and came to rest with the center of the boiler on the riprap on the east or right side of the center pier, its right side being partly supported by the crumbled east end of the pier, the tender remained coupled to the engine and came to rest on its side, almost entirely submerged. The mail car was also on its right side, the head end being entirely submerged, while the combination car was leaning to the right, with the front end extending over the south abutment and the forward trucks hanging in place. The engine and mail car were considerably damaged. Both spans of the bridge were demolished. The employee killed was the engineman.

FIG 1—VIEW OF OVERTURNED ENGINE RESTING ON PARTIALLY DESTROYED CENTER PIER OF BRIDGE AND RIPRAP FOUNDATION SHOWING ALSO OVERTURNED TRUSSES OF BOTH SPANS FLOOR TIES NEARLY IN VERTICAL PLANE

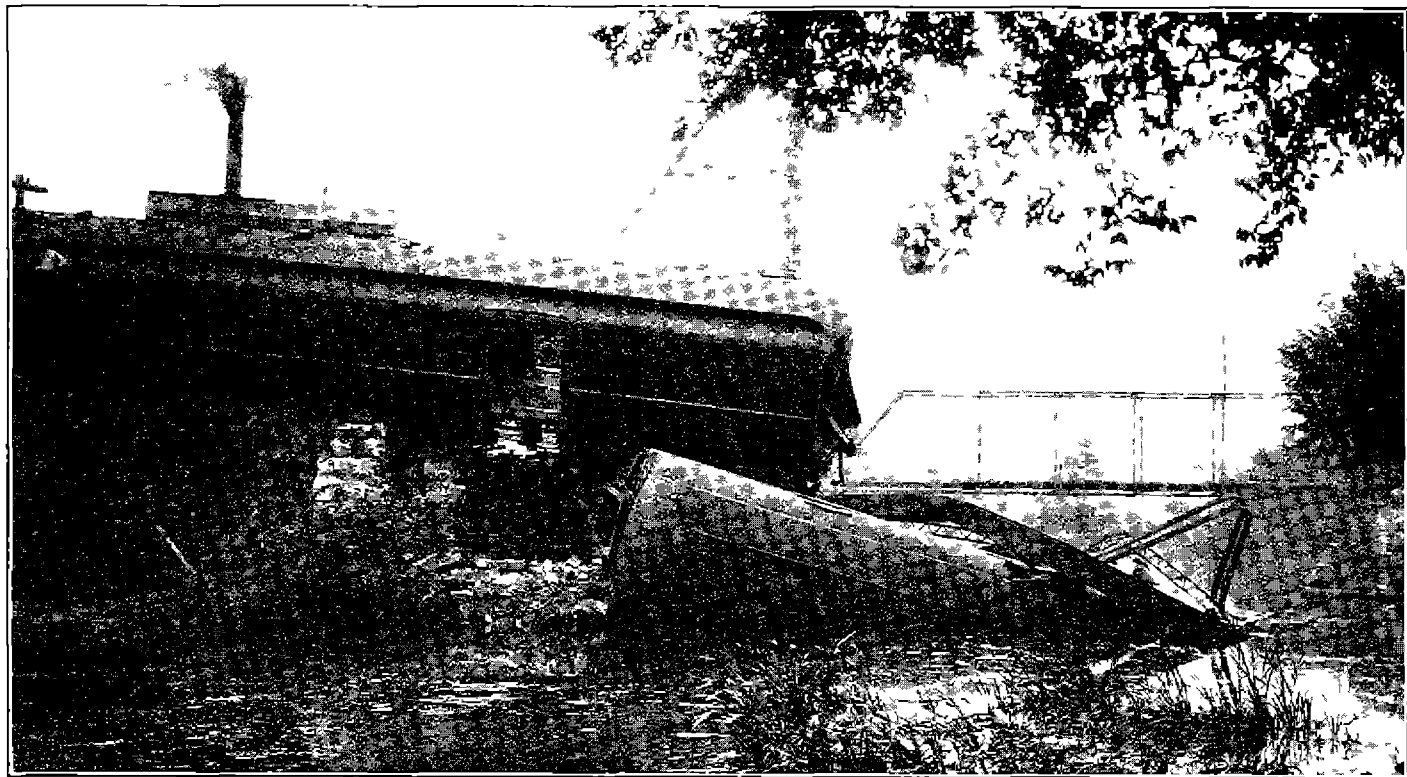
The single line of marks on the gauge side of the left rail constituted the only wheel marks on all of these ties, the east ends of the ties were bunched and badly scraped. When the combination car came to rest, the cellar containing the batteries was resting on the south abutment, and apparently this cellar had caused the damage to the ties. Of the bridge ties, the first and second ties beyond the head block tie could not be identified, while a short section from the center of the span was still in the river, with the exception of the head block tie, no wheel marks were found on any of the bridge ties which would indicate that any part of the train was off the track while on the bridge, prior to the collapse of the bridge.

FIG 2—VIEW OF PARTIALLY SUBMERGED MAIL CAR WITH COMBINATION CAR OVERHANGING THE SOUTH ABUTMENT OF THE BRIDGE

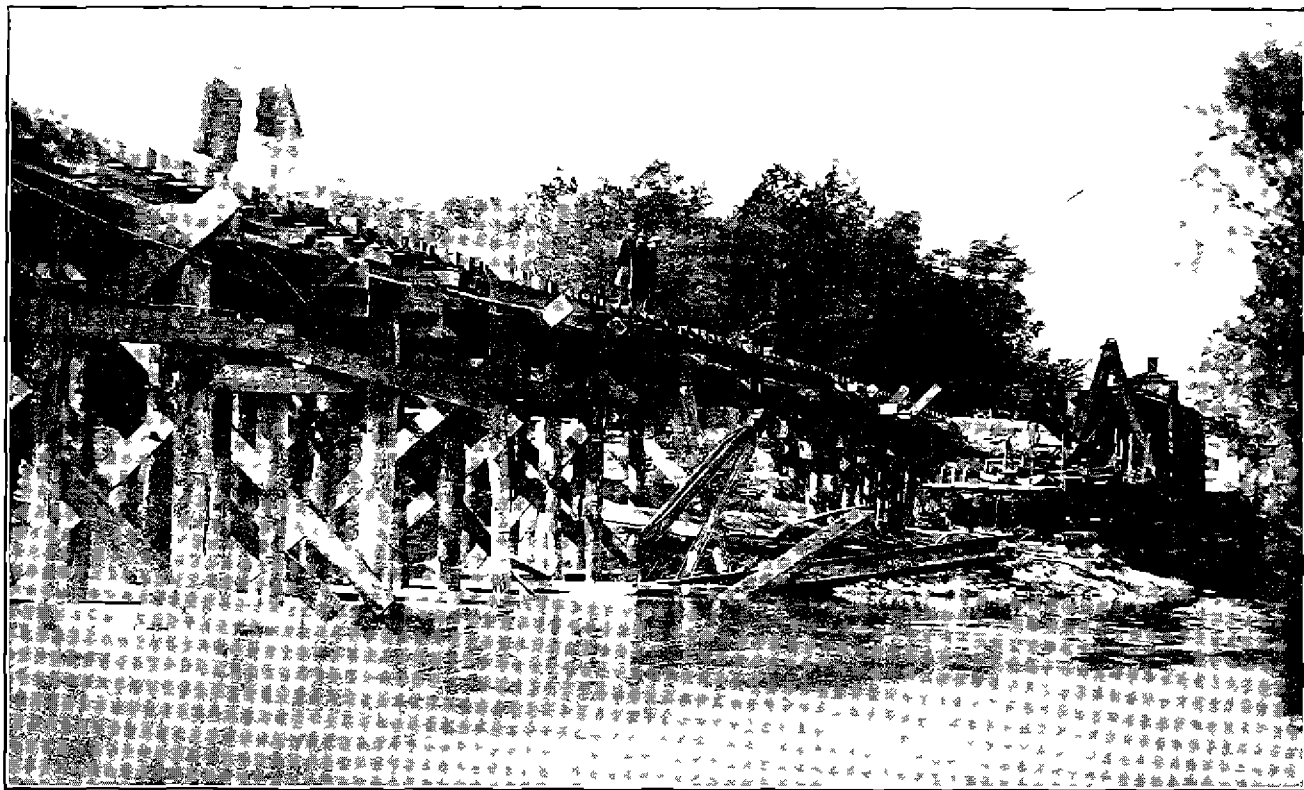
The most plausible explanation of the accident places the responsibility upon the condition of the upstream end of the center pier. Its failure would account for the series of events which followed. The condition of the masonry of the abutments and the standing portion of the center pier lead to the conclusion that the cause of the accident was the structural weakness and failure of the upstream end of the center pier.

In conclusion, it is therefore believed that this accident was due to the failure of the upstream end of the center pier, the masonry of which had been weakened by the partial disintegration of the limestone ashlar masonry, successive high stages of water also having washed away some of the mortar from the interior of the pier, and in this weakened state failure occurred.

FIG 3—VIEW CENTER OF CUT OF PARTIALLY DESTROYED CENTER PIER UPSTREAM END OF PIER DESTROYED DOWNSTREAM END USED WITH TEMPORARY PILE BENTS FOR CARRYING TRAFFIC FAILURE OF THE UPSTREAM END OF THIS PIER REGARDED AS THE PRIMARY CAUSE OF THE ACCIDENT

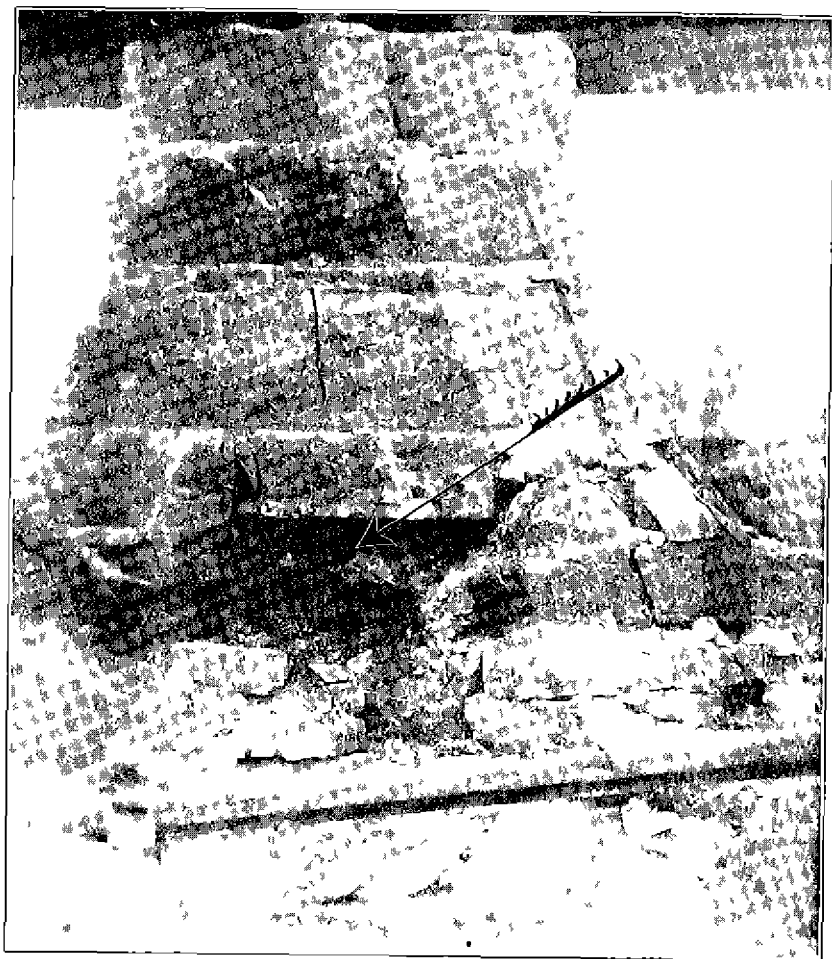
In addition to the structural state of the ashler masonry occasioned by its exfoliation the upstream end of the pier showed other unsoundness. An interior pocket filled with mud was exposed to view, located above the mean level of the water of the creek but below that of high water. Within this pocket of mud there were angular stones. Apparently mortar originally used in the interior of the pier had been washed away and replaced by alluvial silt, brought down during high stages of water. Beyond this pocket solid masonry seemed to exist.

FIG 4—VIEW OF BROKEN FACE OF CENTER PIER. ARROW POINTS TO LOCATION OF MUD POCKET IN THE INTERIOR OF THE MASONRY

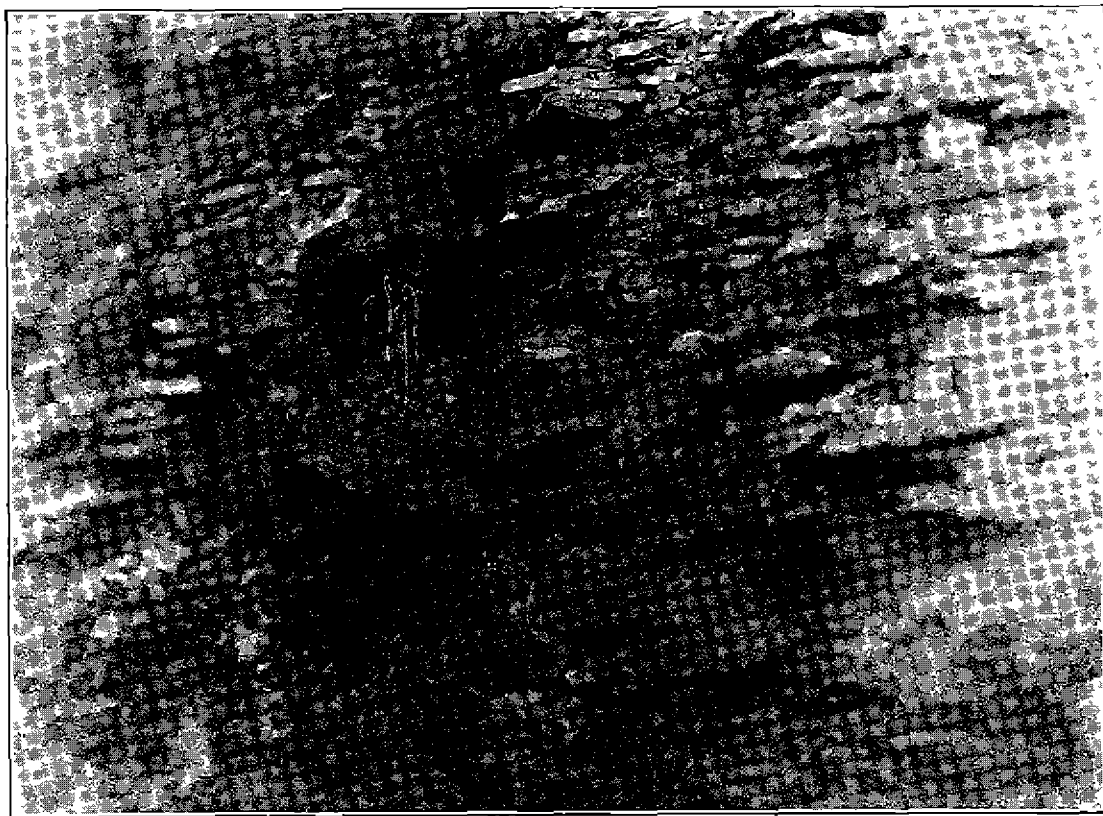
This pier and the abutments of the bridge were built in the year 1854 of native limestone. During the long intervening period of time certain of the ashler face stones, in both the abutments and pier were broken into small fragments by exfoliation. Stones thus partially broken are deficient in strength, attended with a loss in bonding power between courses. In advanced stages of exfoliation the stones practically lose all supporting power and value for engineering purposes. Deficiency in strength due to this cause is believed to have prevailed in the center pier when train No. 327 entered upon the bridge.

FIG 5—VIEW OF FACE OF SOUTH ABUTMENT SHOWING DISINTEGRATION OF LIMESTONE ASHLER MASONRY

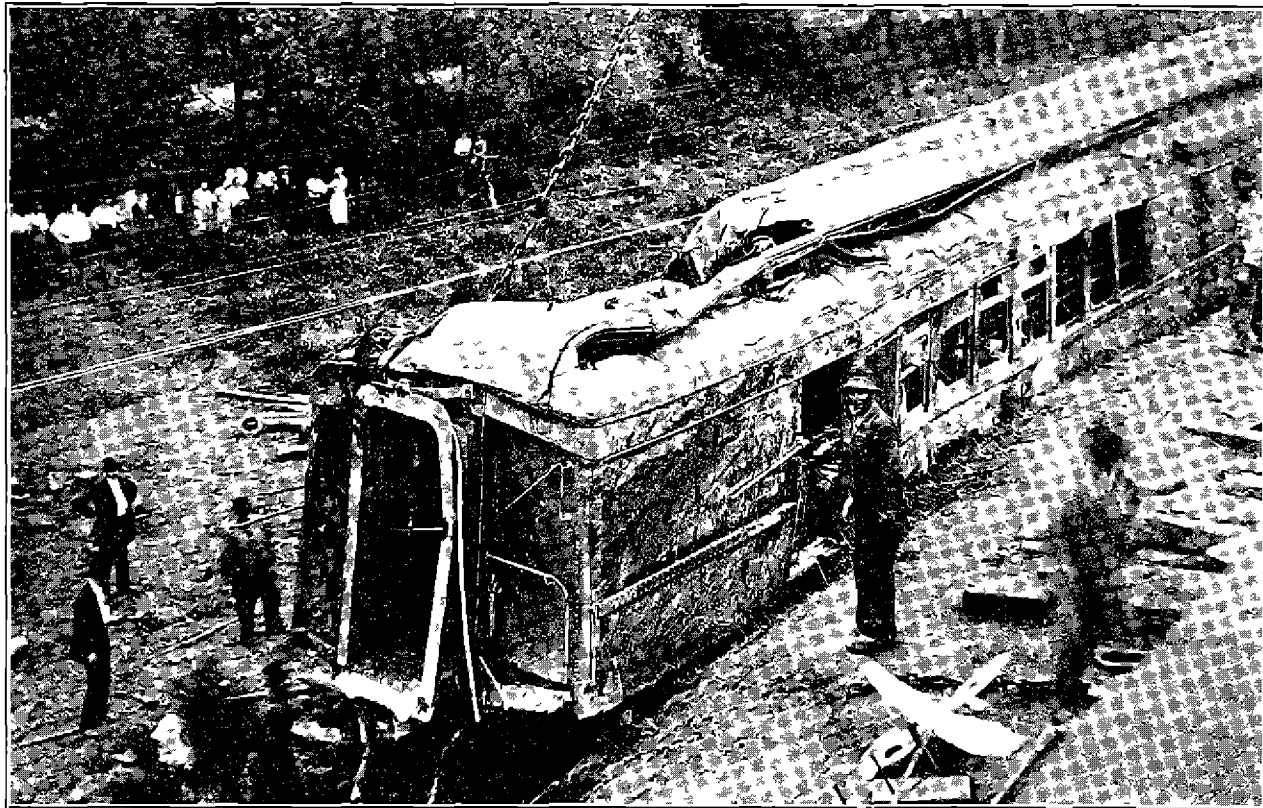
FIG 8—VIEW OF TOP OF MAIL CAR AFTER REMOVAL FROM BED OF CREEK

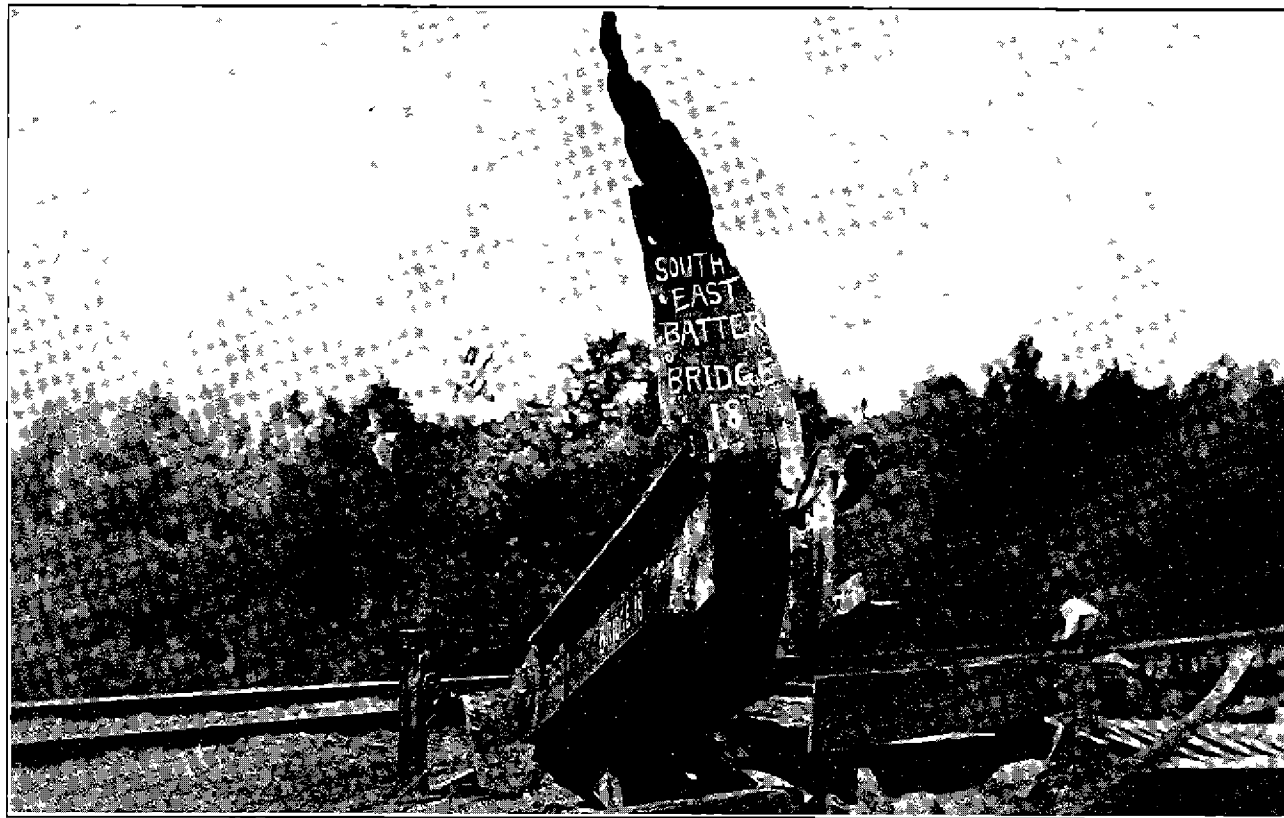
The fractured batter post, at the southeast corner of the bridge, seemed in the minds of the railroad officials to unravel the question concerning the manner in which the bridge fell, and was accepted by some as the primary cause of the accident. It had been struck by the mail car without doubt and destroyed by the blow. In the sequence of events which attended the accident the thought does not seem tenable, however, that the forward car of the train could have been diverted several feet from the center line of the track with the engine and tender still on the rails. There was no evidence that the train separated and emergency brakes automatically applied in consequence of the separation, nor was there any obstruction found which would divert this car to such an extent.

FIG 9—FRACTURED BATTER POST SOUTHEAST POST OF SOUTH SPAN RUPTURE OF THIS POST HELD TO BE A SECONDARY FRACTURE INCIDENT TO LOCOMOTIVE PULLING MAIL CAR EASTWARD AGAINST UPSTREAM TRUSS OF SOUTH SPAN
