INTERSTATE COMMERCE COMMISSION

REPORT OF THE CHIEF OF THE BUREAU OF SAFETY IN RE INVESTIGATION OF AN ACCIDENT WHICH OCCURRED ON THE PENNSYLVANIA RAILROAD NEAR GOULD, OHIO, ON SEPTEMBER 25, 1921

OCTOBER 19, 1921

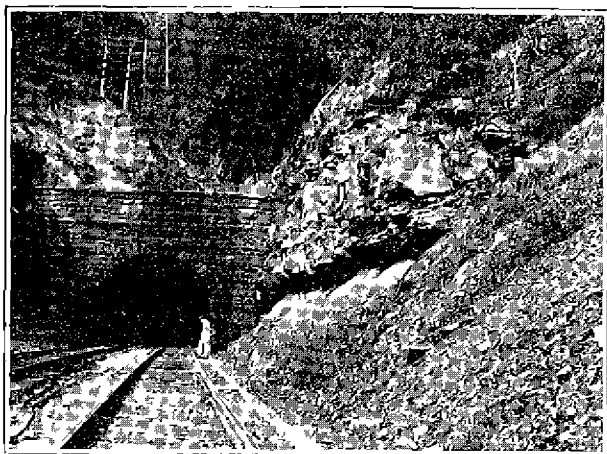
FIG. 1—Eastern entrance to No. 5 or Gould Tunnel

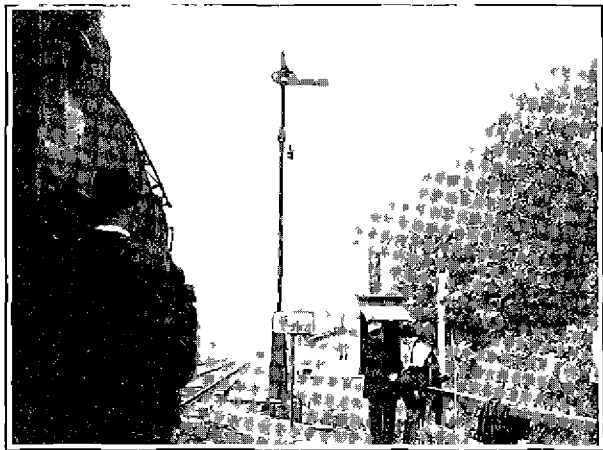
FIG. 2—Semiautomatic signal 13 governing block section extending, through the tunnel, to signal 13 at NA Cabin

This accident was caused by signal 13 displaying a caution instead of a stop indication when the block which it governed was occupied.

This signal failure was the result of defective wiring. Tests conducted by the railroad company subsequent to the accident disclosed grounds on the wiring in five different locations. If these grounds existed for any considerable period of time prior to the accident, they should have been discovered by careful inspection and tests, and corrected.
