## INTERSTATE COMMERCE COMMISSION

### REPORT OF THE DIRECTOR OF THE BUREAU OF SAFETY IN RE INVESTIGATION OF AN ACCIDENT WHICH OCCURRED ON THE PENNSYLVANIA RAILROAD NEAR GRAY, PA, ON JUNE 16, 1926

JUNE 26, 1926

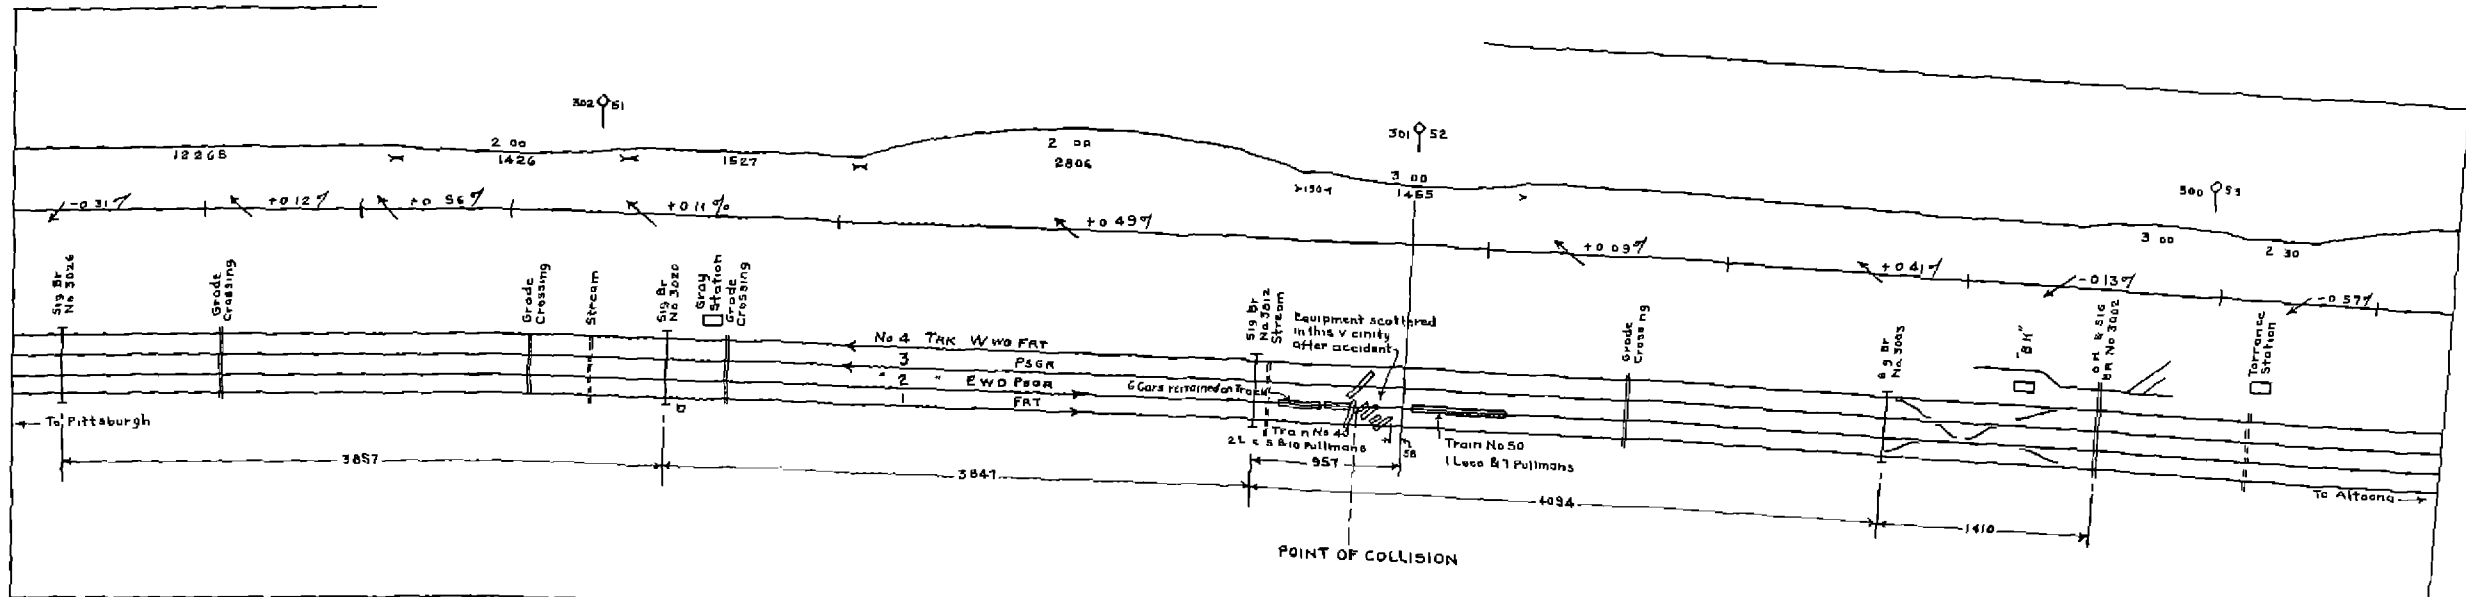
ALIGNMENT PROFILE AND SIGNALS IN VICINITY POINT OF ACCIDENT  
 Scale 1 = 500

964 feet. From the fireman's side, signal 3020 could first be seen at a distance of 2,002 feet, it passes out of view at a distance of 1,512 feet and again comes into view at a distance of 1,152 feet. Signal 3012 can be seen from the fireman's side for a distance of 401 feet. Under the rules, a train finding a fusee on or near its track must stop and extinguish the fusee, and then proceed with caution prepared to stop short of a train or obstruction. The explosion of torpedoes is a signal to reduce speed and look out for a train ahead or an obstruction.

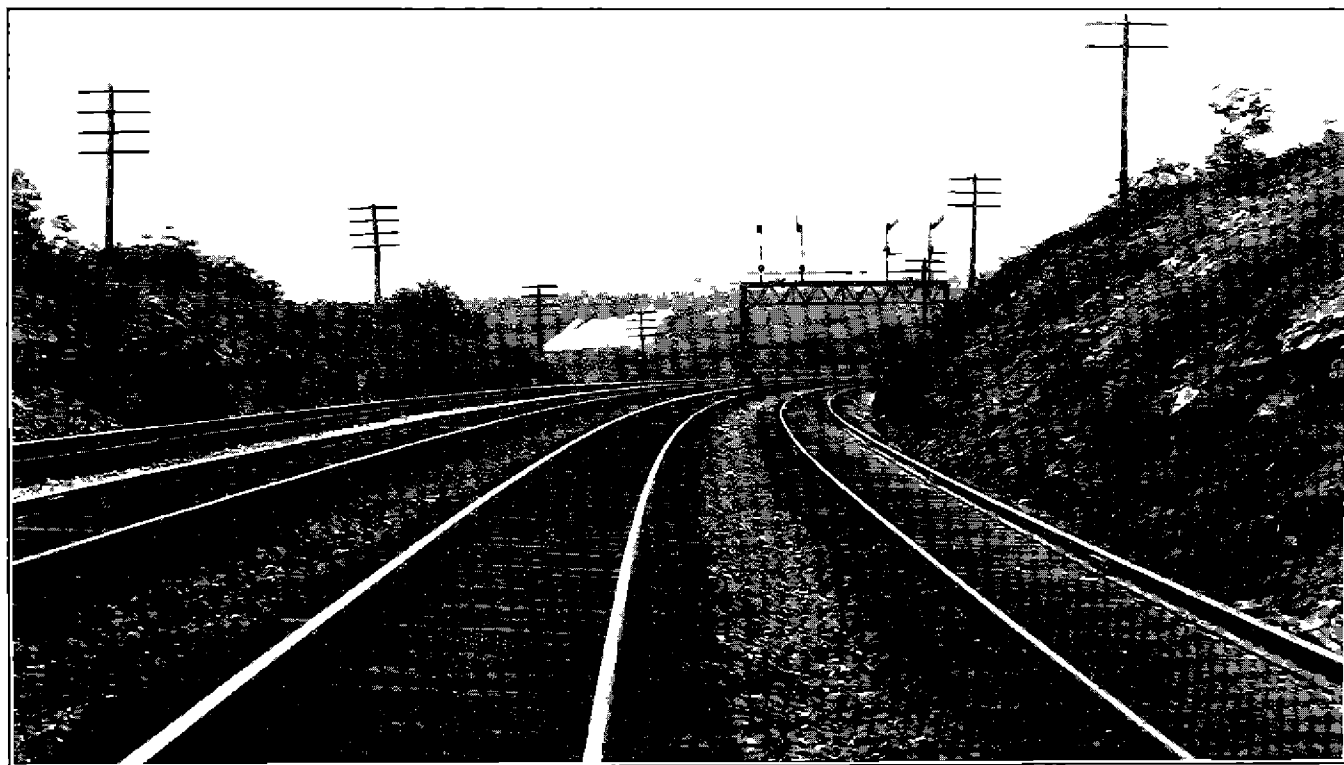
FIG. 1.—View of signal bridge 2012, taken on track 2 from point 16 rail lengths west of signal bridge

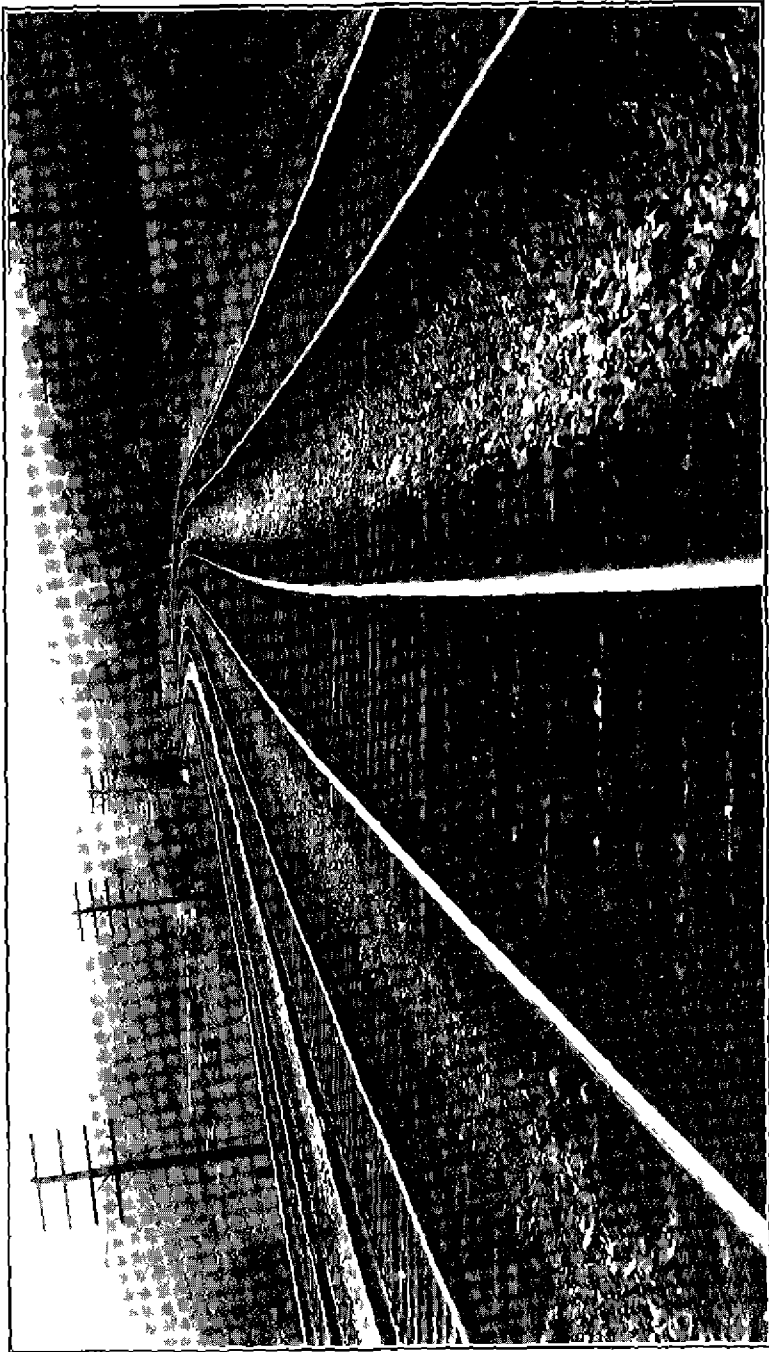
FIG. 2.—View approaching curve to left on which accident occurred taken on track 2 from point under signal bridge 3012

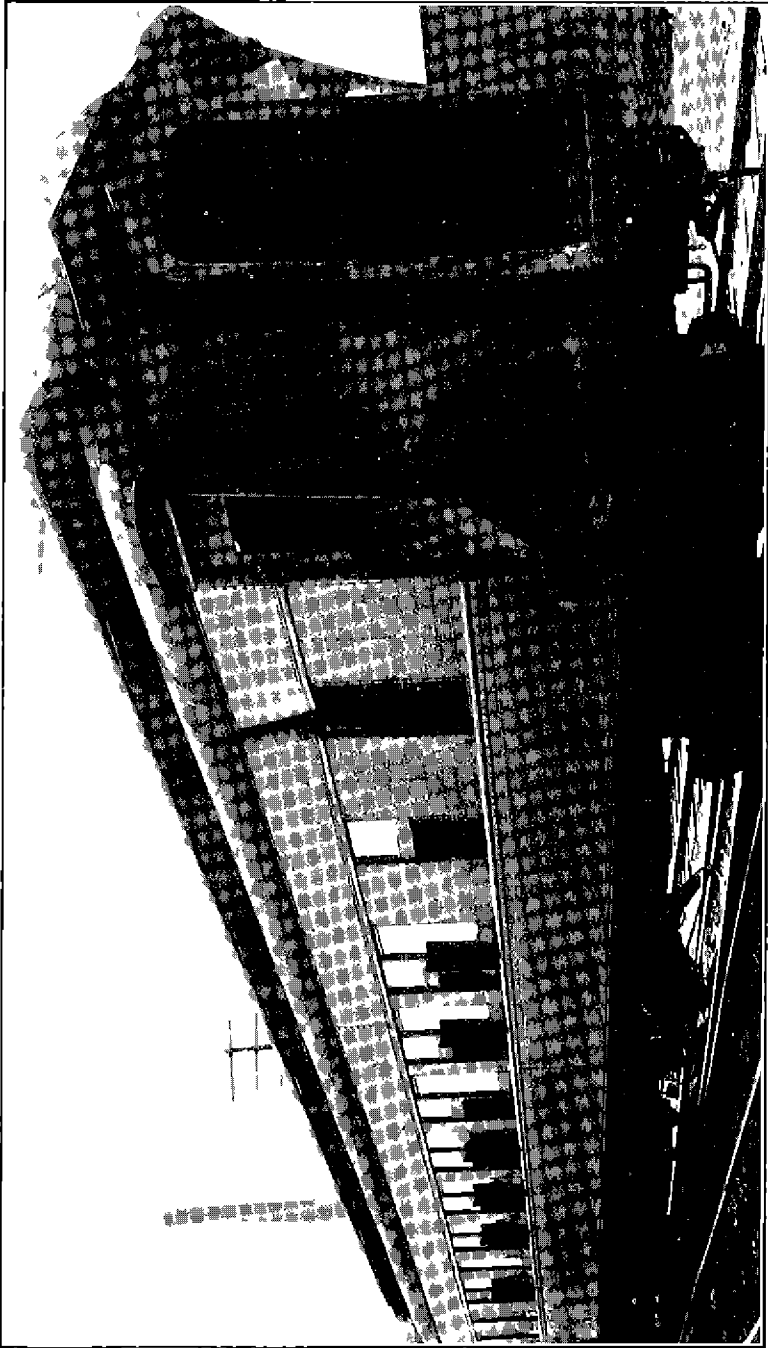
FIG 4.—Sleeping car Fieldsboro, next to rear car of train No 50 which telescoped the Rutland

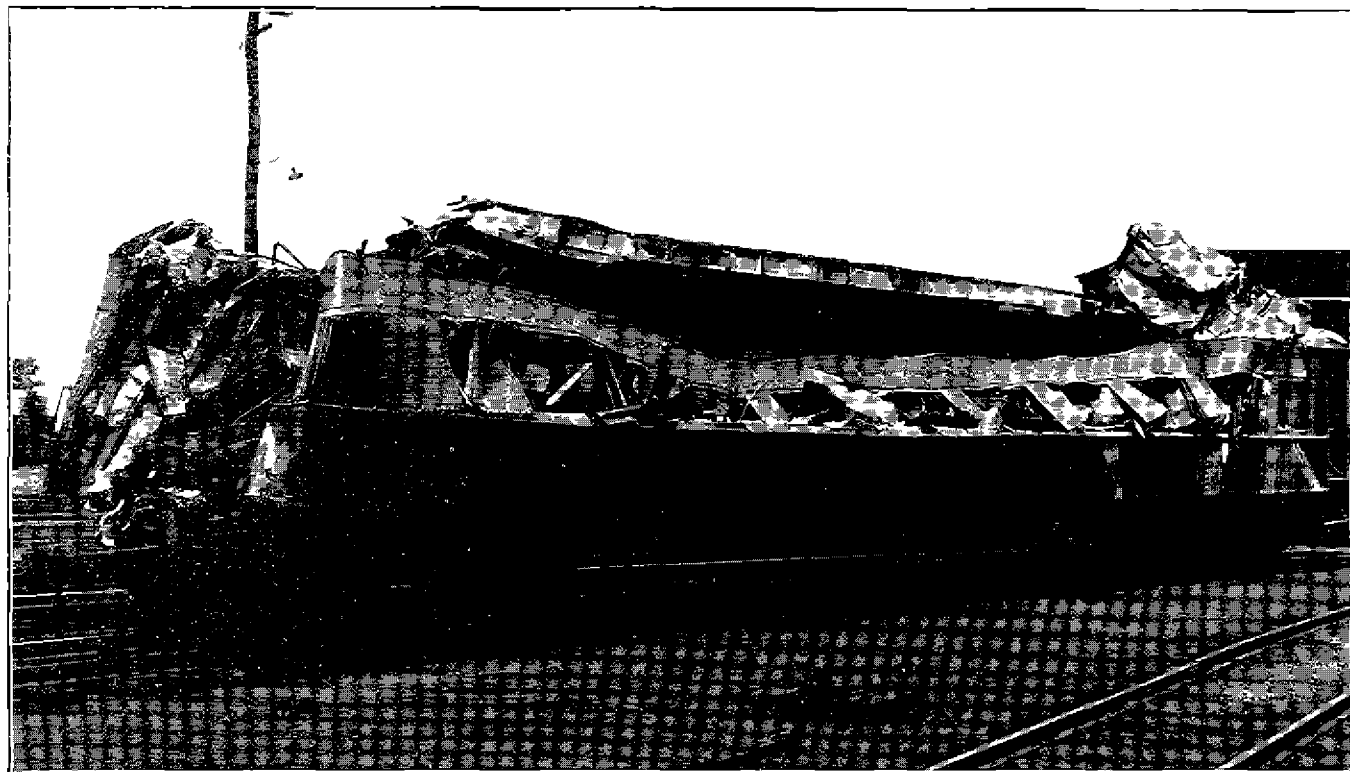
FIG. 5—Sleeping car crushed fifth car in train No. 70, telescoped nearly its entire length by the Fieldstone
