## INTERSTATE COMMERCE COMMISSION

### REPORT OF THE DIRECTOR OF THE BUREAU OF SAFETY IN RE INVESTIGATION OF AN ACCIDENT WHICH OCCURRED ON THE PENNSYLVANIA RAILROAD AT MANHATTAN TRANSFER, N J, FEBRUARY 24, 1925

MARCH 19, 1925

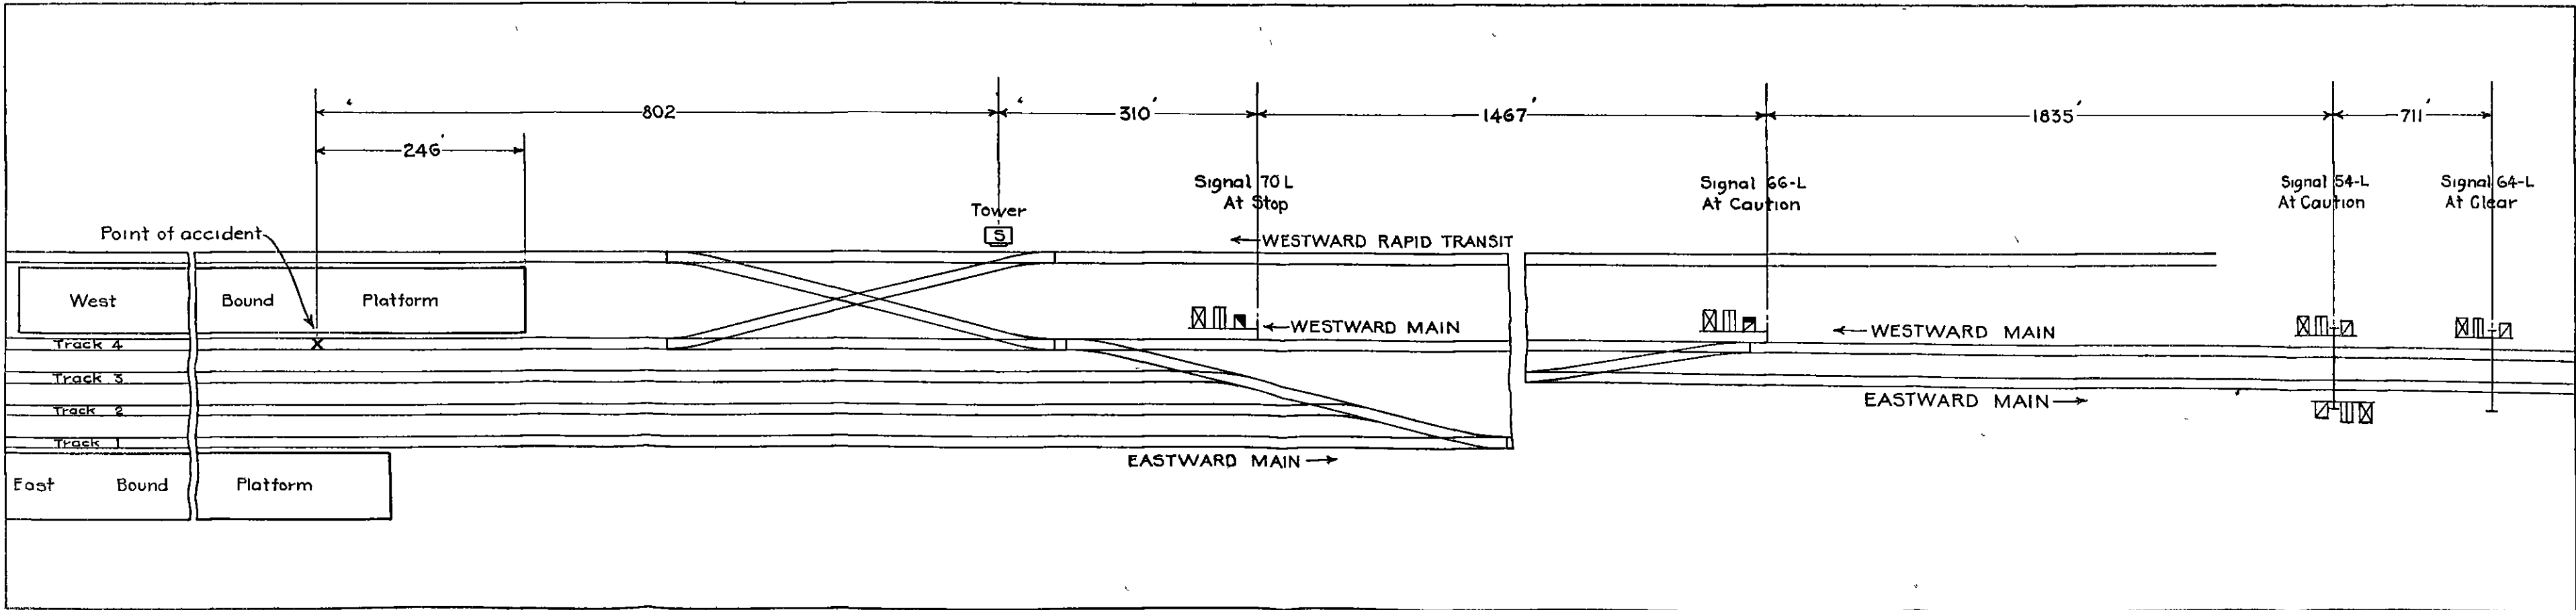
Approaching tower S there are four home interlocking signals governing westbound trains, namely, signal 64-L, 4,323 feet east of tower S, signal 54-L, 711 feet west of signal 64-L, signal 66-L, 1,835 feet west of signal 54-L, and signal 70-L, 1,467 feet west of signal 66-L. Signal 70-L is 310 feet east of tower S.

Diagram showing relative location of tracks and signals in vicinity of point of accident

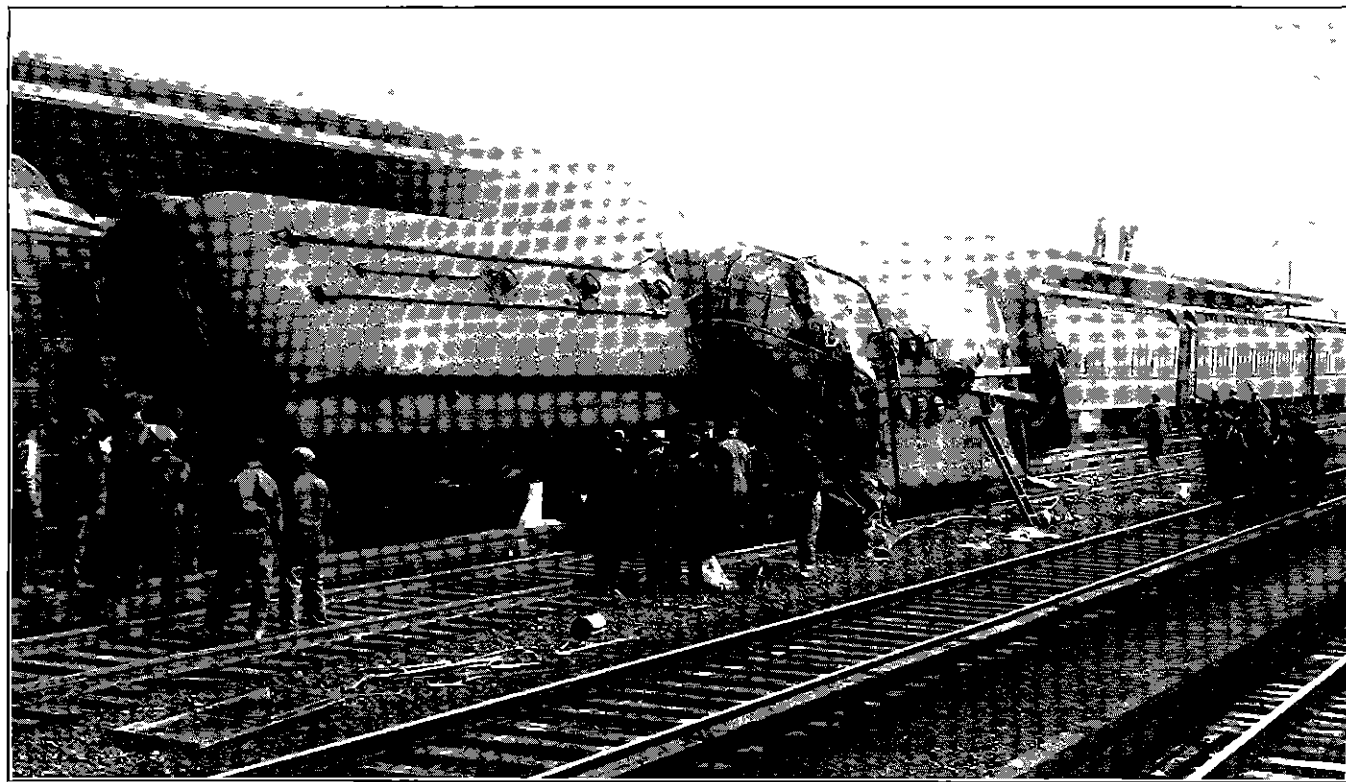
The force of impact moved train No 185 ahead a distance of approximately one-half car length. Electric locomotive 12 struck the dining car on the kitchen end, overrode the steel center sill, and plowed its way approximately to the middle of the car, and then turned over on its left side. The steel sides and roof of the dining car were sheared off and forced upward and outward, slightly damaging the station platform roof. The leading unit of the electric locomotive was torn loose from its truck and came to rest on its left side, fouling track 3, the adjoining track toward the south. The rear unit of the locomotive was partially overturned and was derailed, it was broken loose from the leading unit but remained

coupled to the train. The dining car was practically destroyed and the electric locomotive was badly damaged, other cars in the two trains sustained relatively slight damage, principally to brake rigging and draft gear. The employees killed were two car inspectors, who were making the coupling between the steam locomotive and cars of train No. 185, and a chef in the rear dining car of train No. 185.

FIG NO 1—GENERAL VIEW OF ACCIDENT TAKEN SHORTLY AFTER ITS OCCURRENCE

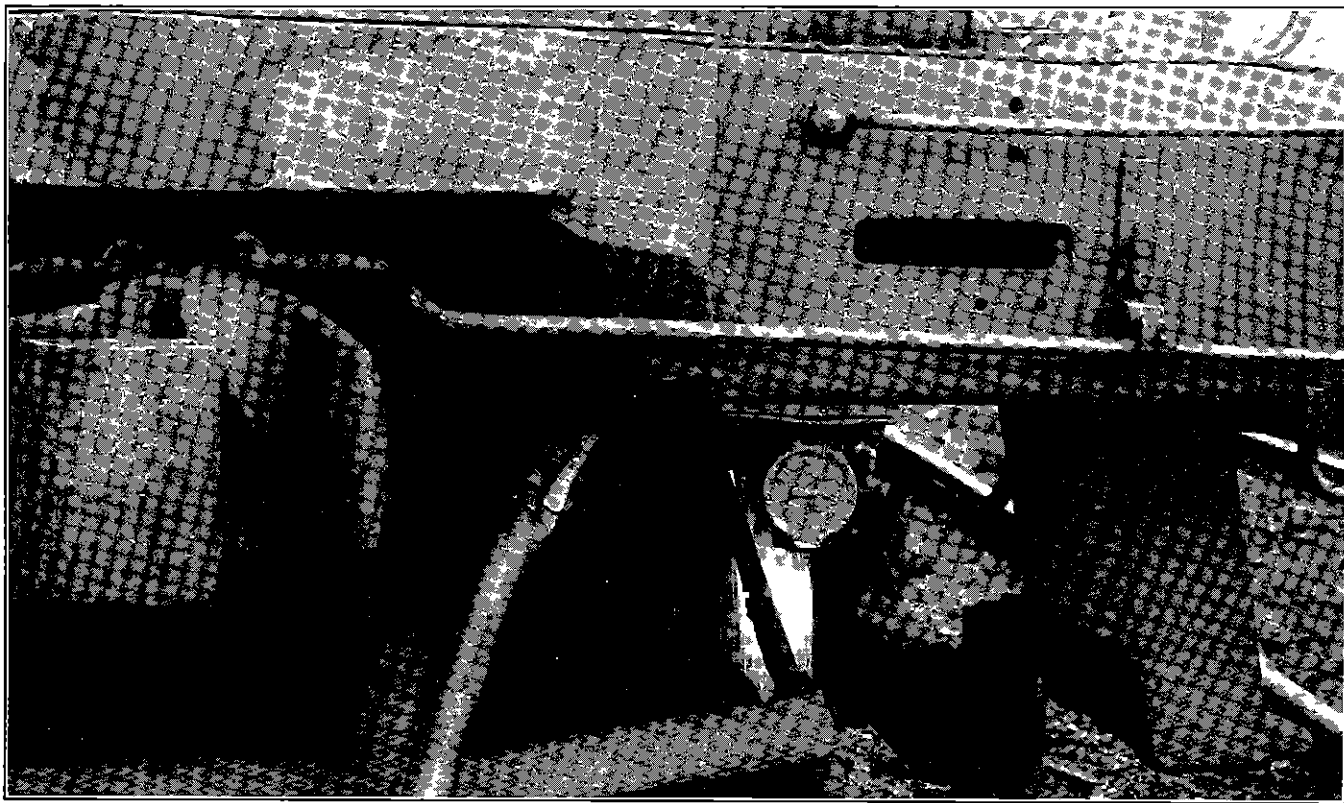
Road Foreman of Engines Garabrant stated that he arrived at the scene of the accident, accompanied by Assistant Road Foreman of Engines Mayo, at about 10 10 a. m., and that he and Mr. Mayo discovered that the brake-pipe angle cock on the rear end of electric locomotive 12 was nearly closed. This angle cock is of the self-locking type, and the cock was not closed sufficiently to allow the handle to drop into locked position. Careful examination of the angle cock failed to disclose any mark or scar upon it, and the paint

FIG NO 2—VIEW OF REAR OF ELECTRIC MOTOR SHOWING PROTECTED POSITION OF ANGLE COCK HANDLE

in the handle was not marked in any way, as would probably have been the case if the handle had been struck and moved to the position in which it was found at the time the accident occurred. The position in which the angle cock handle was found was marked, the angle cock was then carefully removed, to avoid moving the handle, and subjected to various tests.

Shortly after the accident and before the position of the angle cock handle was changed the angle cock was attached to the brake pipe on another engine carrying 110 pounds brake-pipe pressure, and it was found that the valve was so nearly closed that only a very small amount of air would flow through it. On following days this angle cock was installed on another motor, and a number of trips were made with the angle cock nearly wide open, but not locked, to determine whether the vibration and jar of a train running at various rates of speed would cause any movement of the angle cock toward the closed position. The handle did not change its position in any of these tests. In another test, with a train consisting of an electric motor and the cars used in train No. 219 on the day of the accident, this angle cock installed on the rear of the motor was placed in the position in which it was found after the collision, with the brake pipe fully charged, the brake valve was placed in emergency position. The result was a heavy application of the brakes on the motor, but the brakes on the train did not apply for a period of one and three-fourths minutes, at which time the brake on the first car applied lightly, and after an additional period of two minutes the brakes on the third car applied lightly. The brakes on the other cars did not apply during the next eight minutes, at which time the test was concluded. Following this test an attempt was made to release the train brakes with the condition of equipment unchanged. The brake valve on the motor was placed in full release position for a period of about five seconds and then placed in running position. The brakes on the motor released properly, but the brakes on the train did not release in a period of 10 minutes, when the test was concluded. The results of these tests indicate that with the angle cock in the position in which it was found immediately after the accident it would have been impossible to charge the train-brake system or to make a terminal test, as was done in the New York station before train No. 219 left that terminal.

During these tests the angle cock which at the time of the accident was on the rear end of motor 12 was operated by several observers to determine whether it moved freely, it was found that while it was not difficult to operate, yet an appreciable amount of effort or strength was required to move it. These observations tend to discredit any theory that the position of the angle cock was accidentally changed while the train was en route from New York to Manhattan Transfer.

This accident was caused by the loss of control by the motorman of the power train-brake system by reason of the angle cock in the brake pipe on the rear of the motor being partially closed.

The running test of the brakes which is required to be made on a train leaving a terminal is made for the purpose of giving the engineer positive information whether the train-brake system is operating properly. The investigation indicated that in this case the running test which was made by Motorman Keilt was not made in such manner as to furnish reliable information concerning the condition of the train-brake equipment. The time consumed in this test was too short and the reduction in speed was too slight to enable the motorman to know definitely whether the train brakes applied, and Motorman Keilt admitted that he did not pay any particular attention to the length of the brake-pipe exhaust when the reductions were made for this running test. As one measure to prevent recurrence of accidents of this character steps should be taken to require running tests of the train brakes which will positively reveal whether or not the train-brake system is in proper operating condition.
