## INTERSTATE COMMERCE COMMISSION

### REPORT OF THE CHIEF OF THE BUREAU OF SAFETY IN RE INVESTIGATION OF AN ACCIDENT WHICH OCCURRED ON THE PENNSYLVANIA RAILROAD NEAR MANHATTAN TRANSFER, N J, ON OCTOBER 28, 1921

NOVEMBER 21, 1921

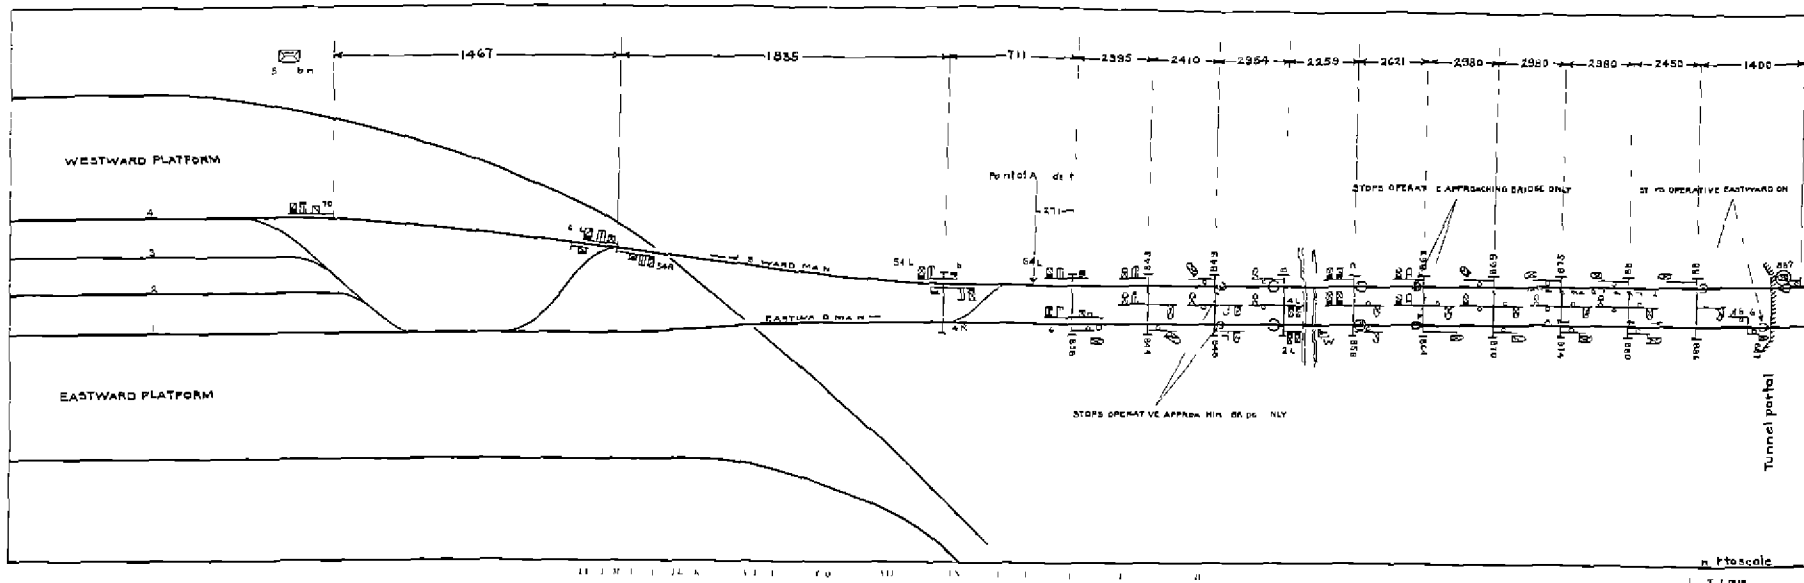
In the vicinity of the point of accident this railroad is a double-track line, over which trains are operated by time-table, train orders, and an automatic block-signal system, both tracks being signaled for movements in both directions. The automatic signals are of the three-position, upper-quadrant semaphore type, the night indications being red, yellow, and green, for stop, caution, and proceed, respectively. Light signals are used in the tunnel. An automatic train-control system of the ground mechanical-trip type is installed in part of this territory. All electric motors operated over this line are equipped with automatic train-control trip-arms and valves, and track trips are installed in connection with signals in the tunnel at the western portal of the tunnel and at the approaches to the draw-bridge over Hackensack River, approximately  $2\frac{1}{2}$  miles east of Manhattan Transfer. The accompanying diagram shows the block-signal

and train-control installations between the western portal of the tunnel and the point of accident

This accident occurred on the westbound main track. Westbound automatic signal 849 is located 5,076 feet east of the point of accident. Automatic signal 843 is located 2,410 feet west of signal 849, this is a two-arm signal, the upper arm having three positions while the bottom arm is fixed. Interlocking signal 64-L is located 2,395 feet west of signal 843 and 271 feet east of the point of accident. Signal 64-L is operated from S interlocking station, located a short distance east of Manhattan Transfer. Interlocking signal 54-L is located 711 feet west of signal 64-L. The accident occurred at about 12 30 a. m. at which time a heavy fog prevailed, which rendered the observation of signal indications difficult.

H. E. Stump, supervisor of telegraph and signals, said that with a train between signals 54-L and 64-L, as was the case with train No. 701 in this instance, signals 64-L and 843 would display stop indications, while signal 849 would display a caution indication. Mr. Stump said these indications were observed within less than an hour after the accident, and that men were stationed at each signal location for 48 hours afterwards for the purpose of observing the operation of the signals, the signals operated properly throughout this period.

As previously noted all motors operated in this territory are equipped with the automatic train-stop apparatus, and the extension of the system can be made by installing additional track devices. To prevent the recurrence of accidents of this character, it is recom-

mended that the installation of the automatic train-stop system be extended to cover the entire line between New York City and Manhattan Transfer.
