INTERSTATE COMMERCE COMMISSION

REPORT OF THE DIRECTOR OF THE BUREAU OF SAFETY IN RE INVESTIGATION OF AN ACCIDENT WHICH OCCURRED ON THE PENNSYLVANIA RAILROAD NEAR MARTINSVILLE, ILL., ON MAY 14, 1925

SEPTEMBER 15, 1925

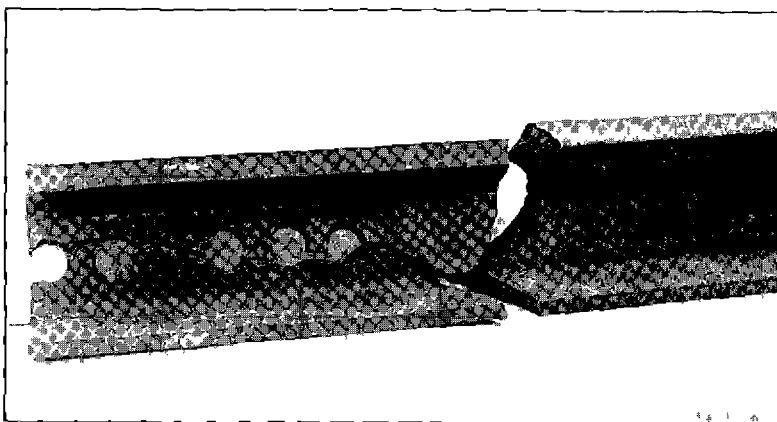
The angle bars were 24 inches long, therefore covering 12 inches in length of the rail. Of this length the five $1\frac{1}{16}$ -inch holes reduced the area of the web along its middle element $49\frac{1}{2}$ per cent. In this weakened condition the rail was put into service, where it remained for a period of 11 months and then failed, precipitating this derailment.

Some time during the period the rail was in service partial rupture of the web took place, separating the section between the first and second bolt holes, counting from the end of the rail. A fracture was also started in the web below the first bolt hole near its junction with the base.

The line of rupture in the final fracture of the rail passed through the remaining sections between bolt holes. From the fifth bolt hole the line of rupture extended obliquely downward to the upper surface of the base. It bifurcated when the base was reached, one branch separated the base, the other branch took an upward course and separated the metal of the web and the head, thus completely rupturing the rail. Longitudinally the greater part of the length of the line of rupture was covered by the angle bars.

FIG NO 1—VIEW SHOWING THE END OF THE LEAD RAIL WEAKENED BY FIVE DRILLED BOLT HOLES. FRACTURE OF THE WEB ACROSS THE LINE OF BOLT HOLES THENCE TO THE BASE AND HEAD CAUSED THE DERAILMENT

the fracture had its origin at the edge of the flange of the base, extending thence across the base, thence upward through the web and head, and then backward through the weakened web, is not even a probability. Such an interpretation of the manner of failure completely overlooks and obscures the real issue.

This rail was weakened in the web by a multiplicity of bolt holes, and the injury which was done was hidden by bolting angle bars over the weakened portion. This weakening of the rail prepared the way for its ultimate failure. Such practice as disclosed by this derailment can find no justification.

This derailment was caused by a broken rail, the lead rail of a switch. The rail had been weakened in the web by the drilling of five bolt holes. The weakness thus caused was responsible for the derailment of the train.

At some period prior to the derailment there occurred a partial rupture of the web in two places—at a section between two bolt holes and at the end of the web just above the base.
