INTERSTATE COMMERCE COMMISSION

REPORT OF THE DIRECTOR OF THE BUREAU OF SAFETY IN RE INVESTIGATION OF AN ACCIDENT WHICH OCCURRED ON THE PENNSYLVANIA RAILROAD NEAR MONMOUTH JUNCTION, N J, ON NOVEMBER 12, 1925

DECEMBER 4, 1925

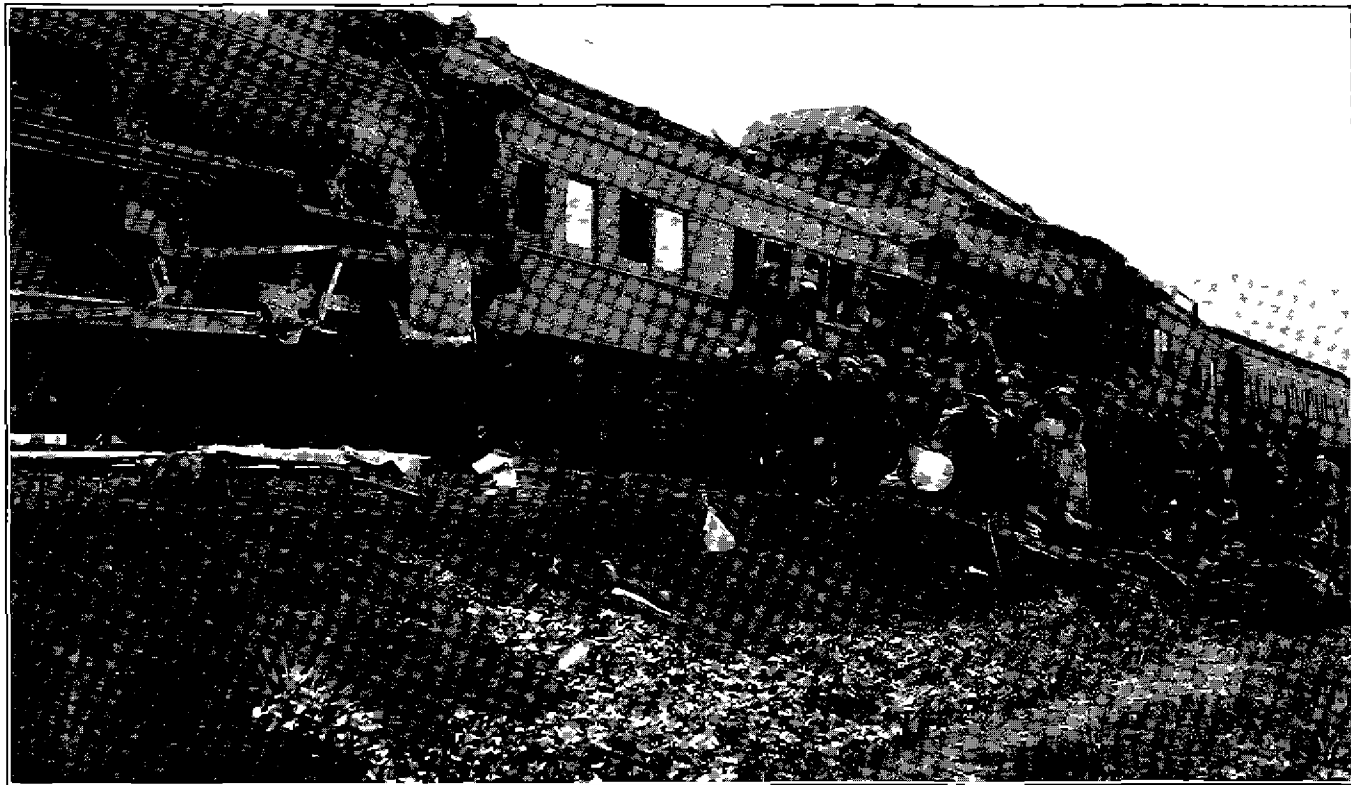
FIG NO 1 —GENERAL VIEW OF ACCIDENT FROM SOUTH SIDE OF TRACK

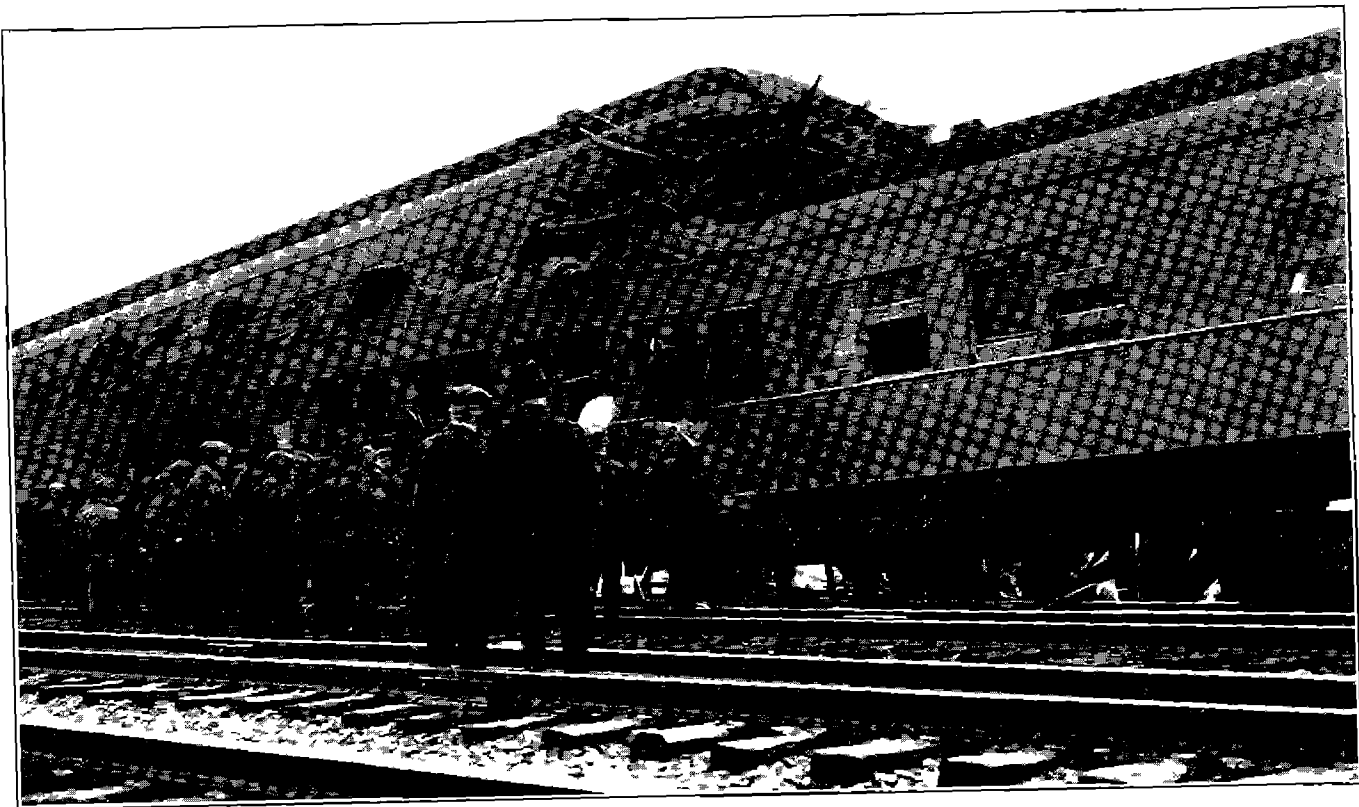
The underframe of the sleeping car on the rear end of train No. 166 was forced under the underframe of the car immediately ahead of it, resulting in the rear car being telescoped at its forward end for a distance of about two-thirds of its length, this car was practically demolished while the car which telescoped it was damaged to some extent. Minor damage was sustained by several of the other cars in this train and also by the engine which was hauling it. Engine 3884 of train No. 6 was not derailed nor was it badly damaged, the only part of this train to be derailed was the forward truck of the first car. The first two cars in this train were damaged to some extent and minor damage was sustained by a few of the other cars. All of the persons killed were riding in the rear car of train No. 166.

FIG NO 2—VIEW OF TELESCOPED CARS FROM NORTH SIDE OF TRACK

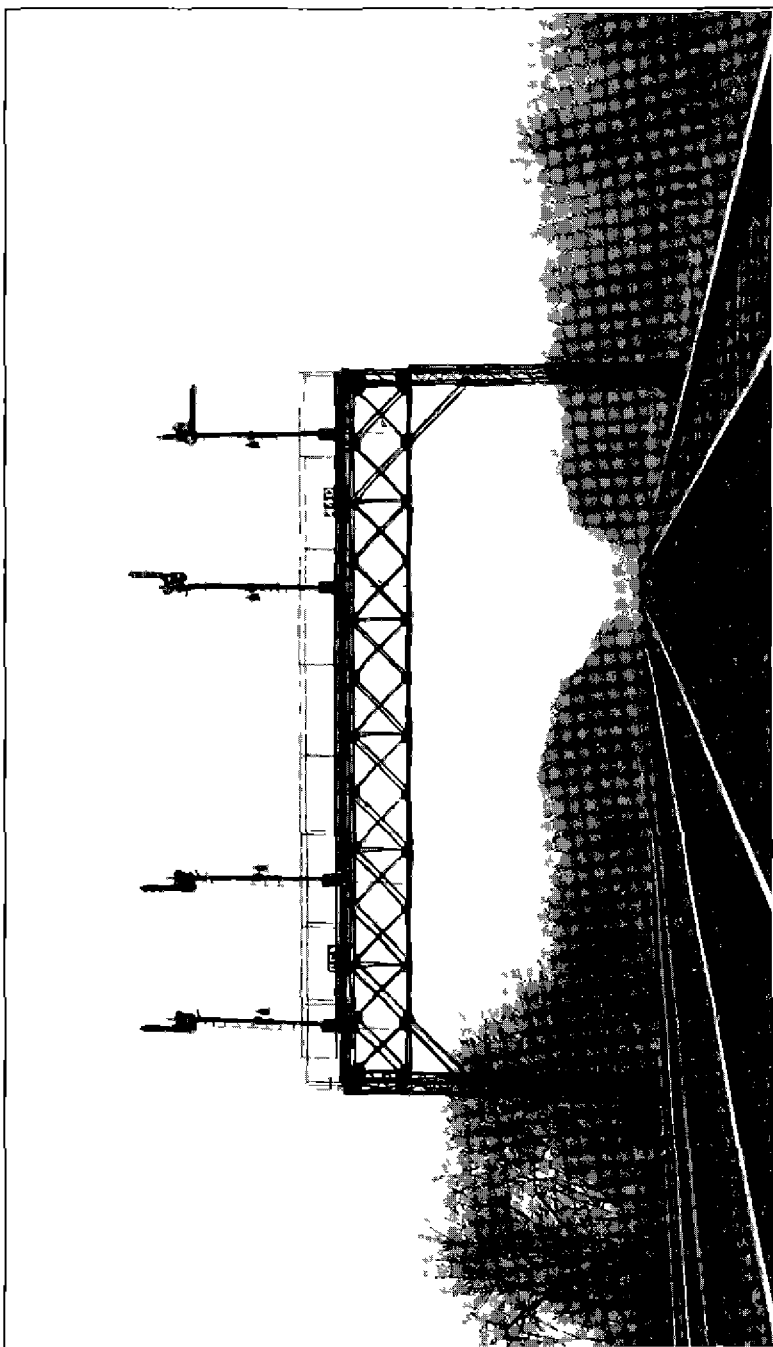
FIG NO 3—SIGNAL BRIDGE 440 SIGNAL GOVERNING TRACK 1 IS IN STOP POSITION

Electrical Inspector Rainey said that when he reached the point of accident at about 10 a. m. he found the case which controlled the signal apparatus had been sealed and was informed by the signal maintainer that the signals were then in the same position as when the maintainer first reached the scene, the signal on bridge 440 governing track 1 was displaying a stop indication while the corresponding signal on bridge 448 was displaying a caution indication. He was also informed that no changes of any kind had been made and he said that after the wreck train had departed at about 10 p. m. he found that the signals operated properly, and continued to operate properly while under observation for several hours afterward.

This accident again calls attention to the necessity for the use of an automatic train-control device which will intervene to stop a train when an engineman for any reason disregards the stop indication of an automatic block signal. Had an adequate automatic train-control device been in use at this point this accident would have been averted.
