REPORT OF THE DIRECTOR OF THE BUREAU OF SAFETY IN RE  
INVESTIGATION OF AN ACCIDENT WHICH OCCURRED ON THE  
PENNSYLVANIA RAILROAD NEAR PORTAGE, PA., ON  
OCTOBER 9, 1929.

October 26, 1929

Inv. No 1558  
 Pennsylvania R R  
 Portage, Pa  
 October 9, 1929

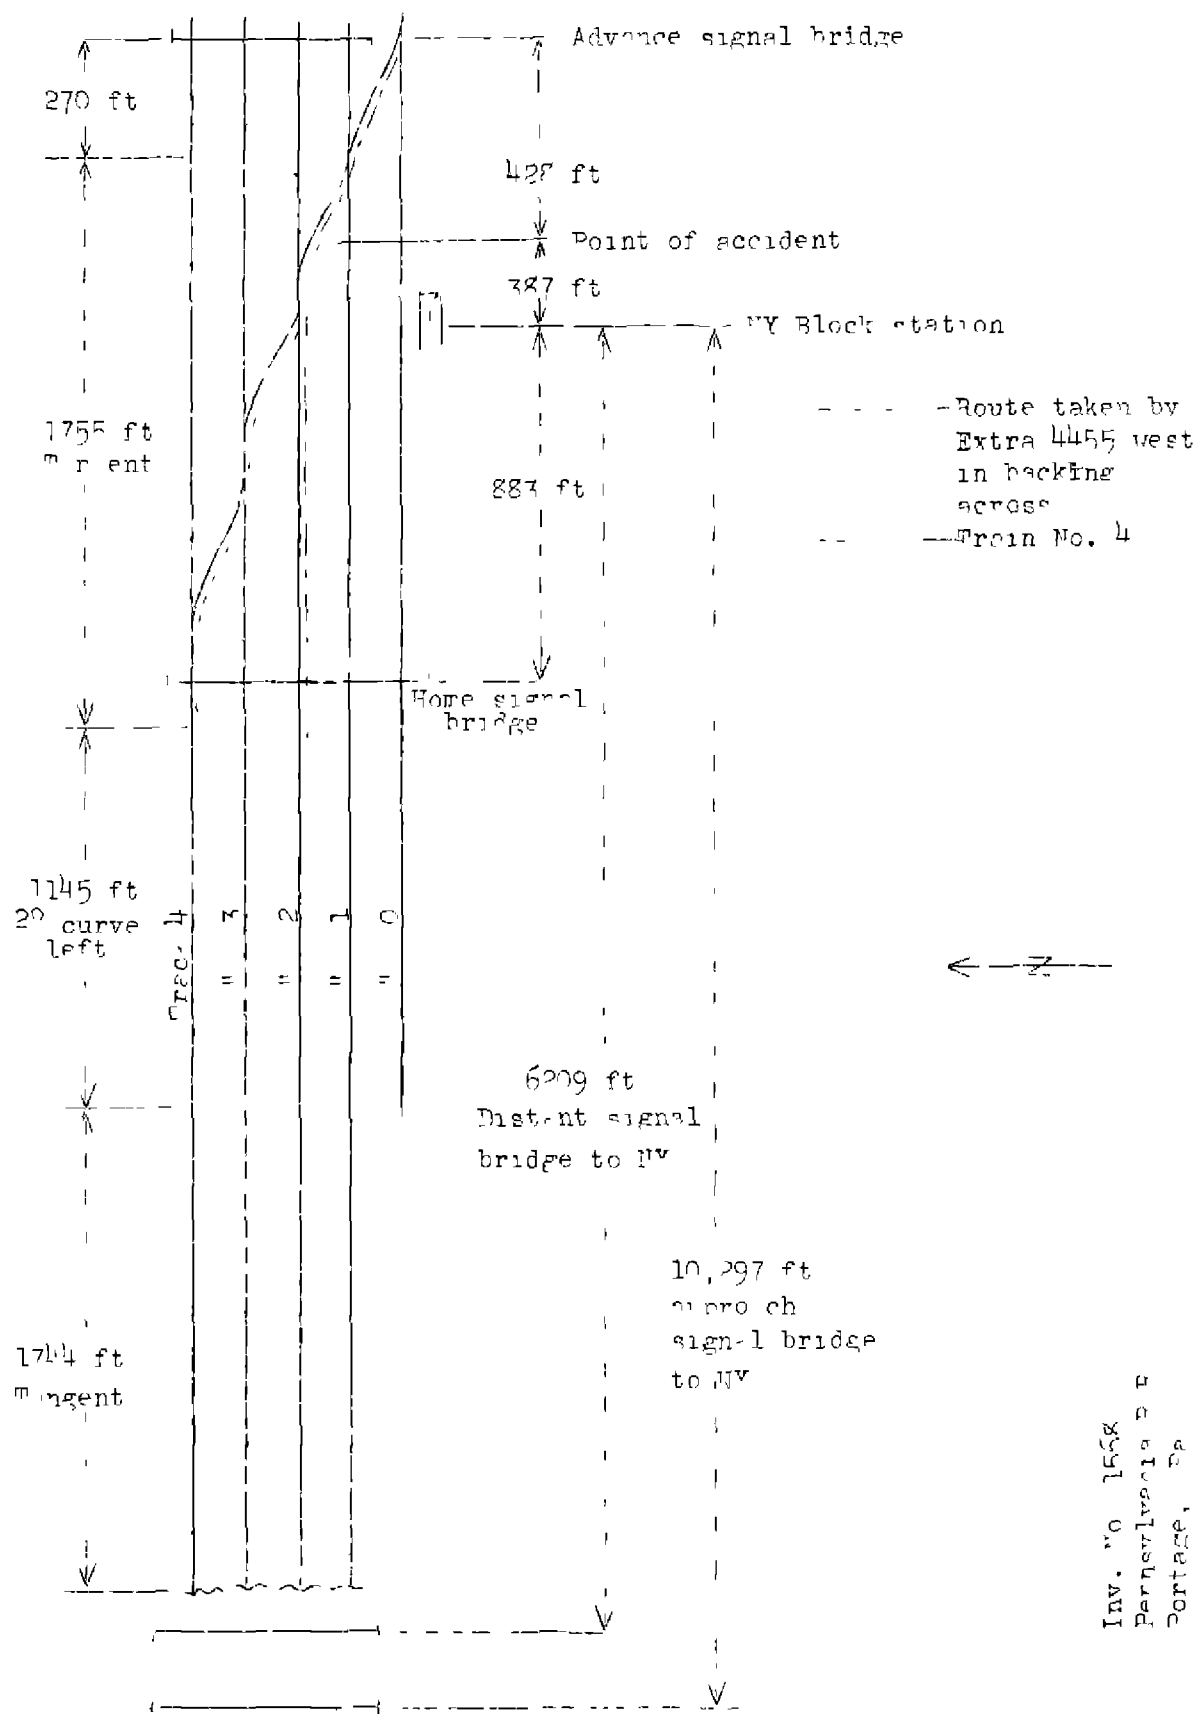
The mechanical interlocking plant at this point is operated from NY Block Station, located 387 feet west of the point of accident. At this point there is a series of crossovers connecting tracks 4 and 3, 3 and 2, 2 and 1, and 1 and 0, the last-mentioned crossover being at the extreme eastern end of the interlocking limits, with the first-mentioned crossover at the western end of the interlocking limits. The home signal bridge at the western end of the interlocking limits spans all five tracks and is 883 feet west of NY Block Station; the home signals

mounted on this bridge for eastbound tracks 2 and 1 are of the position-light type. The signal bridge on which the eastbound distant signals are located is 6,209 feet west of NY Block Station and spans the four main tracks, these distant signals also are of the position-light type, the normal indication being "approach next signal prepared to stop". There is another signal bridge 10,297 feet west of NY Block Station, when an eastbound train on track 2 passes this point the approach locking with which NY interlocking is equipped becomes effective and prevents the trowman from changing the route unless he releases the lock by manually operating the clockwork mechanism which is set to run down in 2 minutes and 35 seconds. At the eastern end of the interlocking limits at a point about 815 feet east of NY Block Station or 428 feet east of the point of accident, there is another signal bridge which spans the four main tracks, on this bridge are mounted what are known as the eastward advance signals, these being three-position automatic signals of the semaphore type. These advance signals are so controlled, however, that they display a stop indication whenever the route is lined for a movement through the crossovers to track 0. Under the interlocking rules, within home-signal limits which are protected by home and distant signals, their indications supersede superiority of trains and crews are relieved from observing rule 152, which requires flag protection when making a crossover movement and which also provides that such movement must not be made when a superior train is due.
