REPORT OF THE DIRECTOR OF THE BUREAU OF SAFETY
INVESTIGATION OF AN ACCIDENT WHICH OCCURRED ON
THE PENNSYLVANIA RAILROAD AT SOUTH ELIZABETH,
N. J., ON JULY 19, 1930.

August 27, 1930.

Inv. No. 1651
Pennsylvania Railroad
South Elizabeth, N.J.
July 19, 1970

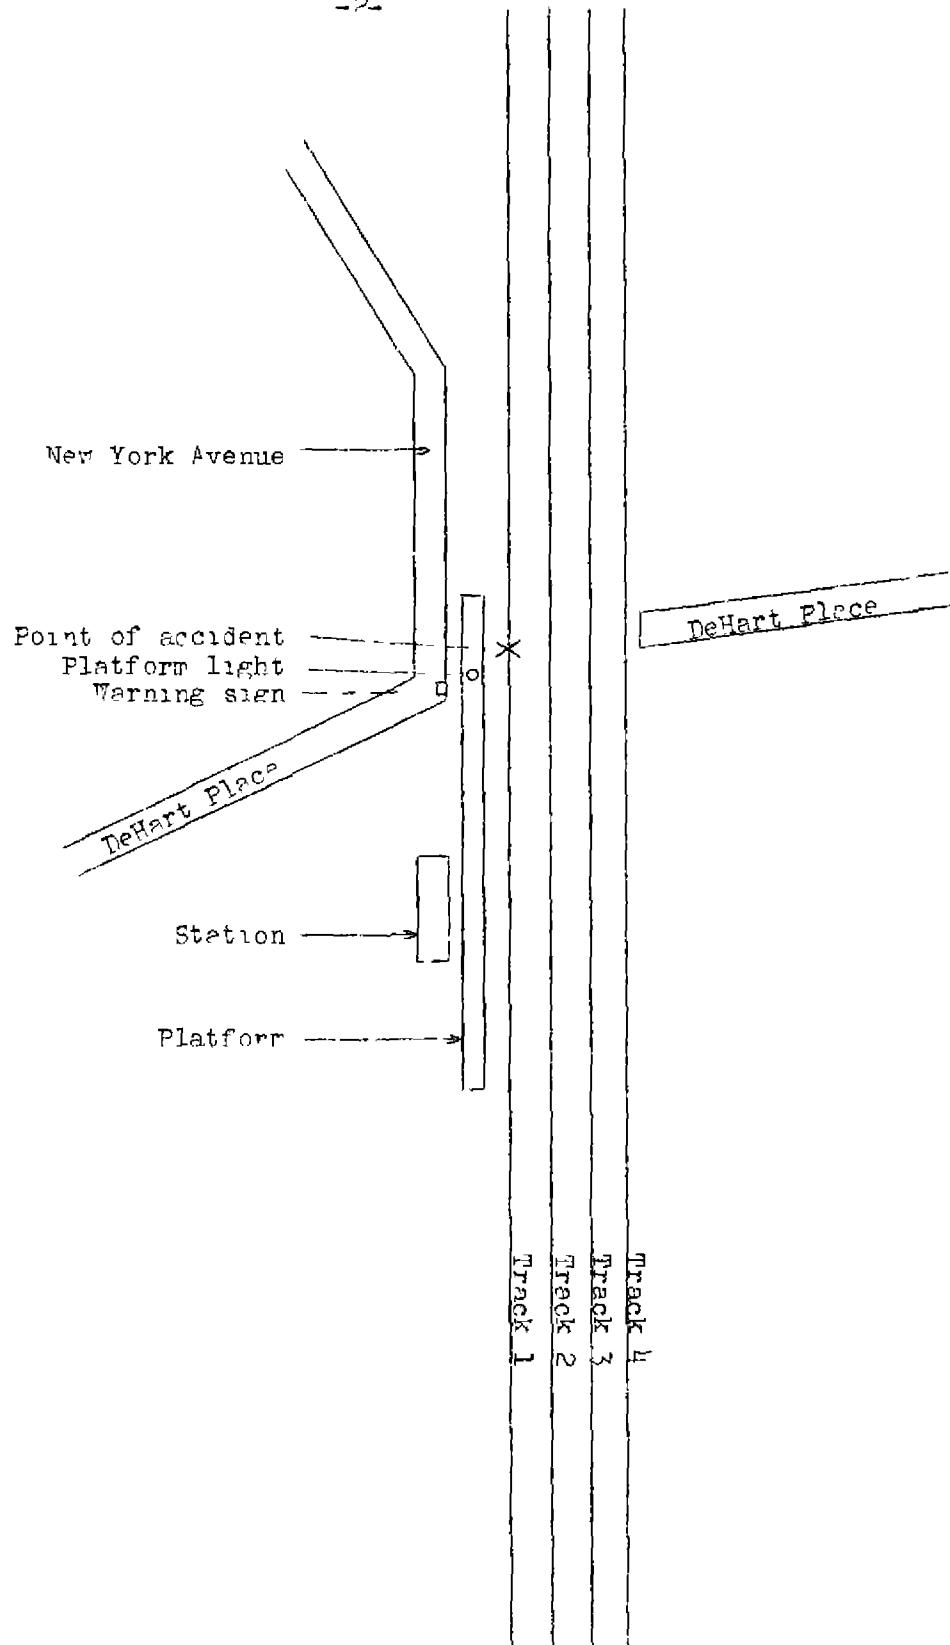
The station at South Elizabeth is located on the south side of the tracks and the station platform extends 260 feet west and 50 feet east, respectively, from the station. This platform is supported on the track side by a concrete curb 27 inches from the south rail and 12 inches above the top of the ties. There is a street known as DeHart Place on the south side of the track which approaches the railroad at an angle of approximately 75 degrees and ends at the station platform about 180 feet west of the station, the street and platform being on the same level. This same street extends northward beyond the tracks but there is no crossing at this point. Beginning at the end of DeHart Place on the south side of the tracks, New York Avenue parallels the track westward for a distance of 240 feet and then veers to the

left. Approaching the platform on DeHart Place the grade is slightly ascending. There is a light on the west end of the platform located at about the center line of DeHart Place and there is a warning sign, also located about the center of DeHart Place, which is 6 feet 6 inches south of the platform. This sign is hexagon shape, 11½ inches wide and 24 inches long and is mounted 4 feet 2 inches above the ground. At the time of the accident the lettering on this sign was illegible, although it originally read "DANGER - ROAD END - Police Dept."
