## INTERSTATE COMMERCE COMMISSION

REPORT OF THE DIRECTOR OF THE BUREAU OF SAFETY IN RE  
INVESTIGATION OF AN ACCIDENT WHICH OCCURRED ON THE  
PENNSYLVANIA RAILROAD AT SHAWMONT, PA., ON MAY 19,  
1930.

June 21, 1930.

Inv. 1340  
 Pennsylvania Railroad  
 Shawmont, Pa.  
 May 19, 1930.

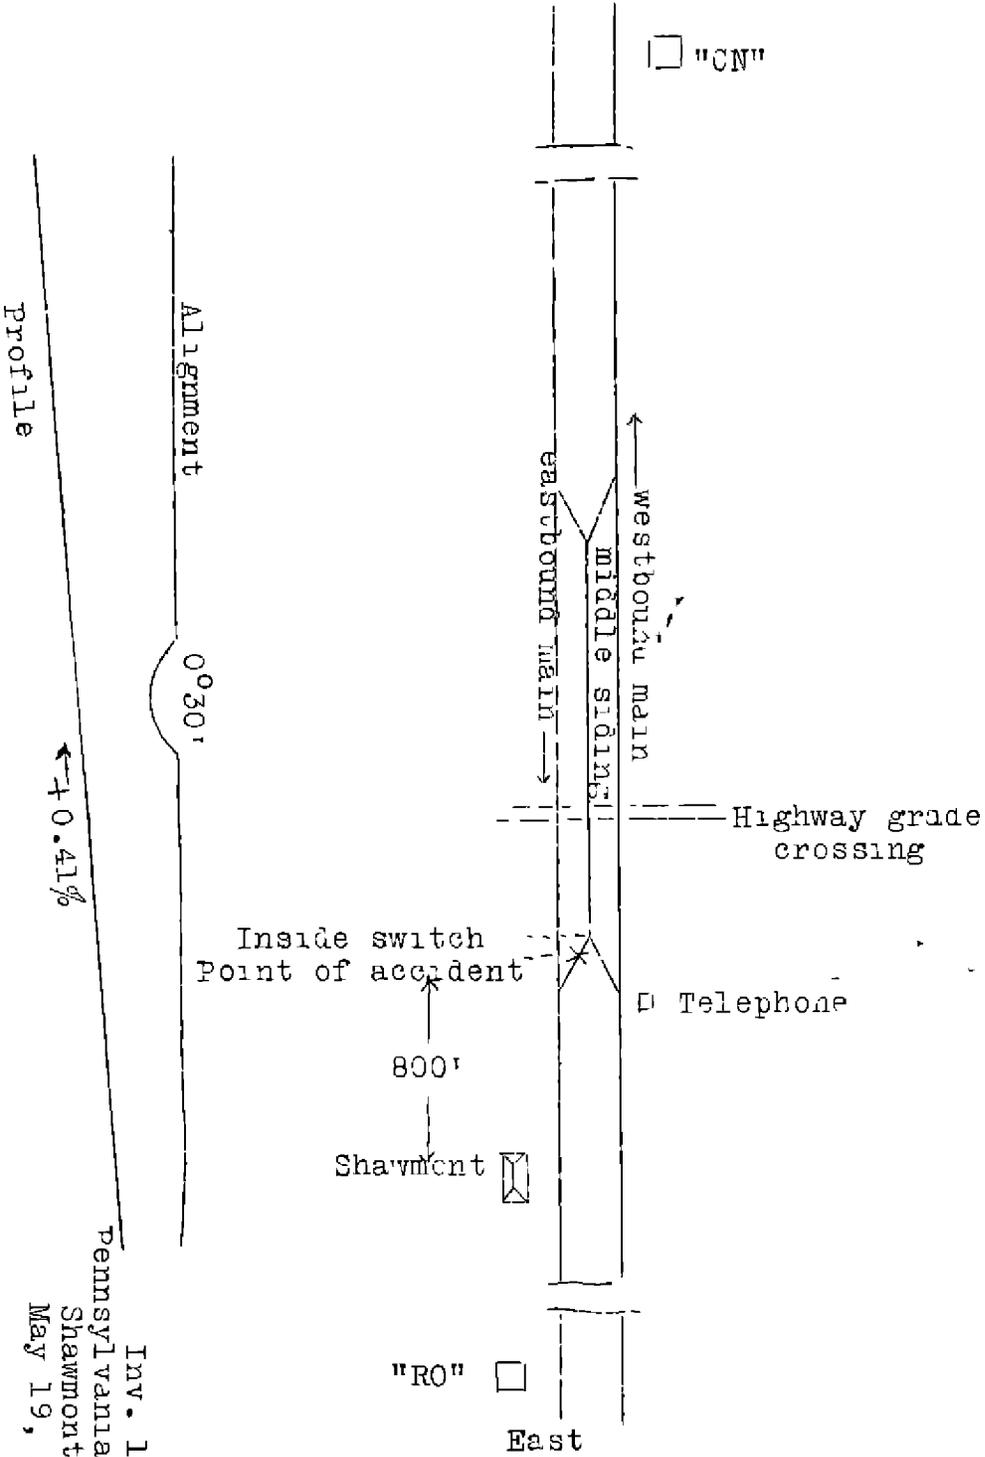
The middle siding is about 3,800 feet in length, overall, and is located between the two main tracks, with hand-thrown switches leading to each end of the siding from both main tracks; the normal position of the inside switch at the east end of the siding is lined for movements from the siding to the eastbound track. The switch stand for this switch is of the low type and is located between the middle siding and the eastbound track; it is not equipped with a target. There is a telephone located

on the north side of the westbound track, opposite the main line switch of the middle siding; this telephone is connected with RO Block Station, located 1.3 miles east of Shawmont, and is for the use of crews in obtaining information relative to their movements to and from the siding.
