INTERSTATE COMMERCE COMMISSION

JOINT REPORT OF THE DIRECTOR OF THE BUREAU OF SAFETY AND THE CHIEF INSPECTOR OF THE BUREAU OF LOCOMOTIVE INSPECTION IN RE INVESTIGATION OF AN ACCIDENT WHICH OCCURRED ON THE PENNSYLVANIA RAILROAD NEAR ST GEORGE, PA , ON JANUARY 30, 1924

MARCH 17, 1924

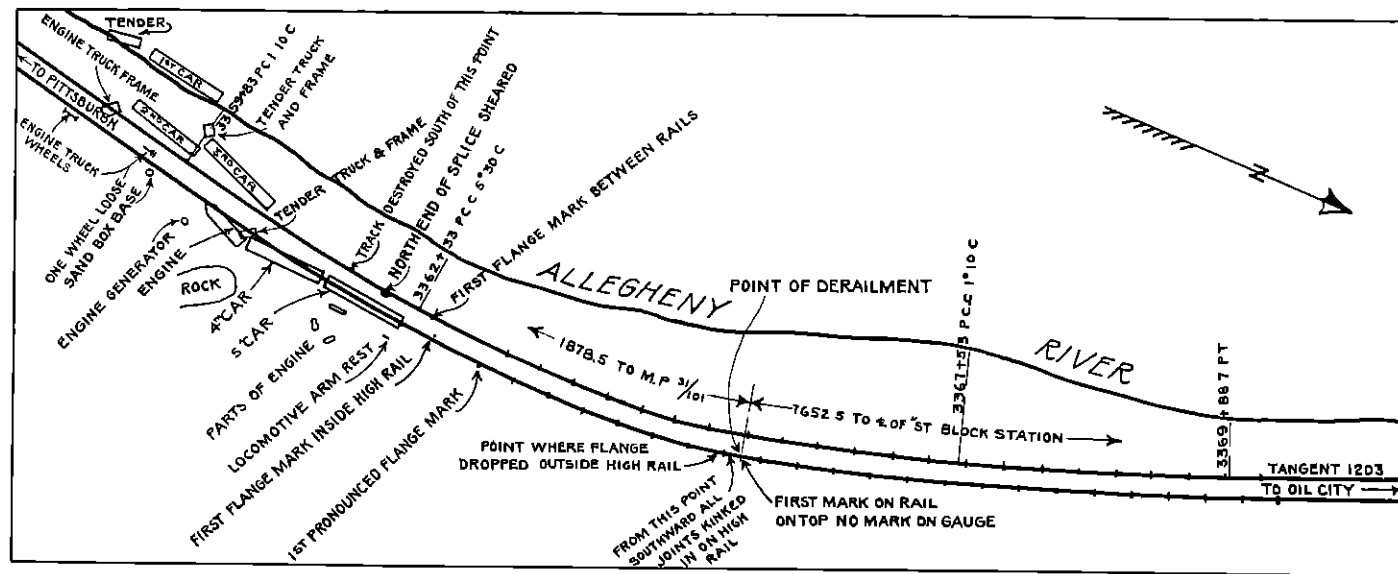
The entire train was derailed. Engine 397 came to rest on its left side east of the track, its head end being on the east rail about 275 feet south of the first pronounced flange mark. The engine truck was torn from the engine and almost entirely demolished. The two pairs of wheels were found separated by considerable distances from each other and from the truck frame. The tender and first car were derailed to the right and went down the embankment into the river, the head end of the tender being about 170 feet beyond the engine, the second and third cars were also derailed to the right or west side of the track, the rear end of the third car being opposite the rear end of the engine. The last two cars remained upright and behind the engine. The first car was practically demolished, the left side of the second car was torn out, and the left side of the third car torn out about half its length. The persons killed were the engineman, fireman, and Pullman porter.

Diagram showing position of equipment after derailment and other information referred to in body of report

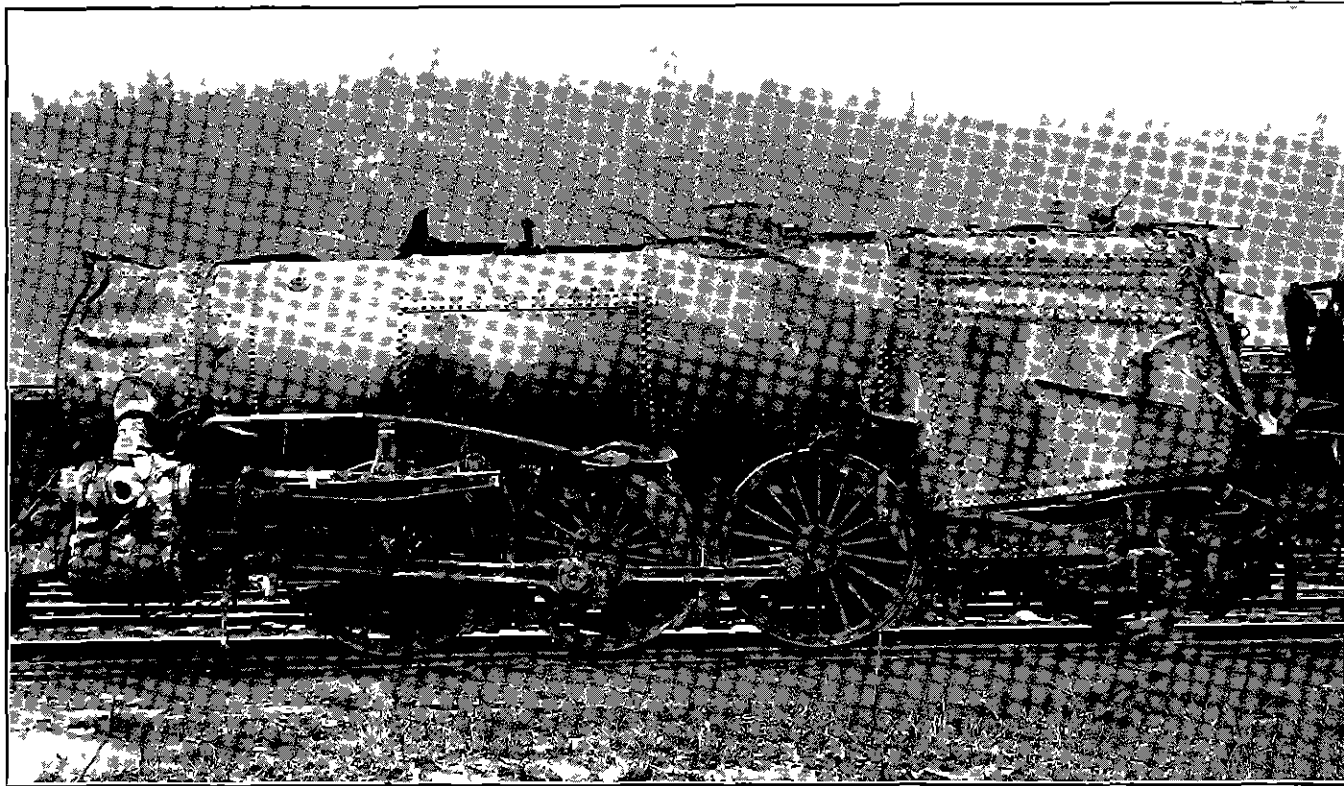
Plate 1 shows locomotive 397 after being picked up and placed on the track.

Owing to the badly damaged condition of the engine and tender, various measurements could not be obtained. The engine truck was almost completely demolished and the frame badly distorted, there were numerous marks and indentations on the frame, axles, and wheels, evidently caused by the accident. Both axles of the engine truck were bent. One wheel of the leading pair of engine truck wheels was found against its mate on the opposite end of the axle. Owing to the absence of identification marks, however, it was not determined whether the wheel found off its seat was the right or left wheel. The commission's inspectors were of the opinion that the marks and indentations on this wheel did not show evidence of a blow sufficient to have loosened it. Micrometer measurements of the wheel seat indicated slight distortion, and close examination disclosed that apparently a perfect bearing was not obtained at the time of original application. Measurements of the wheel seat and bore showed the dimensions of the axle wheel seat to average 0.004 inch larger than the bore. On February 12, at Buffalo shops, the loose wheel was pressed back on its seat, requiring a pressure of 45 tons for the first 2 inches and 80 tons for the other 4 inches.

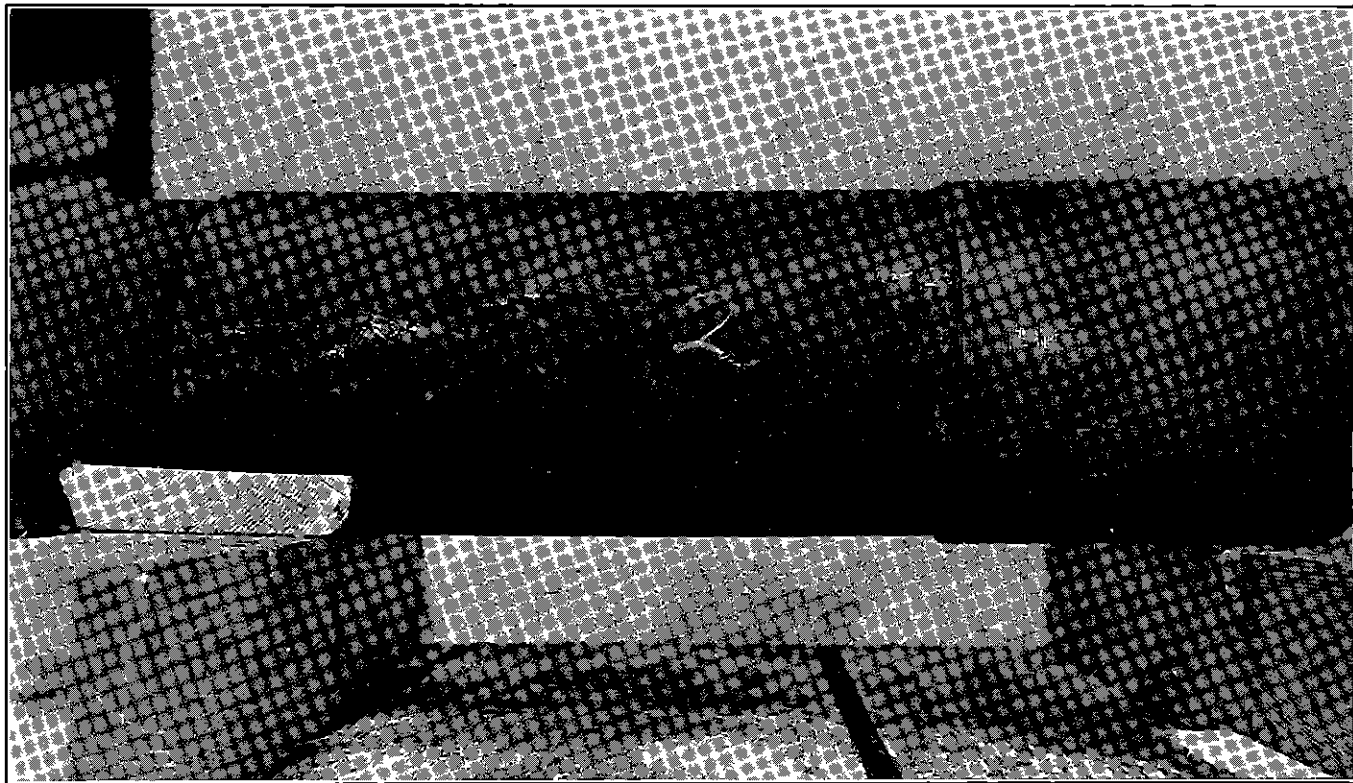
Plate 4 shows front engine truck axle on which one wheel was found against its mate on the opposite end of the axle indicating that a proper bearing was not obtained on the wheel fit at the time of the original application of the wheel

As a result of this investigation it is believed that when the locomotive entered upon the $5\frac{1}{2}^{\circ}$ curve, because of the defects noted and the rate of speed, the thrust to which the left leading engine-truck wheel was subjected caused it to move inward on its axle, the left rear engine truck wheel was forced over the rail where the first mark of derailment was found, continuing along against the outside of the rail until the leading wheel had been forced inward far enough to allow the leading wheel to drop to the ties between the rails and the rear wheel to drop to the ties outside the high rail, thus precipitating the derailment of the train. The belief that an engine-truck wheel was the first wheel to be derailed is supported by the character of the marks on the track, and by the fact that although the train traveled a considerable distance beyond the point where this wheel first left the rail before complete derailment of the train occurred, the engineman was evidently unaware of this condition as the evidence indicates no brake application was made. While it could not be determined by identification of the

It is obvious that adequate maintenance of engines is one of the essentials for safe operation. Had the defects noted not existed on this engine, it is probable it would have successfully rounded this curve notwithstanding the excessive speed at which it was being operated. Measures should at once be taken by responsible officials to the end that proper inspection and repairs of engines shall be made

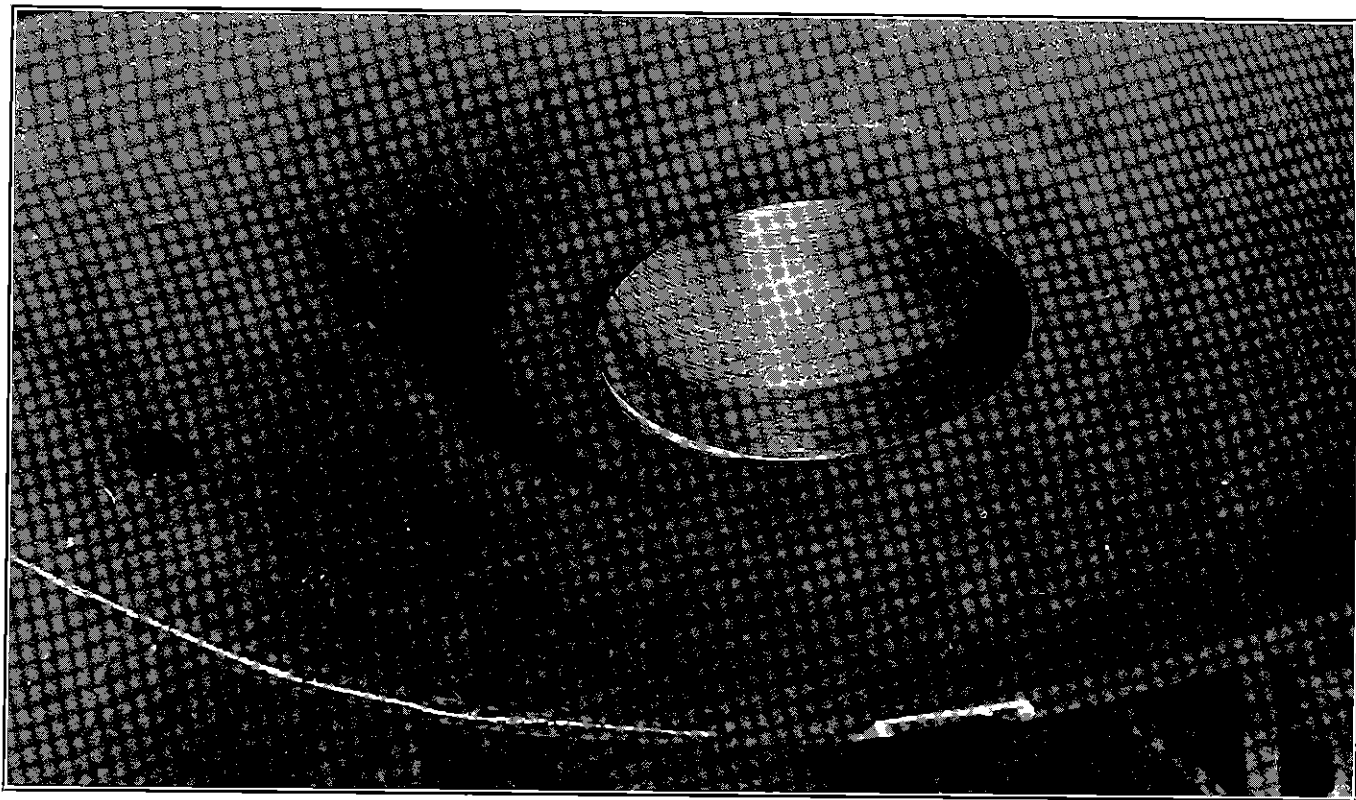
Plate 5 shows bore of engine truck wheel of the leading pair which was found off its seat and on the opposite end of the axle. The tool marks in the bore indicate that a proper fit was not obtained at the time the wheel was originally applied to the axle.

wheel itself that it was the left leading engine-truck wheel which after the accident was found off its seat, this conclusion is warranted by the fact that this wheel would be subjected to the severe thrust incident to guiding the engine, running at high speed, when rounding this curve

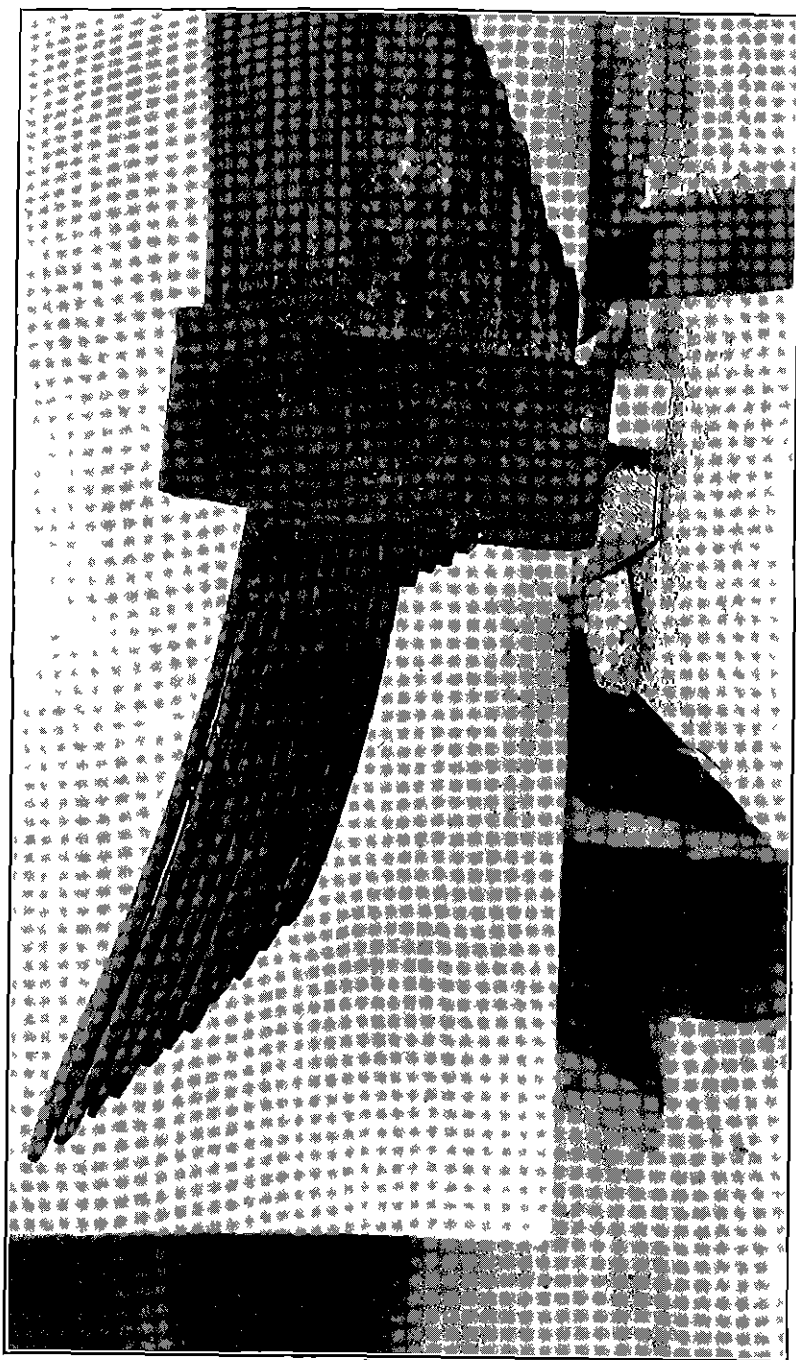
These springs are located between the equalizers and can only be properly inspected from underneath. One of these springs was found to have nine short and five long leaves broken, and the other spring had six short leaves broken at the band, the ends of all broken leaves except one being missing. There was nothing to indicate that they had been broken in the derailment. On February 12 the engine truck springs were dismantled and the leaves referred to showed evidence of having been broken for some time.

Plate 6 shows one of the engine truck springs with 9 short leaves and 5 long leaves broken, which evidently had been broken for some time prior to the accident

The investigation disclosed that both engine-truck springs had a number of broken leaves which had evidently been broken some time prior to the accident, and this condition no doubt resulted in the normal position of the engine-truck frame over the journal boxes being changed, the frame probably being down on top of the boxes and the spring seats riding the equalizers, thus creating a relatively rigid condition of the engine truck, changing the distribution of weight on the engine-truck wheels and retarding the proper movement of the truck when rounding curves. Excessive lateral had been reported so frequently that it is apparent proper correction was not made, and while on account of damage resulting from the accident accurate measurements could not be taken so as to determine the lateral which existed at the time, it is believed that this and others of the defective conditions mentioned existed at the time of the derailment and were primarily responsible for the accident.

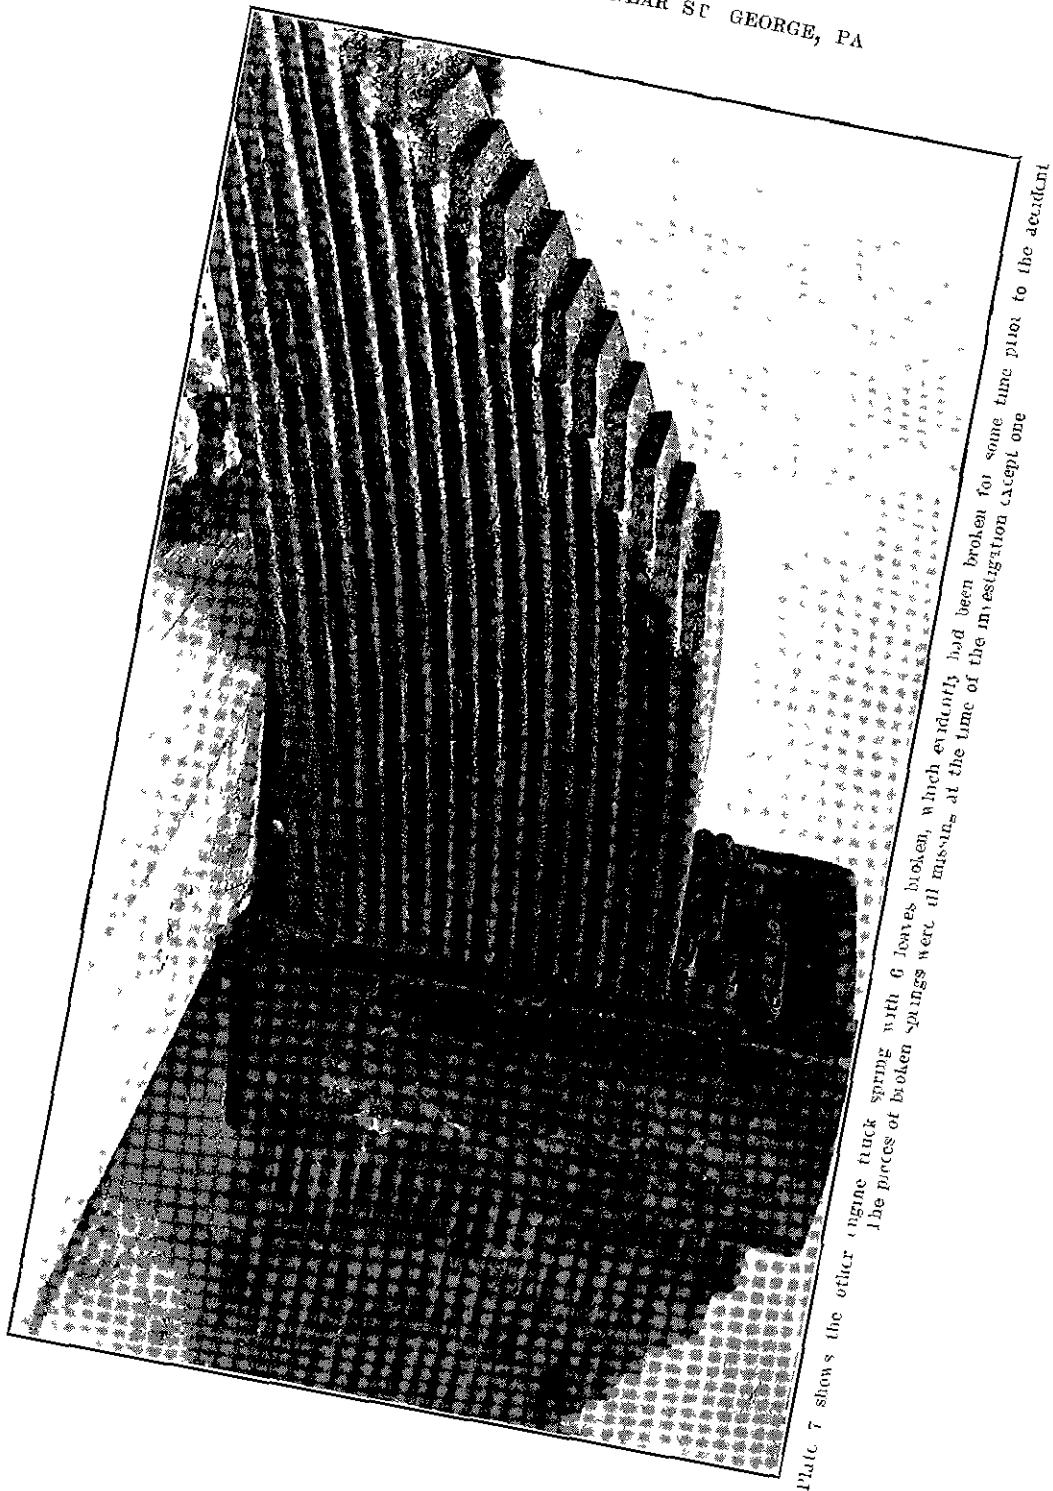
Plate 7 shows the other engine truck spring with 6 leaves broken, which evidently had been broken for some time prior to the accident. The pieces of broken springs were all missing at the time of the investigation except one.
