## INTERSTATE COMMERCE COMMISSION

REPORT OF THE DIRECTOR OF THE BUREAU OF SAFETY IN RE  
INVESTIGATION OF AN ACCIDENT WHICH OCCURRED ON  
THE PENNSYLVANIA RAILROAD AT TOLEDO JUNCTION, OHIO,  
ON MARCH 23, 1930

April 19, 1930

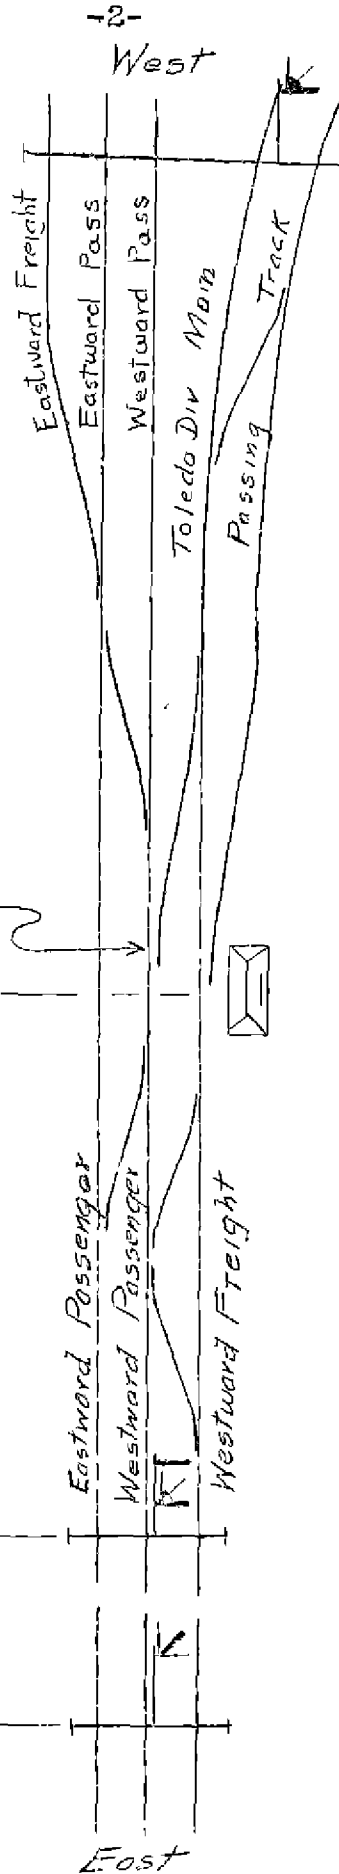
No 1628  
Pennsylvania R R  
Toledo June 0,  
March 23, 1930

Point of Accident

794'

5176'
