REPORT OF THE CHIEF OF THE BUREAU OF SAFETY
COVERING THE INVESTIGATION OF AN ACCIDENT
WHICH OCCURRED ON THE PHILADELPHIA & READ-
ING RAILROAD NEAR FORT WASHINGTON, PA., ON
JANUARY 13, 1919.

APRIL 10, 1919.

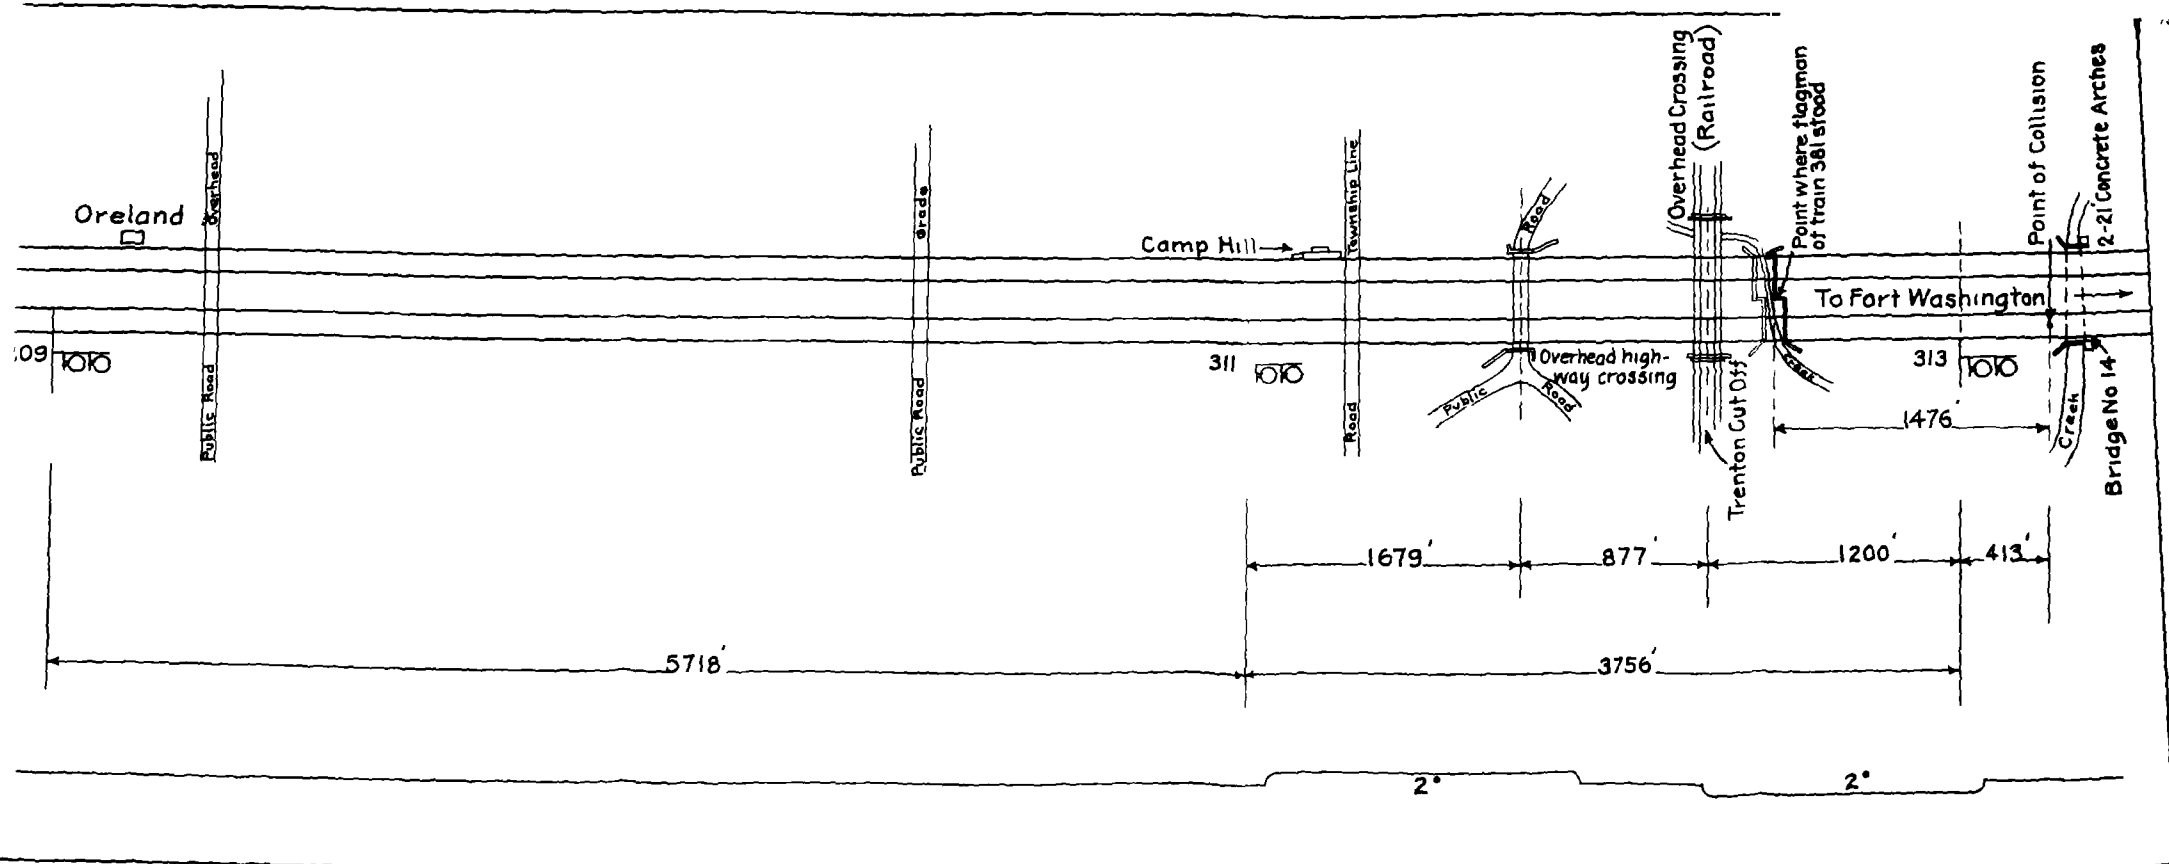
No. 1 - Diagram showing physical conditions approaching point of collision

Illustration No. 1 is a diagram showing the existing physical conditions approaching the point of collision. Illustration No. 2 is a view approaching signal No. 311, while illustration No. 3 shows signal No. 313, just beyond which the collision occurred.

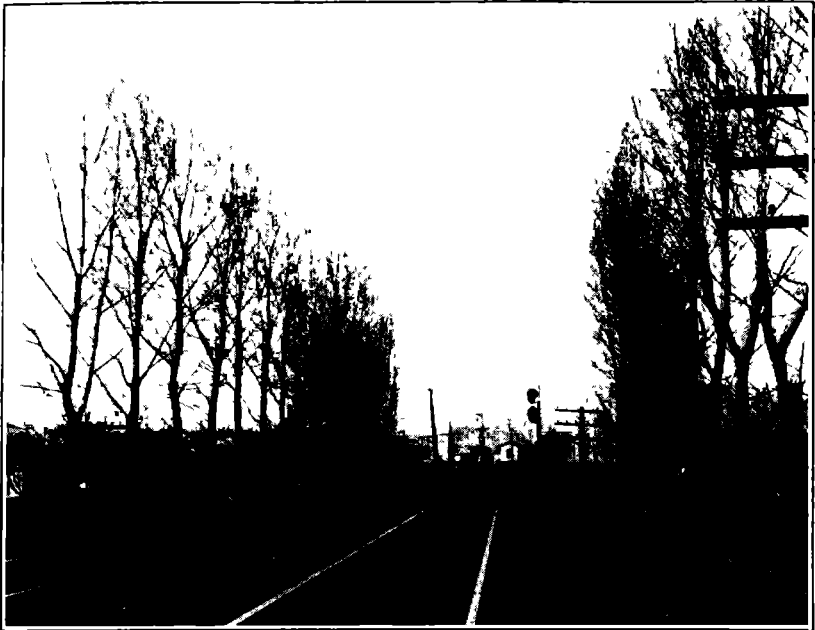
No 2 —View approaching signal No 311

The investigation developed nothing which would support the statement of Engineman Githens that signal 311 displayed a clear indication instead of caution; on the contrary, all the circumstances point to the conclusion that this signal was in the caution position, and it is believed that Engineman Githens must have been mistaken or have misinterpreted the indication of signal 311 when he accepted it as being clear.

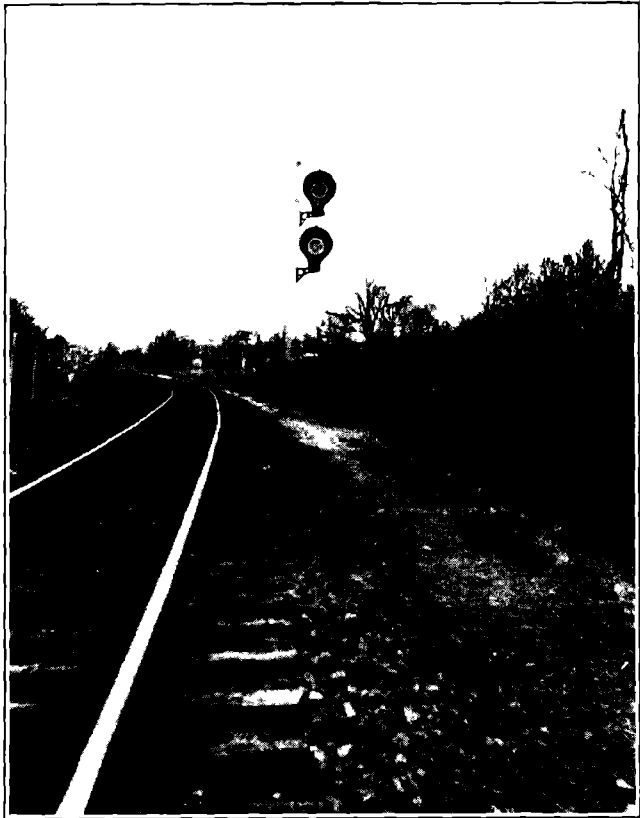
No. 3—View showing signal No. 313 and tangent on which collision occurred.

cation, or red and green, should have been displayed at signal 313. That the proper danger indication was displayed by signal 313 for each of these trains is not questioned; and the proper caution indication was displayed by signal 311 for train 381, and about 20 minutes before train 319 passed it, and for train 387 about 30 minutes after train 319 passed it; nevertheless, the statement of Engineman Githens of train 319 is positive that a clear indication was displayed by signal 311 for his train, and in any event he accepted a clear signal indication at that point and proceeded accordingly.

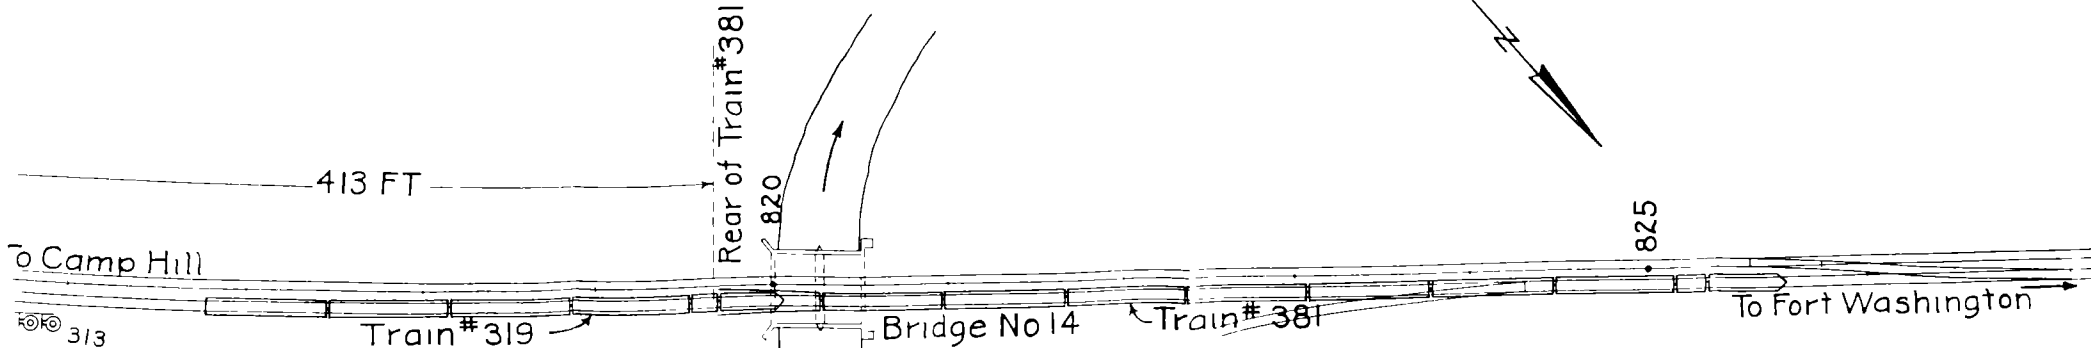
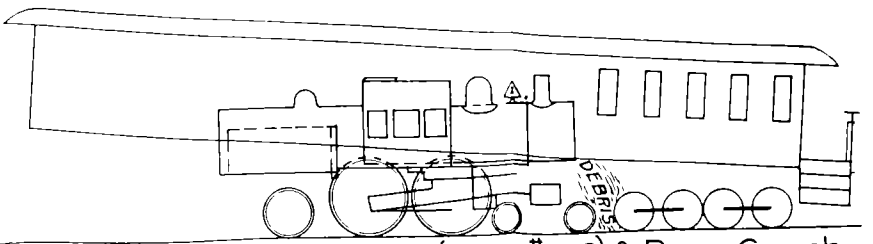
The locomotive telescoped the rear coach of train 381 about 45 feet, demolishing the coach and slightly damaging the locomotive. The next coach forward had the rear platform steps broken and one corner of the roof slightly damaged. Both trucks of the rear coach were jammed up against the rear truck of the next coach forward. None of the cars in either train was derailed and there was no damage to the track or roadbed.

End View
Engine & Car

Side View of Engine (Train # 319) & Rear Coach
of Train # 381 Immediately after crash

As has been pointed out in the foregoing, all the cars in train 381 were of wooden construction, and the rear car was telescoped approximately three-quarters of its length, being practically destroyed. Had steel cars been used in this train the number of fatalities and injuries would undoubtedly have been materially reduced.

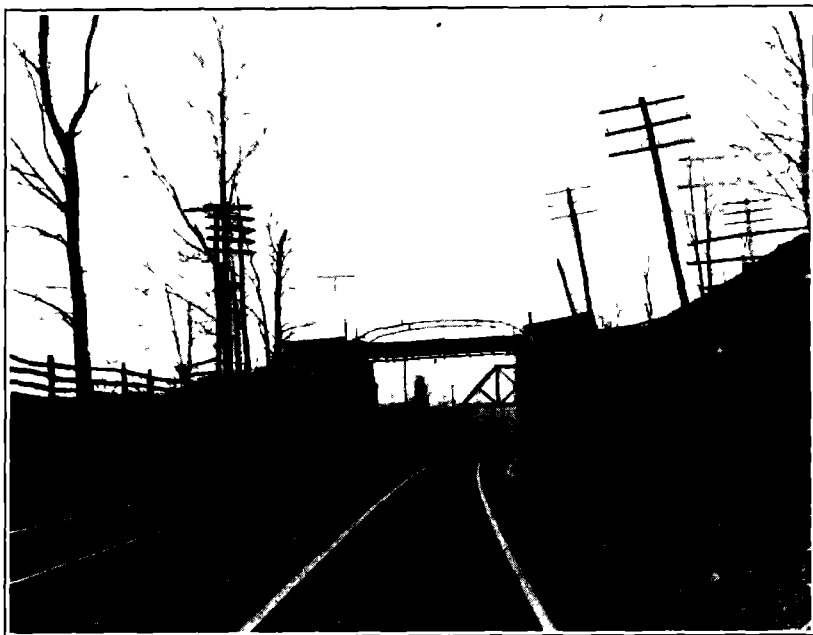
Illustration No 5 is a view taken from a point two telegraph poles south of the highway bridge, showing that from this point the engineman could not have seen the flagman. Illustration No. 6, is a view from a point one telegraph pole south of this bridge, midway between the rails, and shows that from this point the flagman would be visible, standing beyond the second overhead bridge. Illustration No. 7 is a view from the track under the highway bridge, showing the Trenton cut-off bridge, with the curve beyond on which the flagman was stationed.

No. 5—View taken at a distance of two telegraph poles from highway bridge. flagman could not be seen from this point

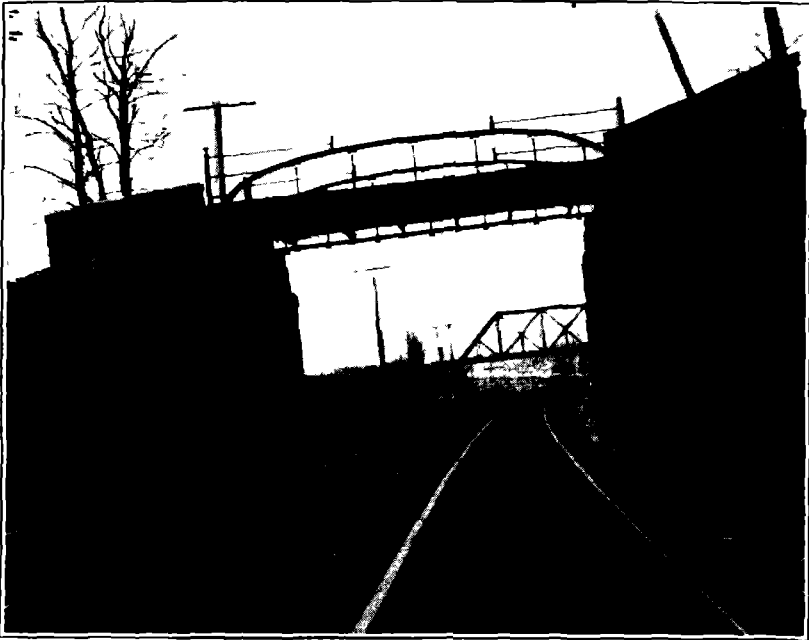
No. 6—View taken at a distance of one telegraph pole from highway bridge, flagman visible from this point

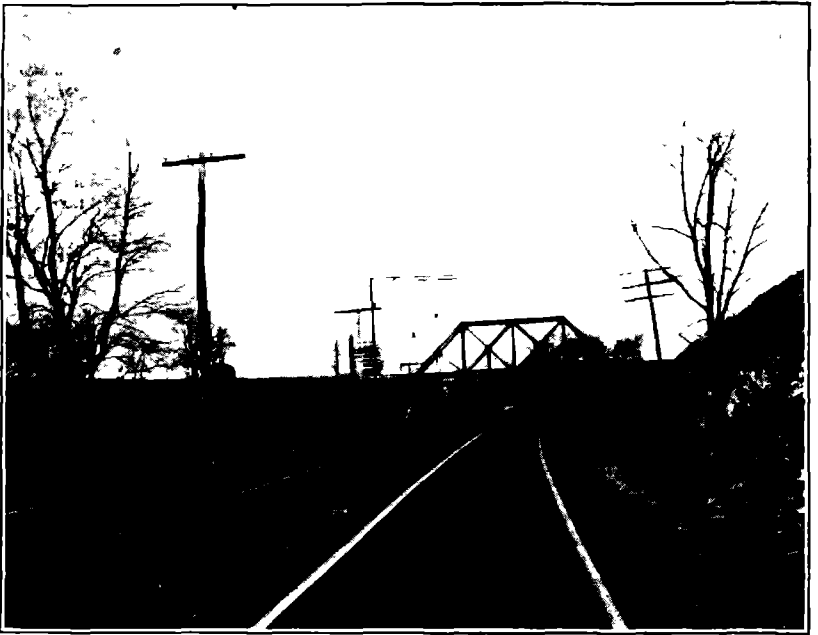
It was conclusively determined by the running tests that if an engineman knew a flagman was located on the concrete bridge north of the Trenton cut-off, and the flagman's stop signals were seen by the engineman instantly on emerging from under the overhead highway bridge at the south end of the tangent south of the Trenton cut-off, and an emergency application of the brakes were made immediately, the train could be stopped before reaching the point where the collision occurred. The test also demonstrated that from a service application, with 35 pounds brake-pipe reduction, made at the same point under the same conditions and circumstances, the train could not be stopped short of the point of collision. These facts indicate that train 381 was not afforded the maximum or full flag protection required by rule 99.

No 7 —View from a point under highway bridge, showing Trenton cut-off bridge and curve on which flagman was standing

Flagman Powers was thoroughly familiar with this rule and understood that operation of the automatic signals did not relieve him in any measure from its requirements. According to the evidence, however, at least 15 minutes elapsed between the time train 381 stopped and the approach of train 319, and in this time Flagman Powers went back approximately only 1,500 feet, which could be walked easily in 5 minutes, and according to his own statement he stood at that location from 3 to 5 minutes before train 319 approached. He, therefore, had ample time to have continued back far enough to have given full and maximum protection instead of providing only a minimum protection on the theory that the engineman of the following train would be governed by the signal indication and be approaching with his train under control. He was derelict in his duty as a flagman and must bear his share of responsibility for the accident.
