INTERSTATE COMMERCE COMMISSION

REPORT OF THE CHIEF OF THE BUREAU OF SAFETY IN RE INVESTIGATION OF AN ACCIDENT WHICH OCCURRED ON THE PHILADELPHIA & READING RAILWAY NEAR WOODMONT, PA , ON DECEMBER 5, 1921

DECEMBER 23, 1921

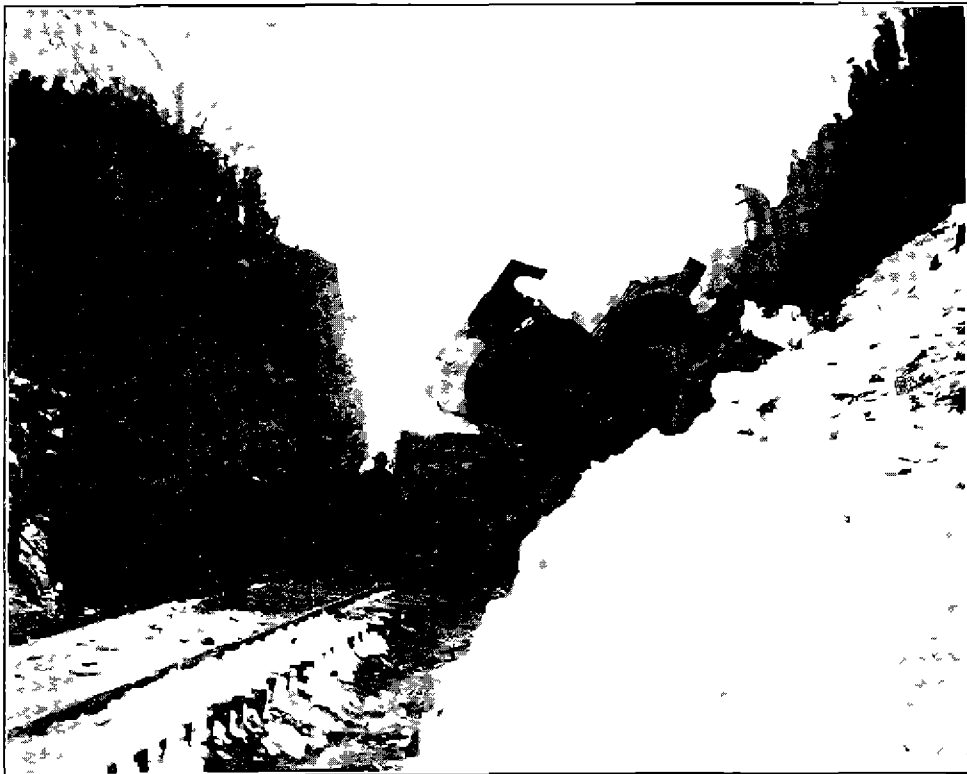
The impact forced both engines upward, engine 167, of train No 151, coming to rest bottom up, headed west and on top of its own tender, while engine 278, of train No 156, was on top of engine 167. The combination car of train No 151 was partially telescoped by the tender of engine 167. The forward end of the second car of train No 151 was also partially telescoped by the rear of the combination car, while the rear car remained on the rails and was only slightly damaged. The first coach of train No 156 was completely telescoped by the tender of engine 278. The next car was partially telescoped at its forward end by the wreckage, while the rear truck remained on the rails. The third, fourth, and fifth cars of train No 156 were practically undamaged by the collision. The wreckage took fire immediately, the first car of each train being completely destroyed. The fire spread quickly and destroyed the superstructures of the second and third coaches of train No 156 and of the second coach of train No 151. It is probable that many of the deaths were the result of the fire that followed the collision. The employees on duty killed were the firemen of each train.

FIG 1—VIEW SHOWING HOW ENGINES CAME TO REST

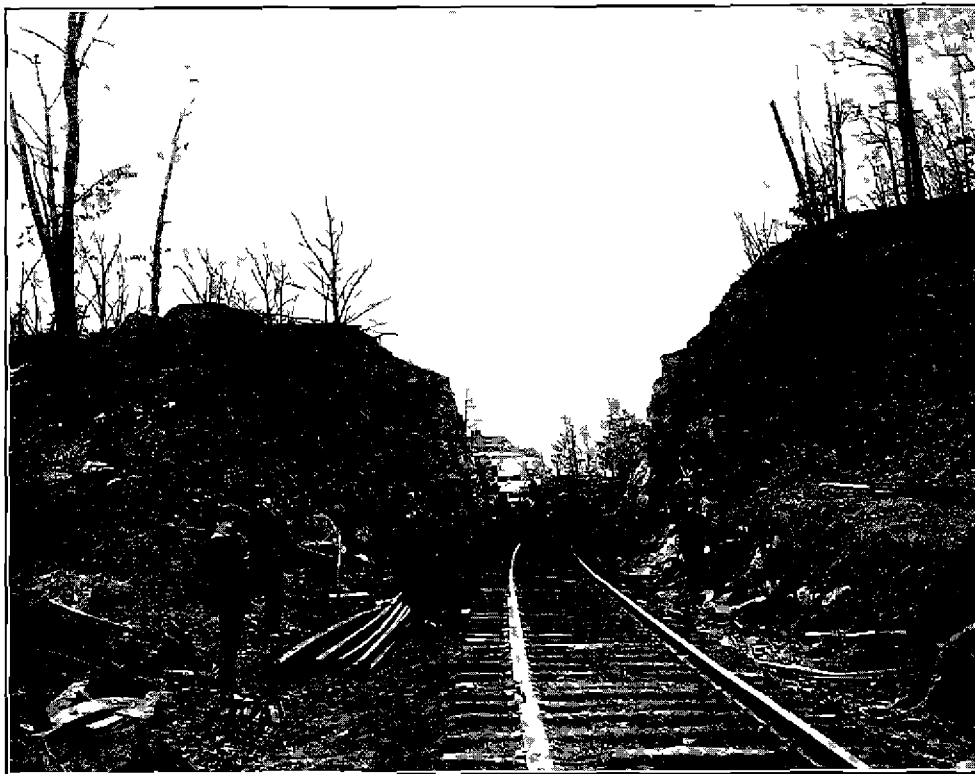
FIG 4—LOOKING EAST TOWARD POINT OF ACCIDENT.

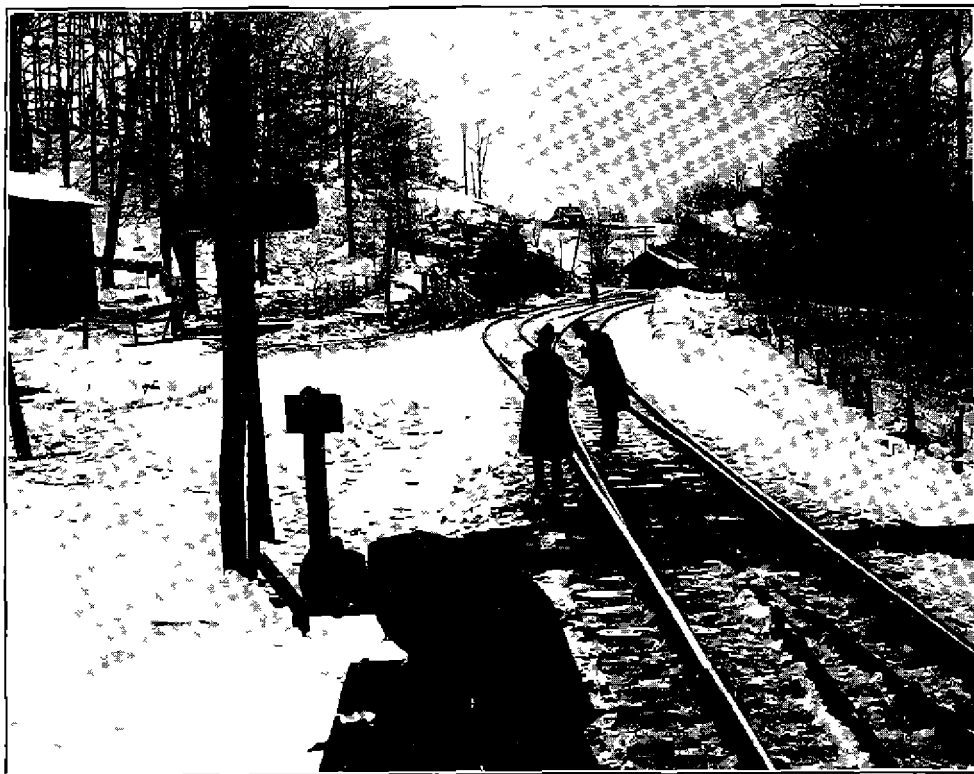
FIG 5—LOOKING WEST TOWARD STATION AT BYRN ATHYN SPUR TRACK ON LEFT
