INTERSTATE COMMERCE COMMISSION

REPORT OF THE DIRECTOR OF THE BUREAU OF SAFETY IN RE INVESTIGATION OF AN ACCIDENT WHICH OCCURRED ON THE RICHMOND, FREDERICKSBURG & POTOMAC RAILROAD NEAR WOODFORD, VA , ON APRIL 2, 1924

APRIL 28, 1924

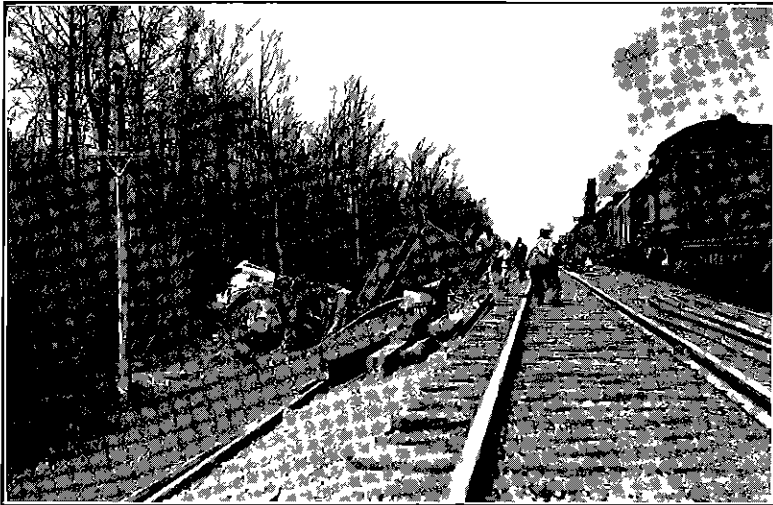
Engine 90 and eight cars were derailed. The engine came to rest down the fill on its right side, parallel with and about 20 feet west of the track, the tender was between the track and the engine, reversed. The cars remained upright, the first car coming to rest about 165 feet south of the engine, fouling the northbound track. The employee killed was the engineman.

FIG. 1.—Location of the accident. View of the derailed engine and tender. Tender turned half way around.

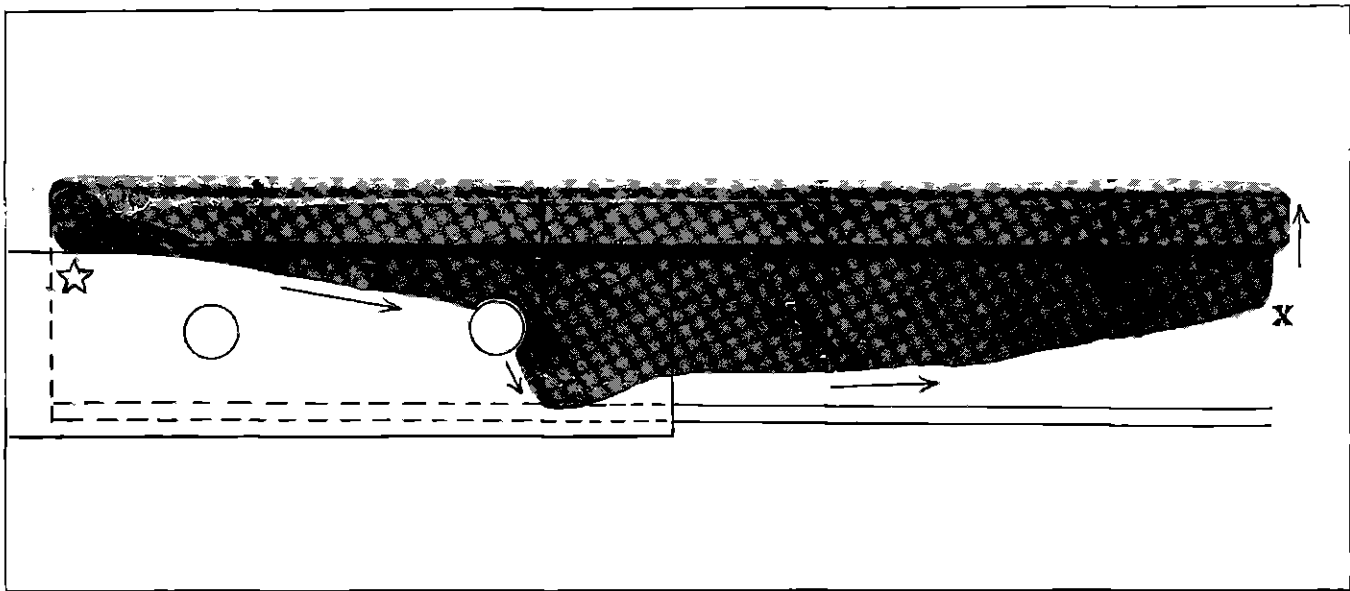
This rail displayed a web fracture which had its origin at its receiving end. It began immediately under the head, thence extending obliquely downward to the second bolt hole. It resumed its course from the opposite side of the bolt hole extending downward to the junction of the web and the base. It then changed direction and developed along the length of the web gradually upward to the middle of its depth, terminating 27 inches from the receiving end of the rail. This line of rupture apparently antedated the time of the accident.

Figures 2 and 3 illustrate the appearance of the fragment from the receiving end of the rail. The origin of the fracture was under the head, at the hot sawed end of the rail, indicated by a star on each of the cuts. Arrows on Figure 2 indicate the direction the line of rupture traveled.

FIG. 2—Gauge side of fragment from receiving end of the rail. Origin of fracture at end of rail under the head at place indicated by star on the cut. Arrows indicate the direction the line of fracture traveled. Position of splice bar shown in outline.

That portion of the line of rupture between the star on the cut and the letter x represents the portion believed to have been formed prior to the time of the accident. When finally broken the short line of rupture above the letter x detached this fragment from the remainder of the rail.

This accident points to the necessity for the most careful scrutiny in track inspection of rails for the detection of incipient lines of rupture of those types which admit of discovery before complete failure is reached.
