INTERSTATE COMMERCE COMMISSION

REPORT OF THE CHIEF OF THE BUREAU OF SAFETY, COVERING INVESTIGATION OF AN ACCIDENT WHICH OCCURRED ON THE RUTLAND RAILROAD NEAR RIVERSIDE, VT, ON MARCH 14, 1920

APRIL 16, 1920

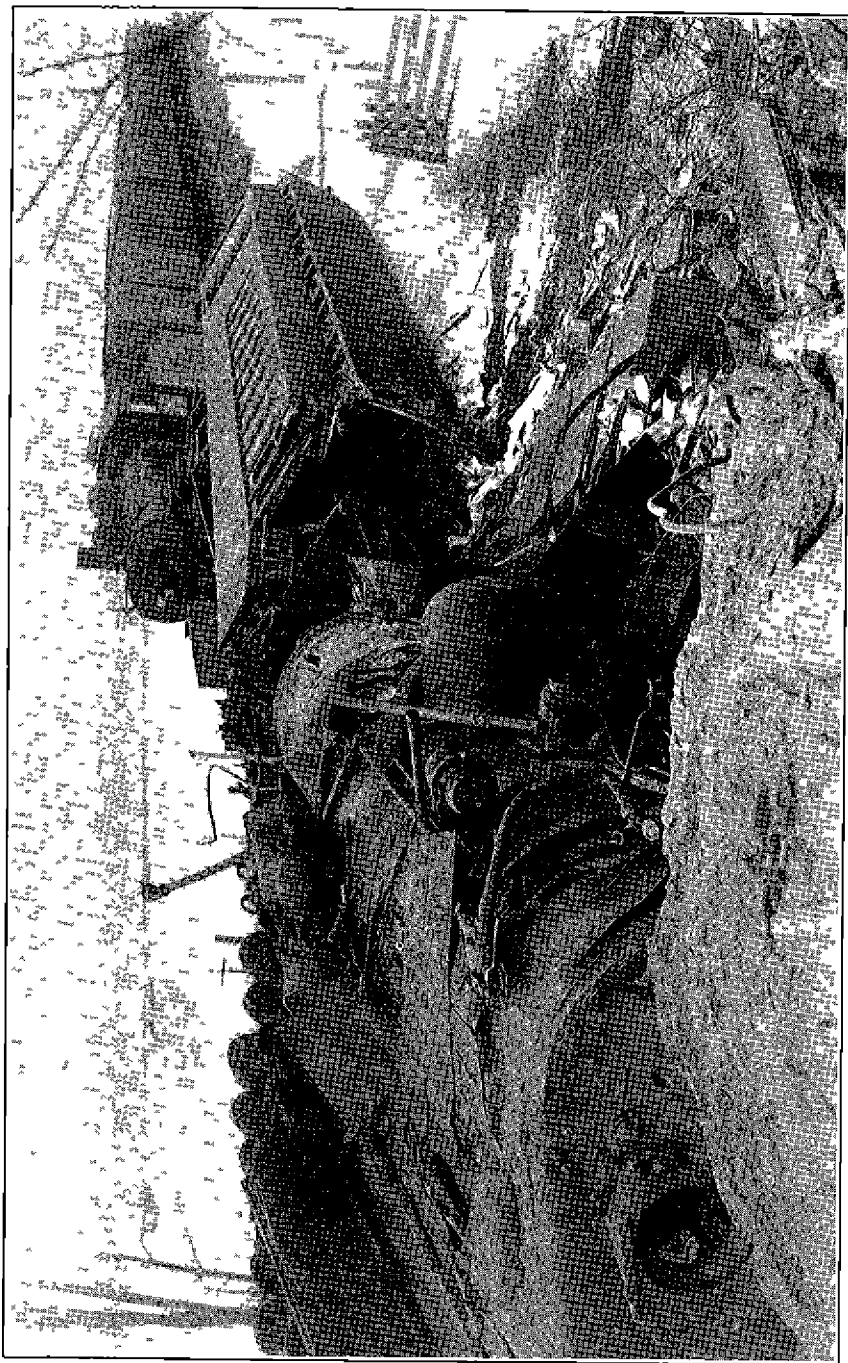
The impact of the collision resulted in the engine of train No 165 being thrown to the west side of the track and it came to rest in a reversed position, with its front end in the forward end of the combination car, as shown by illustration No 2. This engine was completely stripped, its boiler was torn from the frame, and the machinery practically destroyed. The milk car was destroyed, while the forward end of the combination car was badly damaged. The engine of extra 28 was thrown over the embankment on the east side of the track. Twelve cars of the freight train were derailed, eight of which were practically destroyed. Illustrations Nos 3 and 4 are general views of the wreckage of the freight train. On the left in illustration No 3 may be seen the engine of the freight train. The employees killed were the engineman, fireman, and one brakeman of train No 165, and the engineman and head brakeman of extra 28.

FIG 2—Engine and second car of passenger train, engine in reversed position with its front end in head end of coach

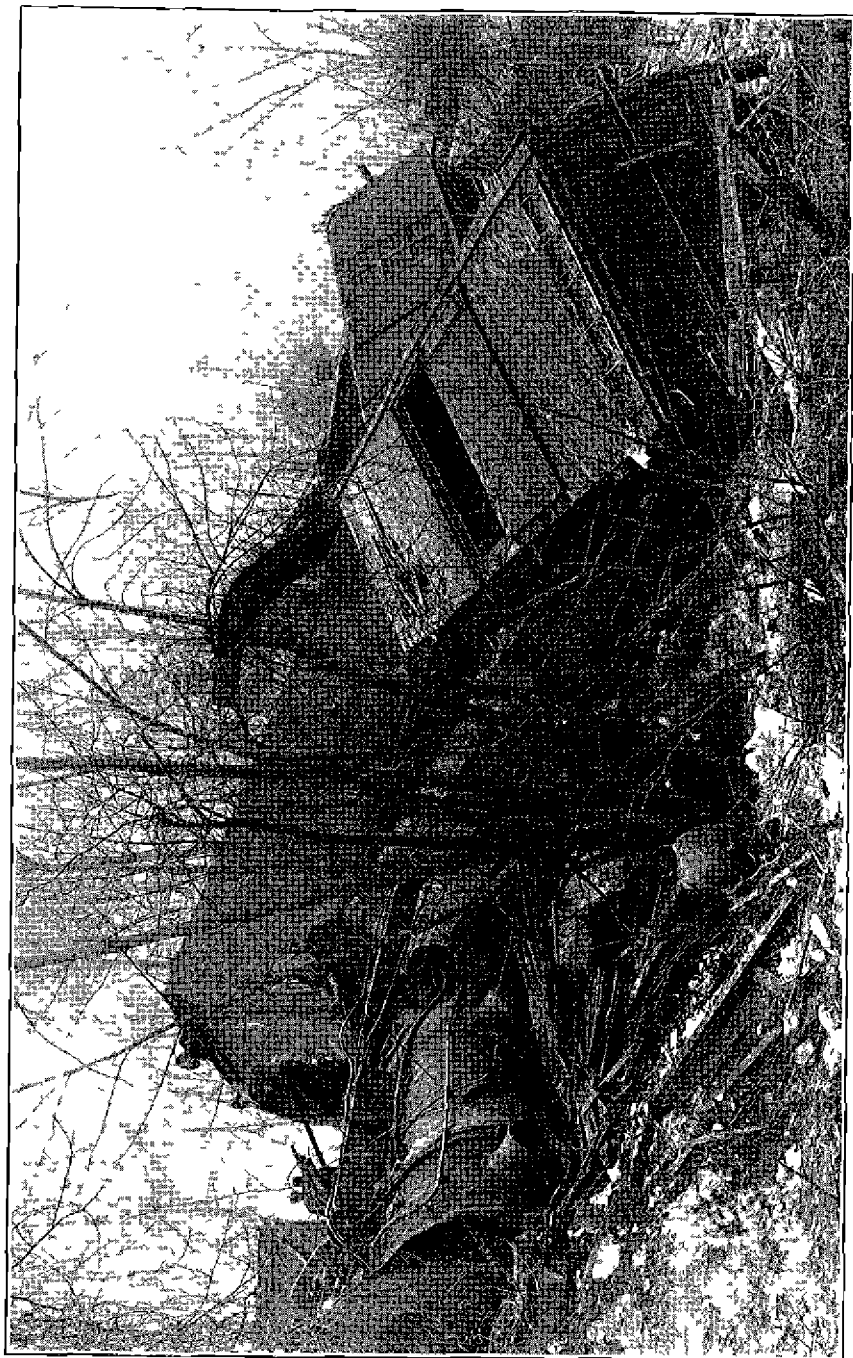
FIG 3 — General view of wreckage, engine of flight train on the left

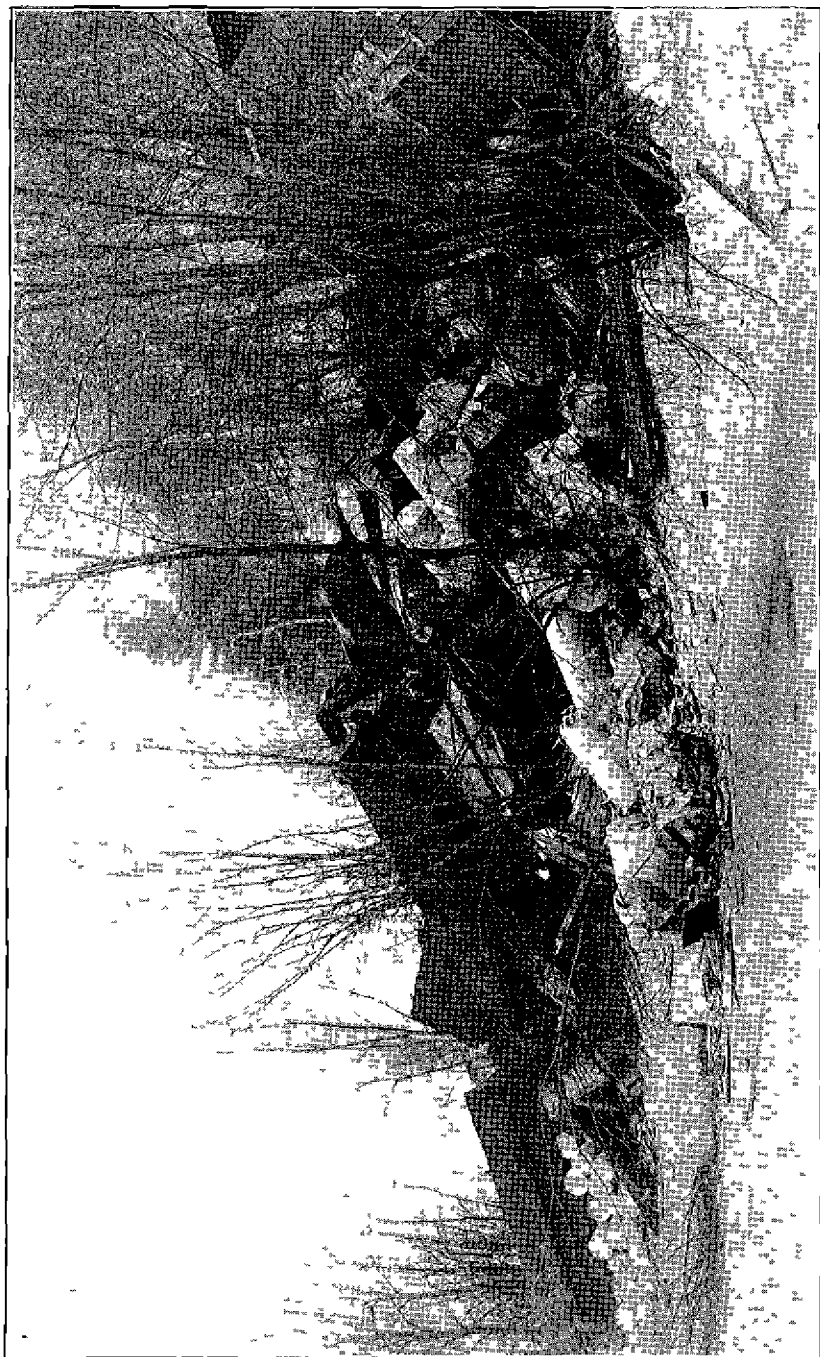
FIG 4—General view of wreckage
