INTERSTATE COMMERCE COMMISSION

REPORT OF THE CHIEF OF THE BUREAU OF SAFETY COVERING INVESTIGATION OF AN ACCIDENT WHICH OCCURRED ON THE LINE OF THE SOUTHERN PACIFIC COMPANY NEAR BERTHA, OREG, ON MAY 9, 1920

JULY 3 1920

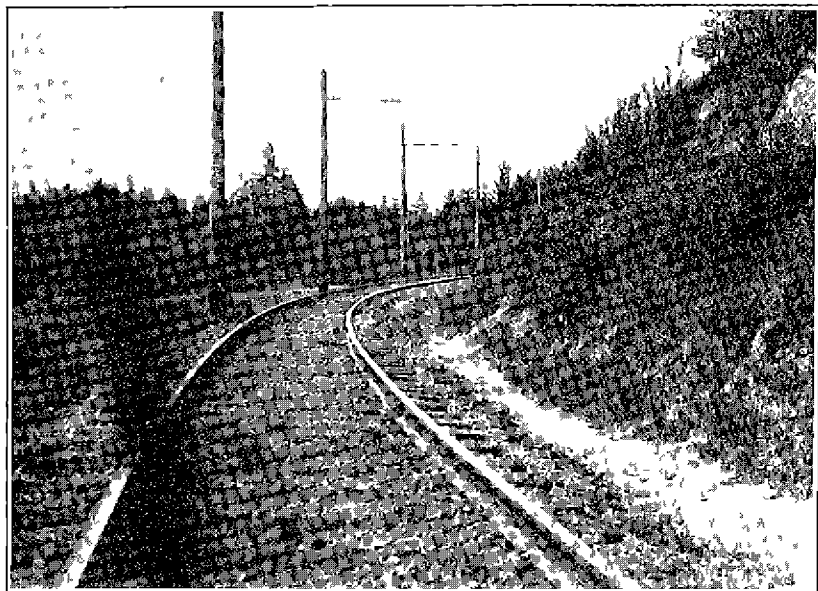
FIG. No. 1—View approaching point of accident from east

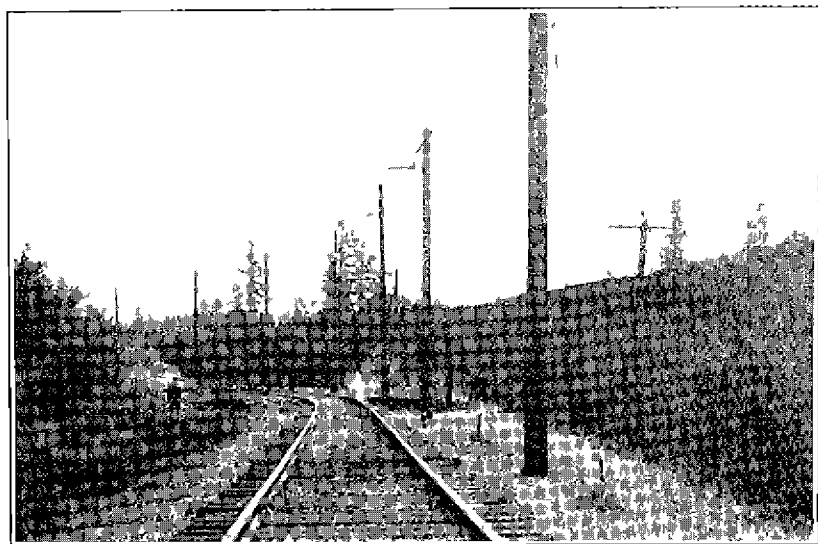
FIG. No. 2—View approaching point of accident from west

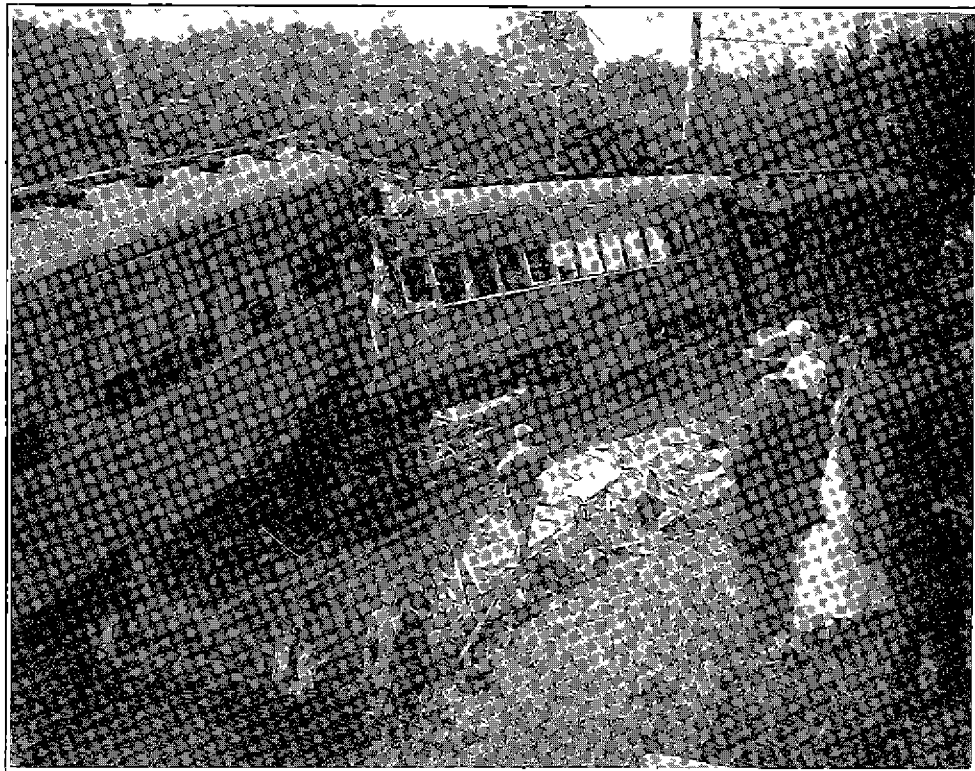
The front ends of the two leading cars were torn from their trucks and forced toward the outside of the curve. The front end of car 503, the leading car of train No 107, was raised above the

FIG. No. 3—General view of wrecked equipment taken shortly after occurrence of accident

floor of car 502, of train No 124, telescoping that car a distance of about 19 feet on its right side and about 13 feet on its left side. None of the other cars was badly damaged. Illustration No 3 is a general view, taken from the embankment on the inside of the curve showing the leading car of train No 107 on the left and the two cars of train No 124 on the right. Illustration No 4 shows the manner in which the front end of car 503 was bent, which undoubtedly contributed to the telescoping of car 502. Illustration No 5 shows the condition of car 502 after it had been moved to the shops. With the exception of an employee off duty, who was riding in the front end of car 503, all of the persons killed were riding in car 502. The employee on duty who was killed was Engineman Willett, of train No 124.

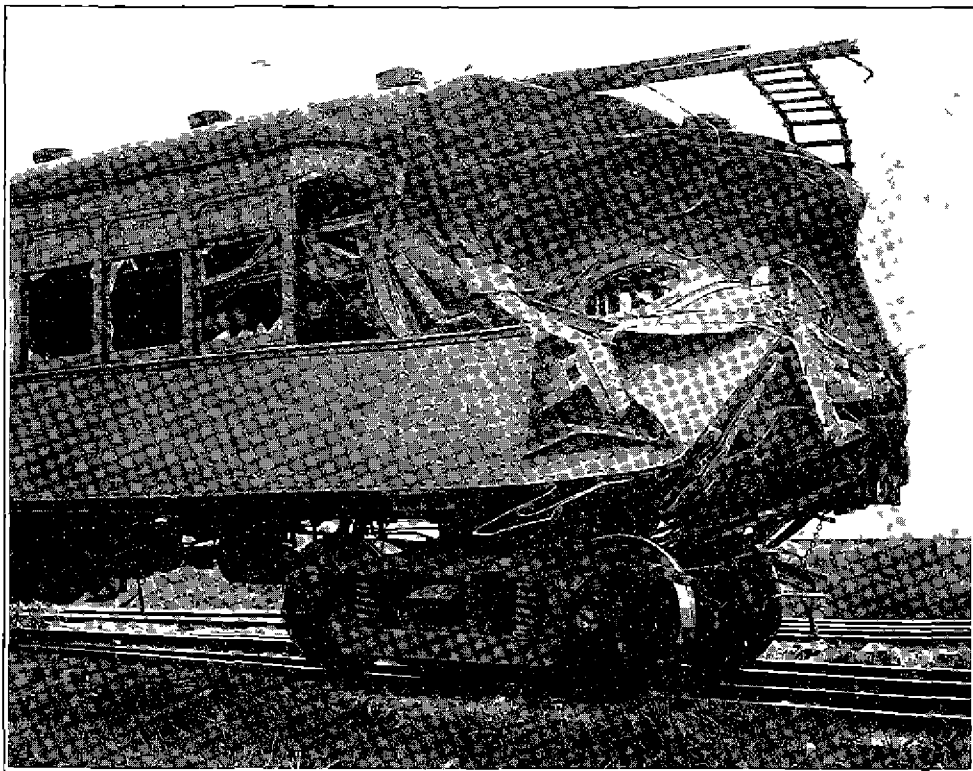
FIG No 4—Front end of car 50 of train No 107

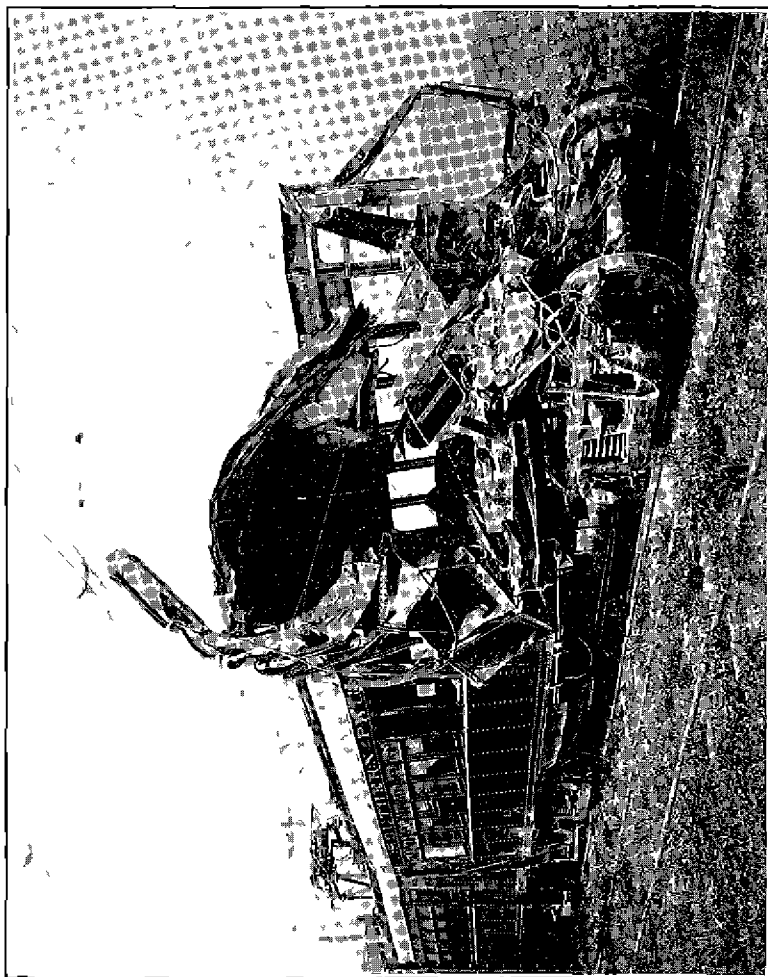
FIG. No 5—Car 502, of train No 124, after its removal to the shops

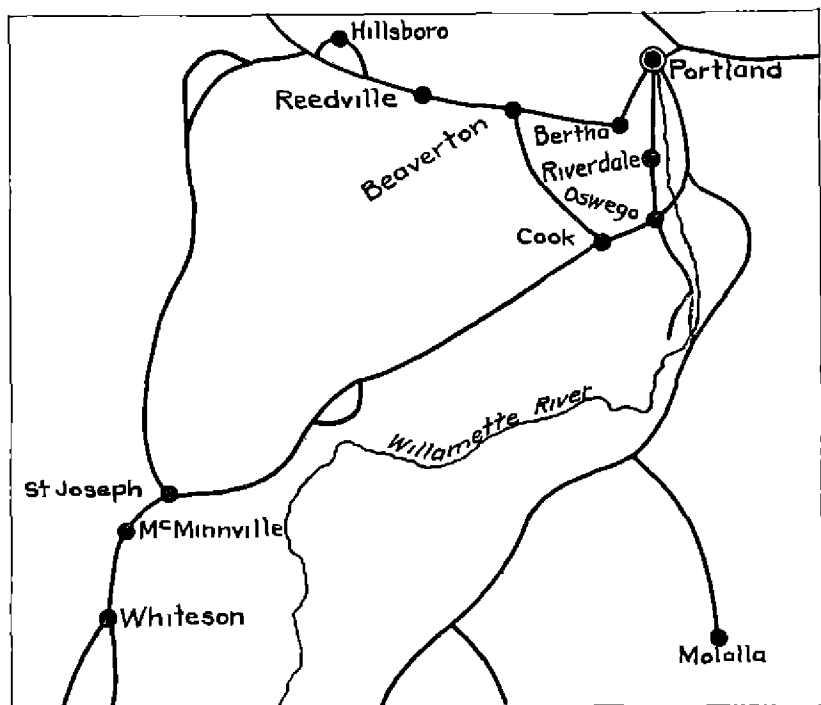
The accompanying sketch indicates the arrangement of the tracks of the Portland division in the vicinity of Portland. Over these

FIG. No. 6.—Tracks of Portland Division in vicinity of Portland

lines there is a large volume of traffic, including a considerable number of suburban trains. Following the Riverdale accident in 1915 the block system was installed on the line from Jefferson Street Depot, Portland, to Oswego, and at the time of the accident near Oswego in 1918 an appropriation had been made for extending the block system west of that point. The traffic on these lines is of such character, including trains making frequent stops and attaining comparatively high speed between stations, that proper protection can be furnished only by block signals and a code of block rules adequate to meet the traffic requirements. In this vicinity, in electric train service, the volume of traffic fluctuates from day to day,

particularly at week ends and in holiday seasons, and it was brought out at the investigation that it is frequently necessary to extend schedules in electric zones. Under these circumstances the train orders for directing the movement of traffic are particularly susceptible to misunderstanding, misinterpretation, or other error, and the necessity for the block system is apparent. The Southern Pacific Co. has recognized this necessity by the installation of the block system on a portion of these lines. On the line where this accident occurred, between Portland and Reedville, there are 20 first-class trains operated daily in both directions, in addition to six other first-class trains which are operated over a portion of this territory. With the exception of one train, which leaves Portland late in the evening, all of these 26 trains are operated within a period of approximately 17 hours. Traffic of this density on a single-track road warrants the installation of an adequate block-signal system, and it is recommended that such a system be promptly placed in operation on this line, in order to insure proper protection for the operation of trains.
