## INTERSTATE COMMERCE COMMISSION

### REPORT OF THE CHIEF OF THE DIVISION OF SAFETY COVERING THE INVESTIGATION OF AN ACCIDENT WHICH OCCURRED ON THE SOUTHERN RAILWAY NEAR HOFFMAN, ILL., ON JUNE 7, 1915

SEPTEMBER 14, 1916

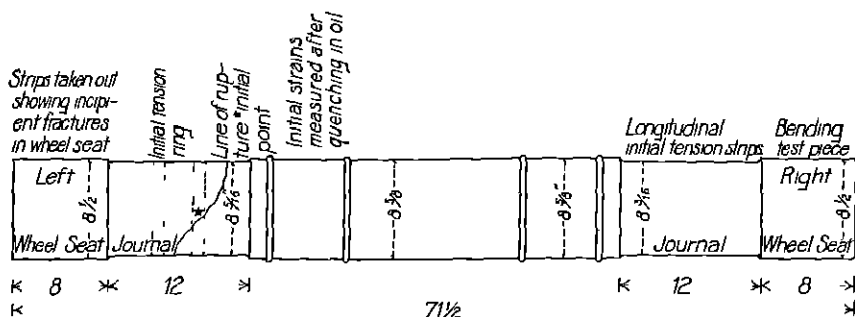
FIG No 1—Sketch of main driving axle which failed under engine No 1056 showing location of fracture in left hand journal with descriptive notes concerning tests and positions of test pieces

The cause of the failure of the main driving axle under engine No. 1056 was an area of metal at the surface of the journal which contained chatter marks and short incipient cracks made by the roughing cut in the lathe during the machining of the forging from which the axle was made. At one place only along the length of the journal were these incipient cracks in evidence, and at that place the line of fracture had its origin. This condition represented a defect in the machine finishing of the axle. The finishing cut in the lathe did not remove the metal which had been injured by the roughing cut.

Figure No 1 shows the shape and dimensions of the axle, on which are entered notes descriptive of the examination which was made of the metal

The line of rupture started at a place in the periphery, about 5 inches from the inner end of the journal, indicated by a star on the sketch of the axle, thence taking an oblique course, ultimately separating the axle The fracture was progressive, according to the evidence presented by the ruptured surface It appeared to have developed gradually until about one quarter of the cross section was separated, after which the remaining stages of rupture were rapidly completed

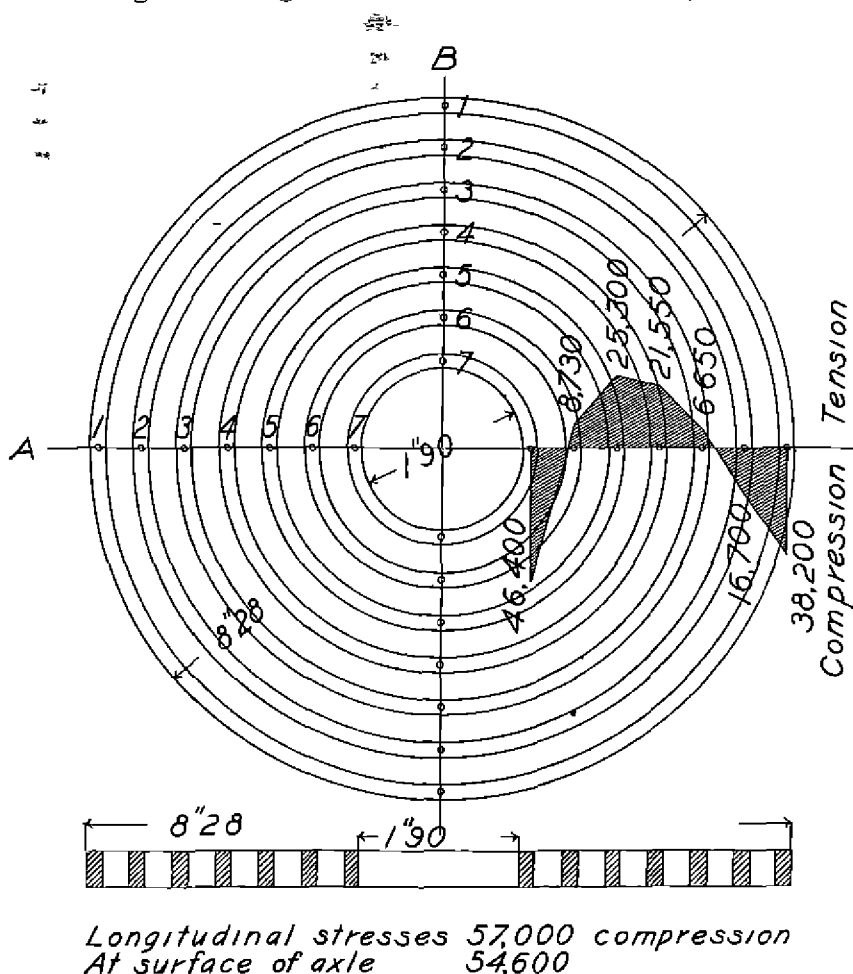
FIG. No. 7—Showing the manner of taking out concentric rings from disk after the axle had been quenched in oil from a temperature of 1550° F. graphically illustrating the initial strains which were found in the rings by shaded zones

Figure No 7 shows the manner of cutting the disk into concentric rings and graphically illustrates the stresses which were displayed by each.

It will be observed that the internal strains in a tangential direction were of compression at the exterior of the axle and next the bored hole, while the interior portion was in a state of initial tension.

The stress of compression in the exterior ring was 38,200 pounds per square inch, and in that of the ring at the bore 46,400 pounds per square inch. The maximum tensile stress observed in one of the interior rings, No. 5, was 25,300 pounds per square inch. These values represent the mean stresses in rings three sixteenths inch in thickness. The range in tangential stress, of tension and compression, is shown to be 71,700 pounds per square inch.

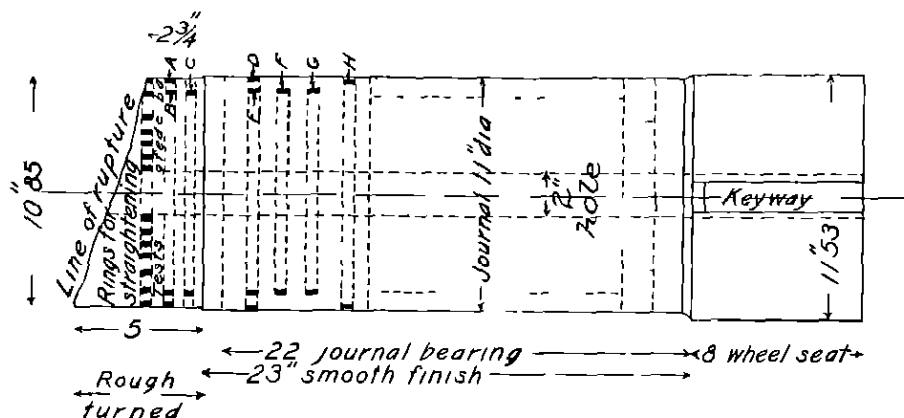
FIG. No 9.—Sketch of the half of the heat treated axle which was examined showing positions of rings on which initial strains were measured and those used for bending tests

Figure No. 9 is a sketch of the half of the axle which was examined, on which are indicated the positions of the several rings on which the internal strains were measured.

Referring to the initial strains which were present in the axle, in the condition it was found after its fracture the metal at the surface of the rough turned section between journals was in a state of tangential compression. The metal of ring A, an exterior ring from this rough turned section, showed an expansion in diameter corresponding to 13,000 pounds per square inch compression. Ring B, located in the same plane as ring A, but taken five eighths inch below the sur-

face of the axle, showed the stresses of compression were there reduced to 8,360 pounds per square inch

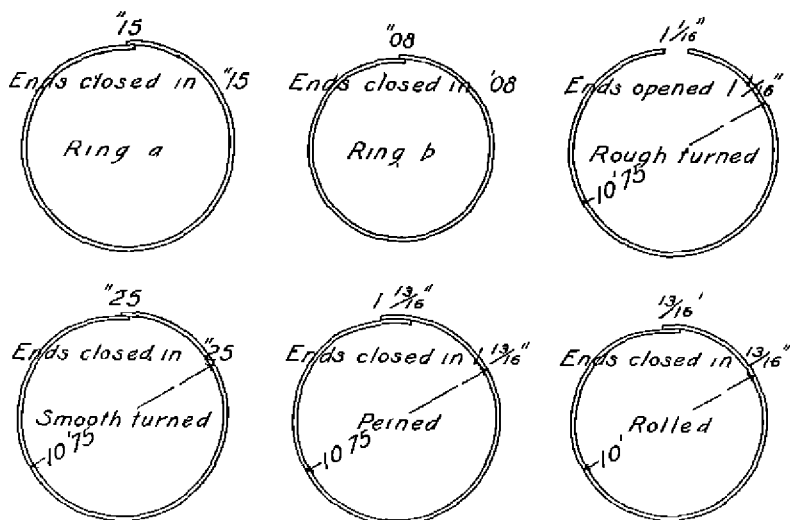
FIG No 10—Sketches of rings from heat treated axle showing changes in shapes when cut apart radially caused by different treatment of their exterior surfaces when they were an integral part of the axle

Several rings from the heat-treated axle were cut apart radially whereupon the ends closed in or sprung apart, according to the progressive character of the internal strains in the metal. Figure No. 10 shows the amounts which different rings changed their shape when further opportunity was given them to experience relief from the residual strains which were in the steel.
