INTERSTATE COMMERCE COMMISSION.

REPORT OF THE CHIEF OF THE BUREAU OF SAFETY UPON AN ACCIDENT WHICH OCCURRED ON THE SOUTHERN RAILWAY, NEAR ORANGE, VA., ON OCTOBER 21, 1917.

NOVEMBER 6, 1917.

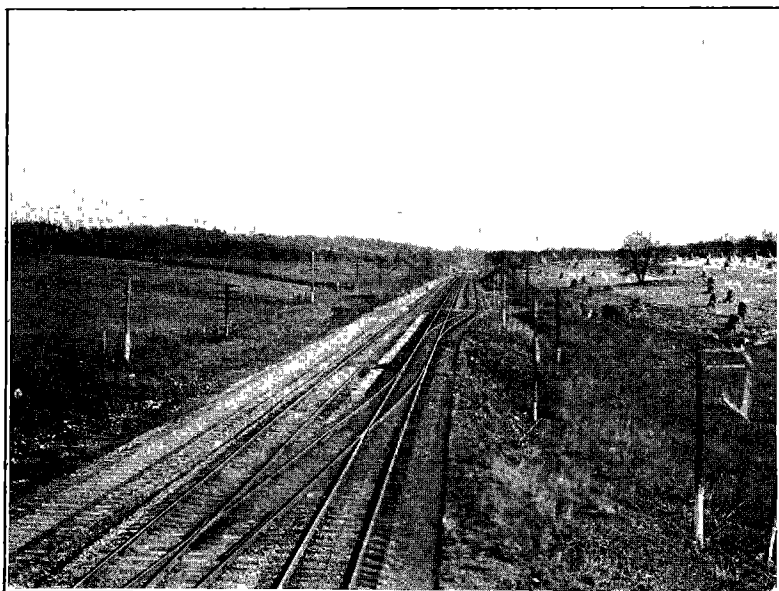
FIG 1—VIEW NORTHWARD FROM SIGNAL NO. 834 TOWARD SCENE OF ACCIDENT

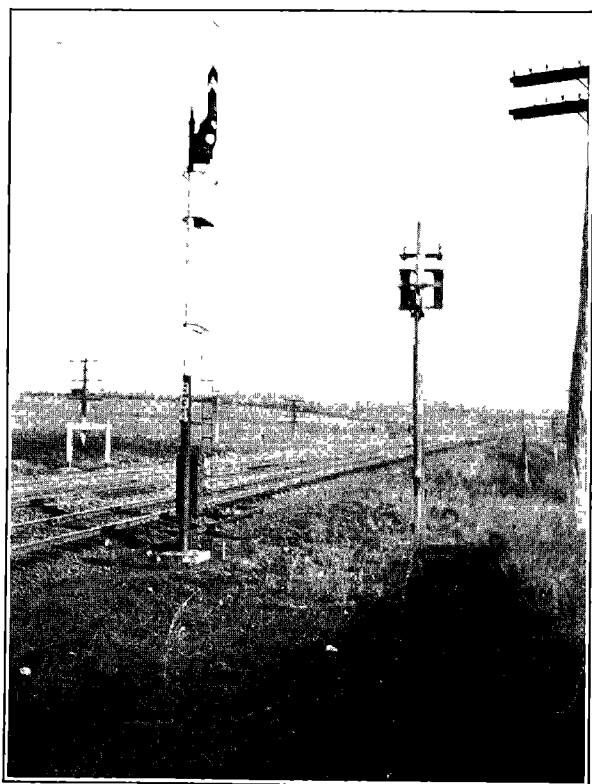
FIG 2. SIGNAL NO. 834

It could not be positively determined whether train No. 38 received a caution or a stop indication at signal No 834 It is noted that Engineman Larmond stated that he received a white indication at this signal. The investigation and tests clearly established that this can not be true, for the reason that the preceding train, No 42, passed Orange only three minutes before train 38, and on account of train 42 being delayed at both signals 842 and 834, train 38 undoubtedly closed up considerably on train 42 shortly after leaving Orange This is borne out by the fact that signal 842 changed from stop to caution only a short distance ahead of train 38, at which time train 42 must have just cleared signal 834; train 42 then had approximately 4 miles to run before signal 834 would go to the clear position, while train 38 had only about 4,000 feet to run before passing that

signal. The tests made indicated that it was quite possible Engineman Larmond should have received either a stop or a caution indication at signal 834, on account of the position of train 42 ahead.

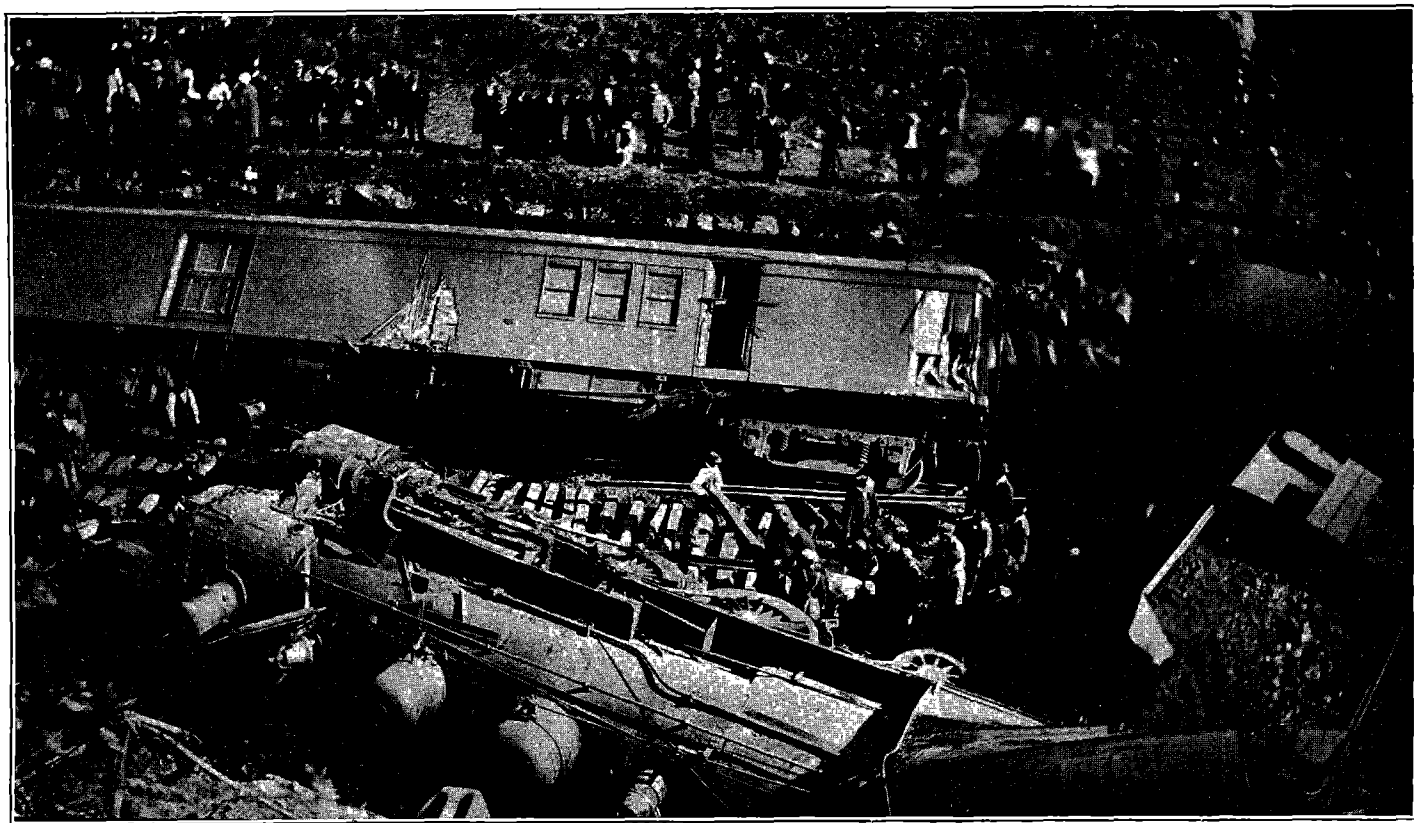
FIG 3—GENERAL VIEW OF WRECKAGE

The locomotive of train No. 38 first struck a glancing blow slightly forward of the middle of the fourth car in train No 16, pushing that car off toward the right, and then struck squarely on the corner of the third car in train No. 16, crushing the side of the car for approximately a third of its length and overturning it against the side of the cut, and the fourth car, a day coach was derailed. The side of the rear car, a day coach, was scraped, but that car was not derailed, and the locomotive, tender and first car remained on the rails of the main track ahead of the wreckage. The locomotive and tender of train No. 38 were thrown across both tracks, the locomotive being overturned, coming to rest on its left side, 251 feet from the point of collision, and the tender being thrown off from its trucks. The first three cars were derailed, two of them also fouling the southbound track; the other five Pullman cars of train No. 38 were not derailed or damaged. Approximately 250 feet of the northbound track and 160 feet of the southbound track were torn up.

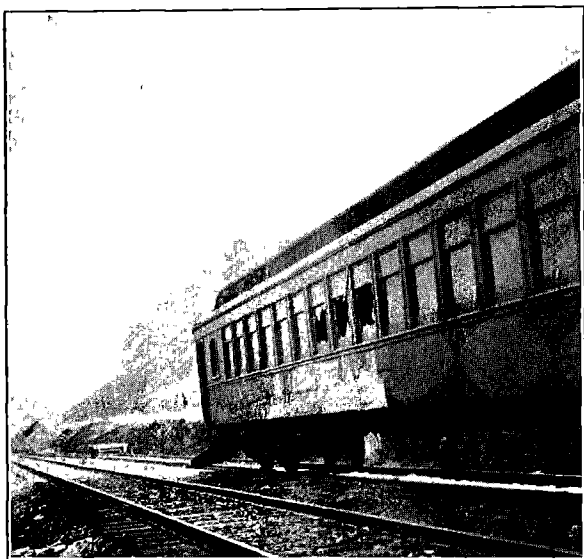
FIG 4 —FOURTH CAR IN TRAIN NO 16

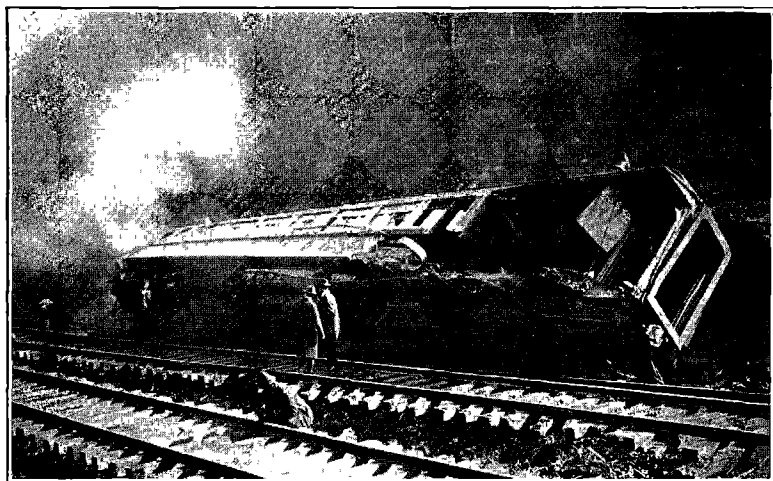
FIG 5 —THIRD CAR IN TRAIN NO 16

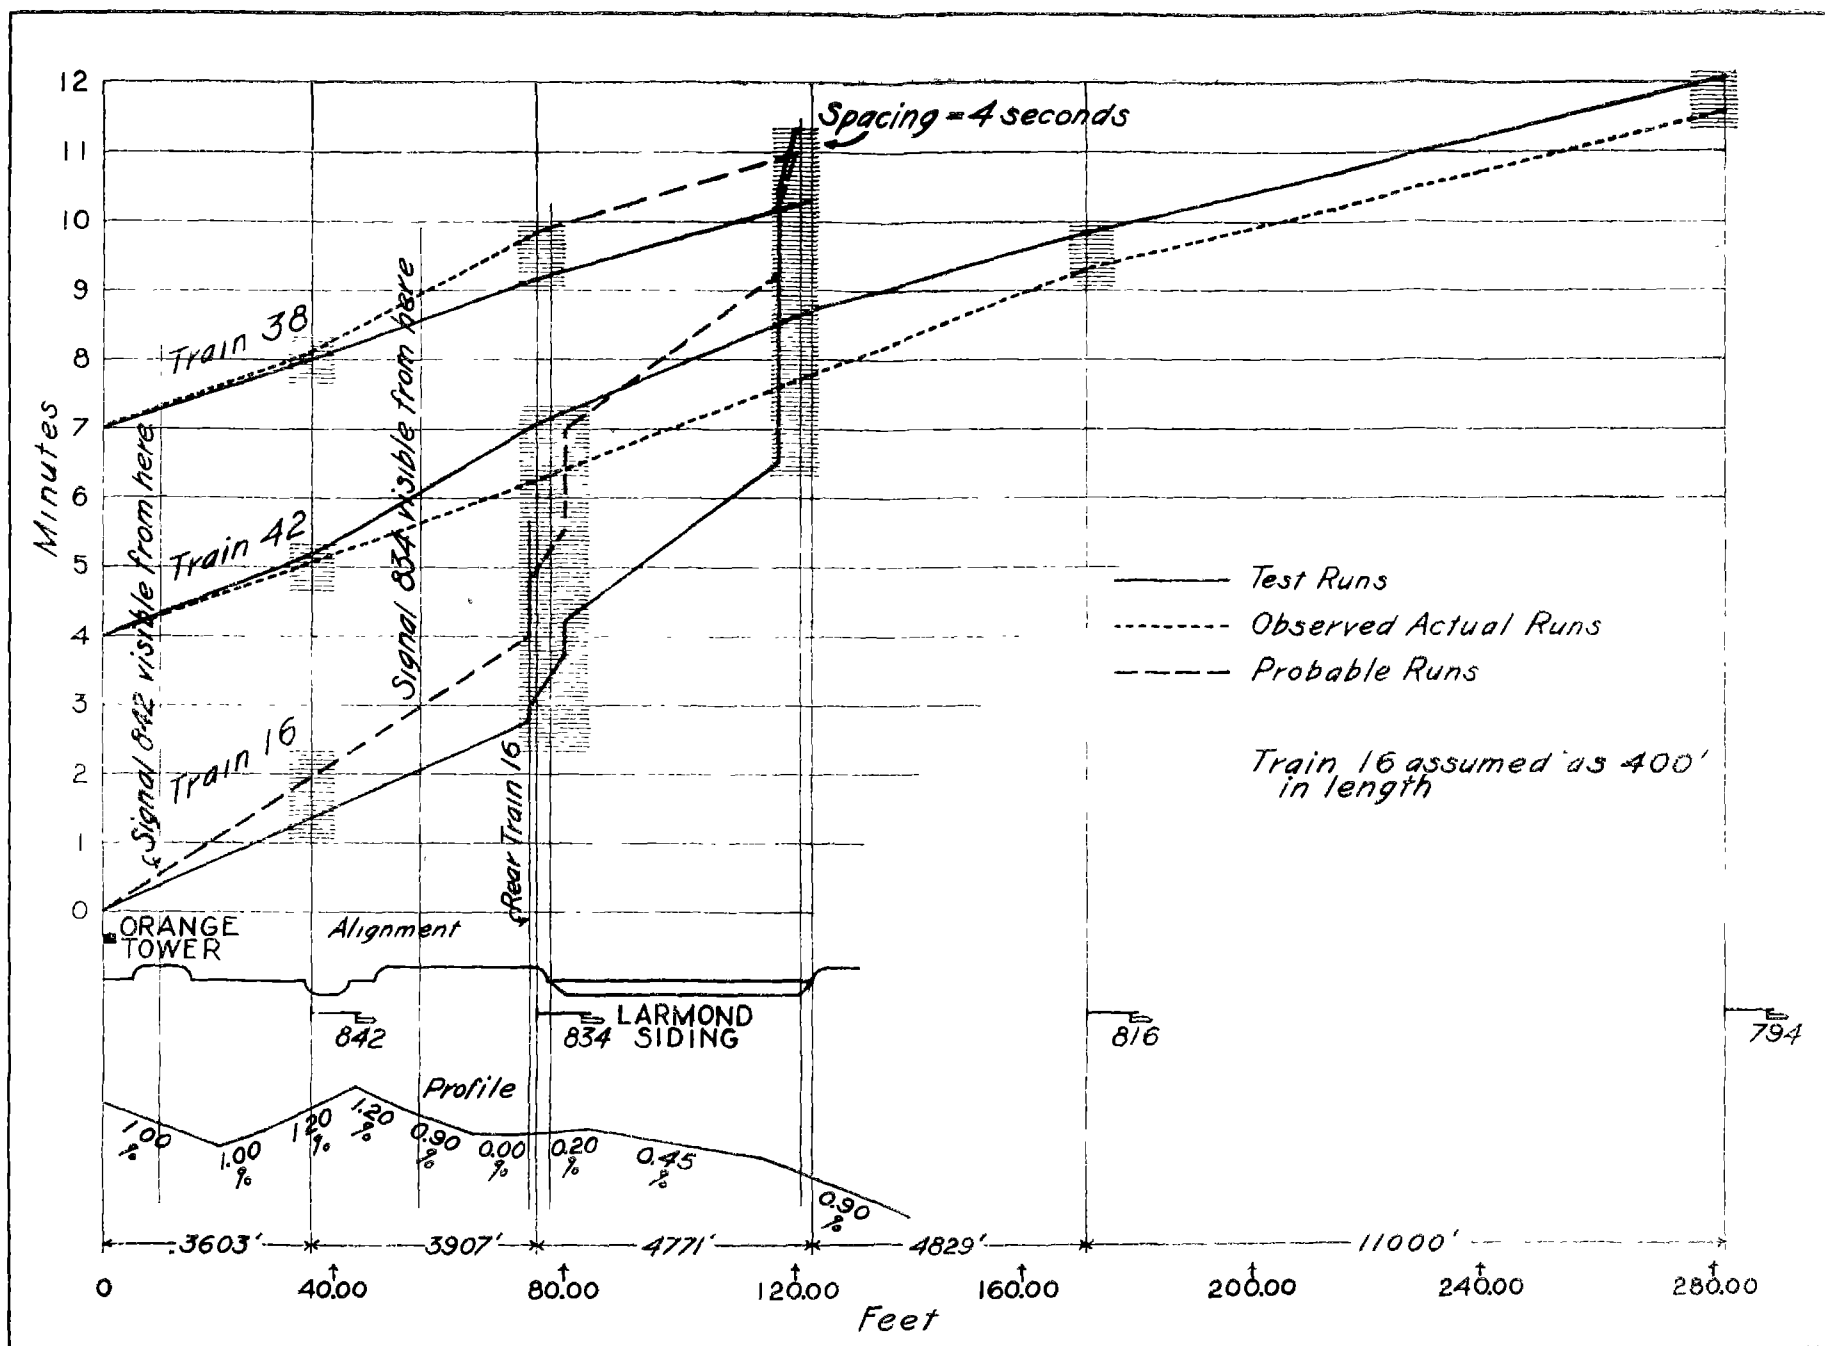
FIG. 6.

On the accompanying diagram the results of the three test runs made on October 24 are shown in full lines. The dotted lines represent the actual runs of trains 42 and 38 as observed on the day following that on which the test runs were made. In order to show the conditions leading up to the accident certain assumptions deduced from the tests and from the evidence have been made as to the movements of trains 16 and 38 on the day of the accident, which are shown on the diagram by dashed lines.

In each case the origin of the speed lines is the time the rear of the train passed Orange tower, and allowance is made where necessary for the length of the train, but no allowance is made for time consumed by the signals in clearing, which was found to be 10 seconds for a full operation from stop to clear. The time shown by the diagram between these trains is taken from the operator's record at Orange tower.

The test run duplicating train 16, as plotted on the diagram, shows that if train 16, on the date of the accident, traveled between the points shown in the time stated by the crew, it would have been into clear at Larmond siding before train 42 left Orange and it would have been standing at the north end about two minutes when passed by that train. This was not in accordance with the statement of Engineman Fairfax at the investigation, when he said train 42 passed him while he was still moving, nor is it in accord with the statements of the crew of train No. 42. It is also shown that if train 16 stood at the north end of the siding four minutes, train 38, under the conditions assumed in the test, would have passed the point where the accident occurred before train 16 started out of the siding. Furthermore, under these circumstances had the switch been opened promptly after arrival of train 16 at the north end signal 834 would have been set at stop shortly after train 38 had left Orange and in time to have given it a caution indication at signal 842.

As it is therefore clearly established that the full line representing the test made in accordance with the statements of the crew of train No. 16 does not correctly represent the run actually made by train No. 16 on the date of the accident, another curve, shown as a dashed line on the diagram, has been constructed, based upon the deductions and conclusions arrived at as a result of the investigation of the accident, representing the run of train No. 16 as it is believed it was actually made. As the accident occurred at 7:01, train 38 must have been a little slower between signal 834 and the point of accident than the test showed, so a dashed line, representing the probable run of train 38 between those points, has been added.

It is clearly established, therefore, and clearly shown by the diagram, that, first, train 16 consumed more time in running from Orange to the point of accident than the test run indicated; second, its crew could not have waited two minutes after throwing the switch before starting out on the main line; third, at the time the switch was thrown, train 38 must have been past signal 834; fourth, on account of the position of train 42, train 38 could not have received a more favorable indication than caution at signal 834, and fifth, train 38 was so close that had any member of the crew looked back immediately before train 16 started out of the siding the accident might easily have been averted.
