INTERSTATE COMMERCE COMMISSION

REPORT OF THE DIRECTOR OF THE BUREAU OF SAFETY IN RE INVESTIGATION OF AN ACCIDENT WHICH OCCURRED ON THE SOUTHERN RAILWAY NEAR RUTHERFORDTON, N C, ON OCTO- BER 1, 1925

MARCH 15, 1926

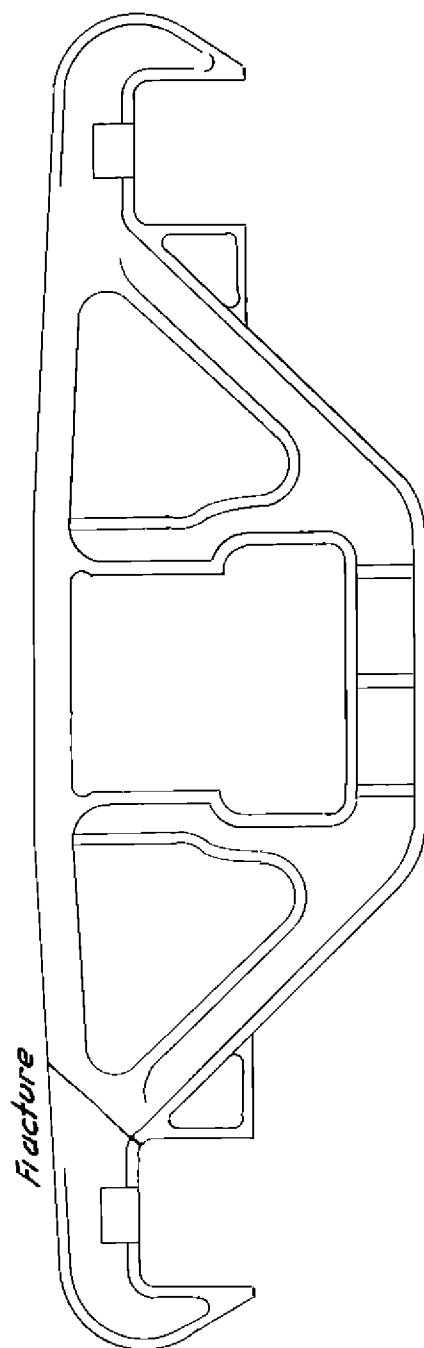
The origin of the earlier part of the fracture was located at the inner angle of the jaw, where bending stresses reach their maximum under the loads which are carried by the frame. It is a vital feature in the design of the frame to provide adequate strength at this place.

Figure 1 is a diagrammatic outline of the truck frame, showing the location of the fracture. This frame was on the left-hand side of the rear truck of the gondola car with reference to the train movement, the fracture occurring at its forward end.

FIG. 1 - Diagram of Vulcan truck frame showing location of fracture. Origin of initiation angle of journal box jaws

The direct cause of the fracture of the frame is attributed to error in the design, resulting in deficiency of metal at a vital place where working stresses attain maximum values. This part of the truck frame, carrying the journal boxes, represents a beam fixed at one end, the bending stresses being greatest at the inner angle of the jaw, at the root of the angle, where, as a matter of fact, the fracture of the frame had its origin. A few additional pounds of metal in the casting at this critical place would have added greatly to the strength of the frame. A few pounds of metal, judiciously disposed, in all probability would have averted this accident.

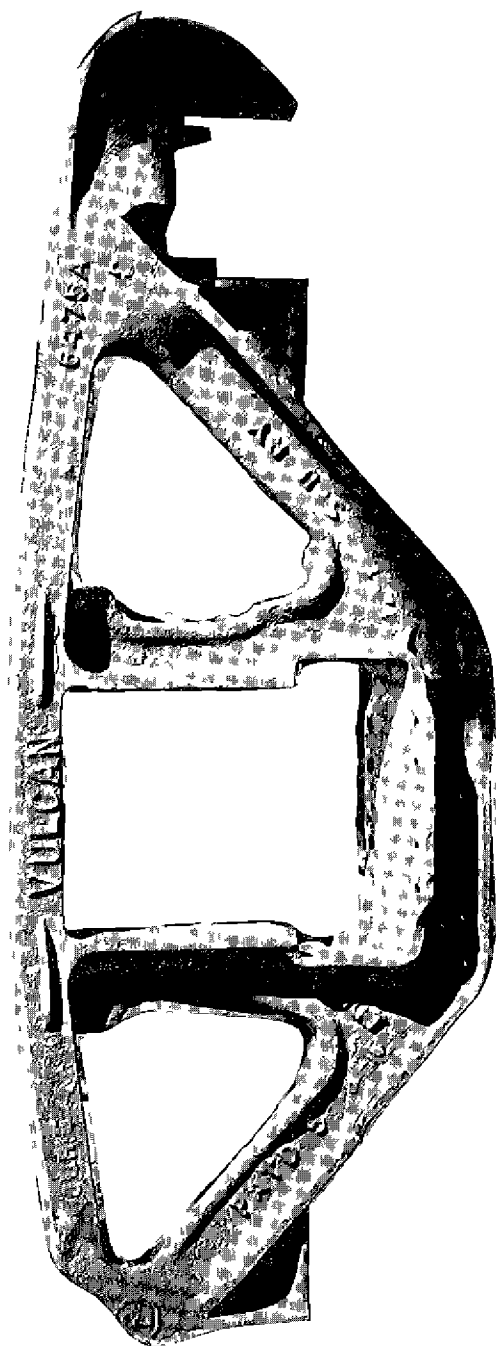
Figure 2 represents a photographic view of the frame. The line of fracture is just beyond the embossed letter E in the circle on the casting.

FIG 2 —Photograph of fractured vulcan truck frame

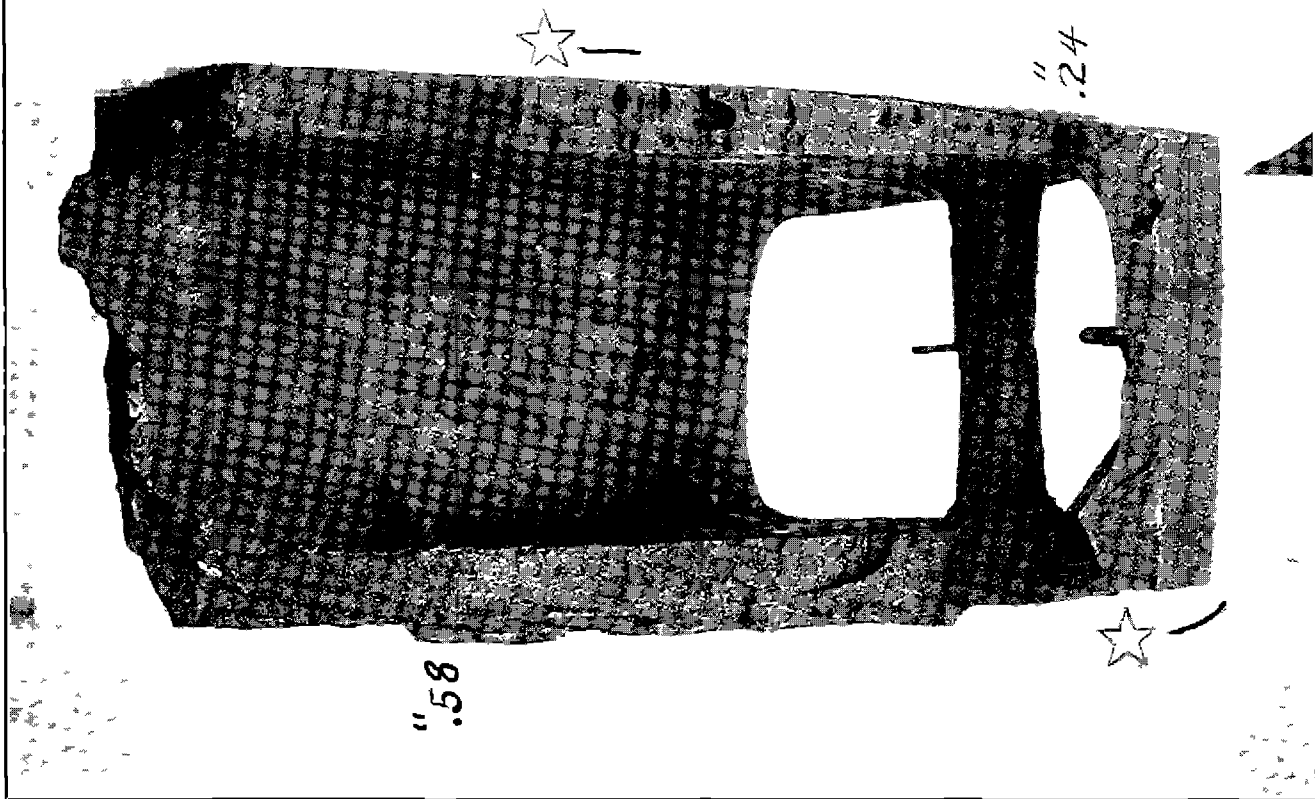
Figure 3 shows the appearance of the fractured surface, as exhibited on the detached fragment. A portion of the fracture existed prior to the accident, the balance occurred at the time of derailment.

The truck frame was partially fractured prior to the time of the derailment. The preexisting portion of the fractured surface is shown by Figure 3, embracing the portion between the stars which have been placed on the cut. This portion was the edge along the inner angle of the jaw and the inside rib of the frame. The fracture of the outside rib and the top web took place at the time of the accident.

FIG 3—Photograph of fractured surface of Vulcan truck frame end which fractured under gondola car. Preexisting fracture section between stars. Balance of fracture made at time of derailment.

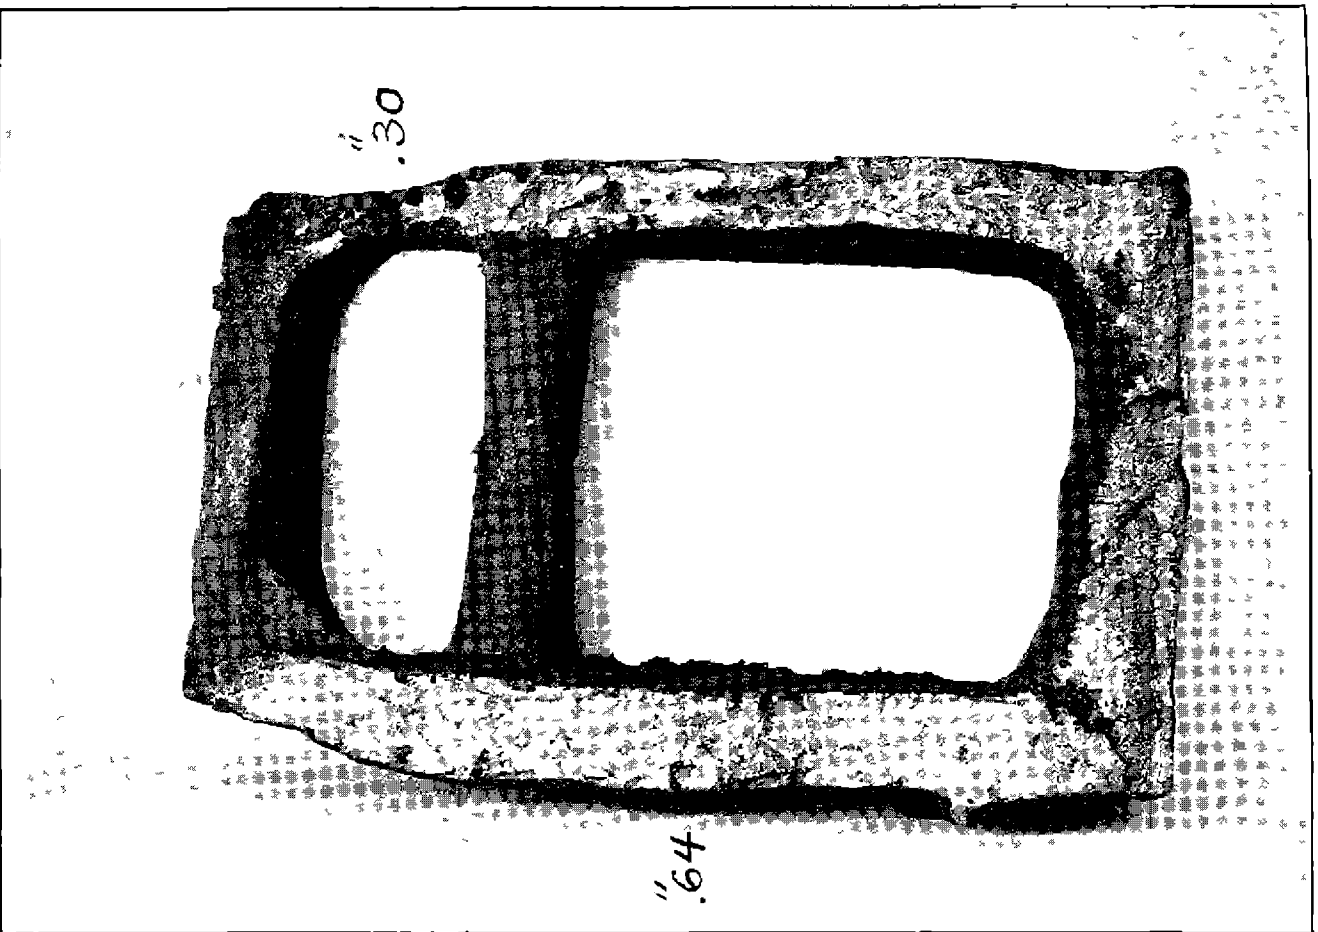
Figure 4 shows the fractured surface of the opposite end of the frame. This fracture was made by a steam hammer on the dismantled frame. Blowholes in the metal and variations in the thickness of the walls of the frame are shown by Figures 3 and 4.

The casting showed numerous blowholes in the inside rib. Blowholes exist in many if not in most steel castings. They are necessarily a source of weakness wherever found. At one place, as shown by Figure 4, the blowholes represented nearly 100 per cent of the cross section of the rib of the frame. It is not held that blowholes were primarily responsible, possibly not remotely accountable, for the fracture of this frame.

This was a cored casting. The core was not set concentric with the ribs. There were variations in thickness of the ribs, ranging from a maximum of 0.58 inch to a minimum of 0.24 inch at the end fractured under the gondola car. At the opposite end, where fractured by a steam hammer, the thickness of the ribs ranged from 0.30 inch minimum to 0.64 inch maximum. This variation in thickness of the metal is correctable in the foundry by the exercise of care in setting the cores.

FIG 4—Photograph of fractured surface of Vulcan truck frame. Fracture made with steam hammer. end opposite fracture which

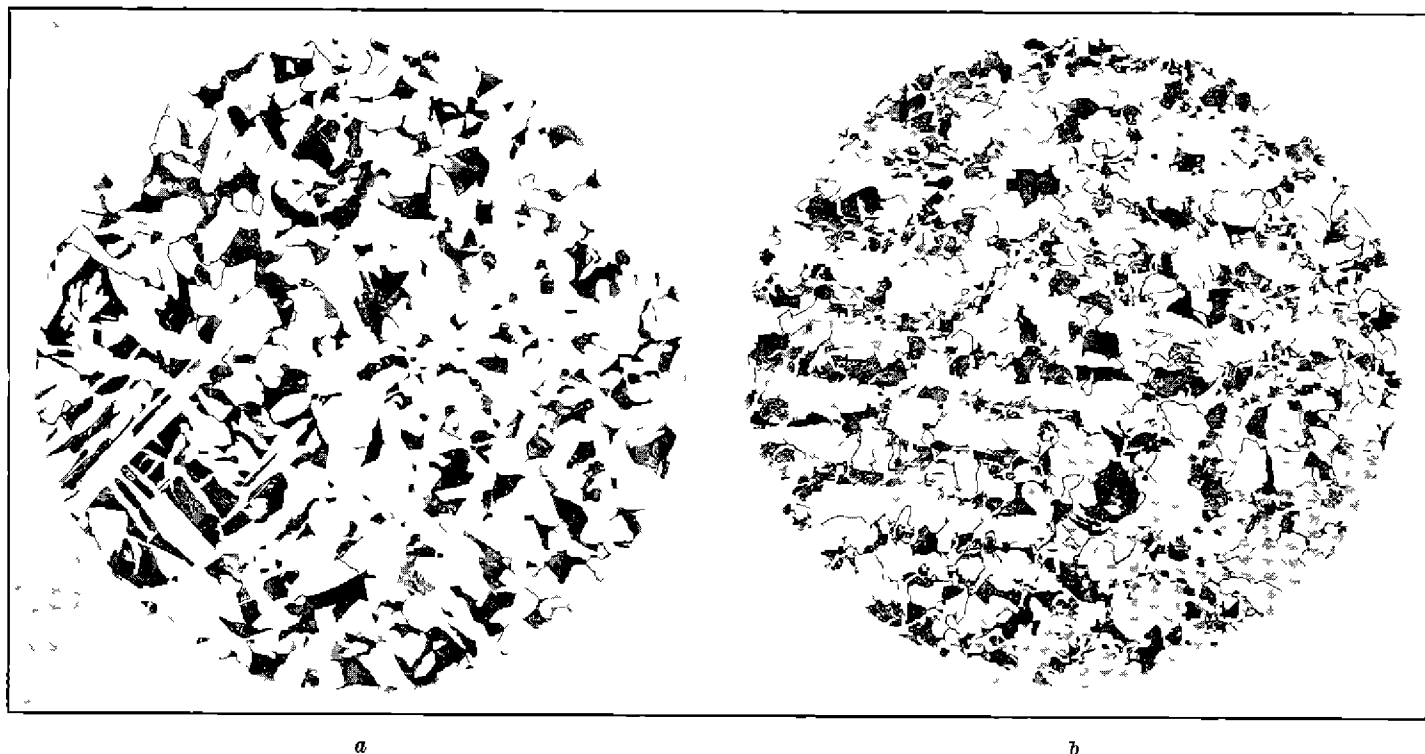
Figure 5 *a* and *b* are photomicrographs, representing the metal in the vicinity of the original fracture. Photomicrograph *a* shows the structure as found in the casting, photomicrograph *b* as it appeared after laboratory annealing. These structures were displayed by a nitric-acid etch, and are shown at a magnification of 100 diameters.

FIG 5—Photomicrographs of steel of Vulcan truck frame *a* Appearance of metal as found in the frame *b* Appearance of metal after laboratory annealing Nitric acid etch Magnification 100 diameters
